Norm Maleng Regional Justice Center - Kent

Heating Piping Assessment Final Report

November 20, 2008
Revised January 13, 2009

Sazan Group, Inc.

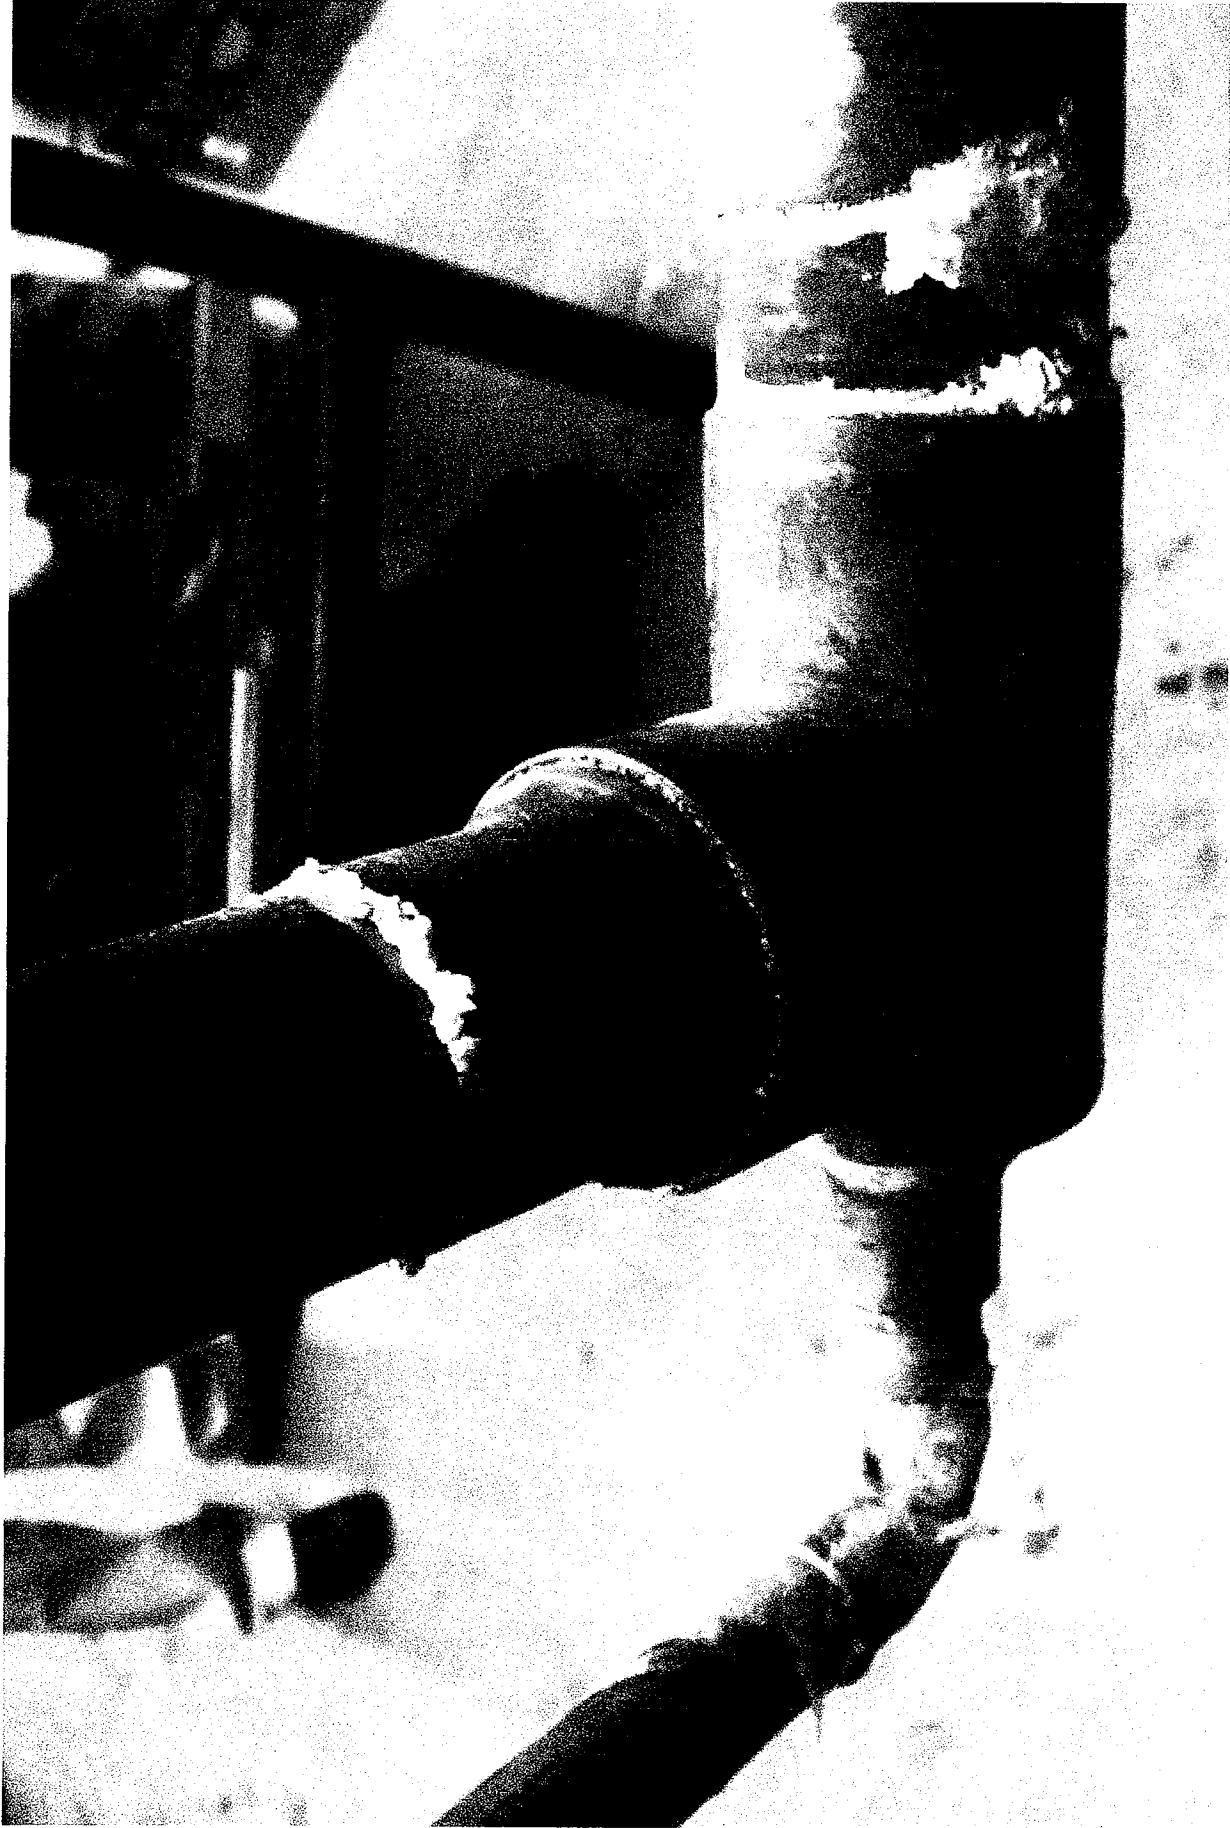
P-1 Pipe Sample At Water Heater
Crystalline substance at joints is like a salt from a pipe weep (instead of from a drip/leak).

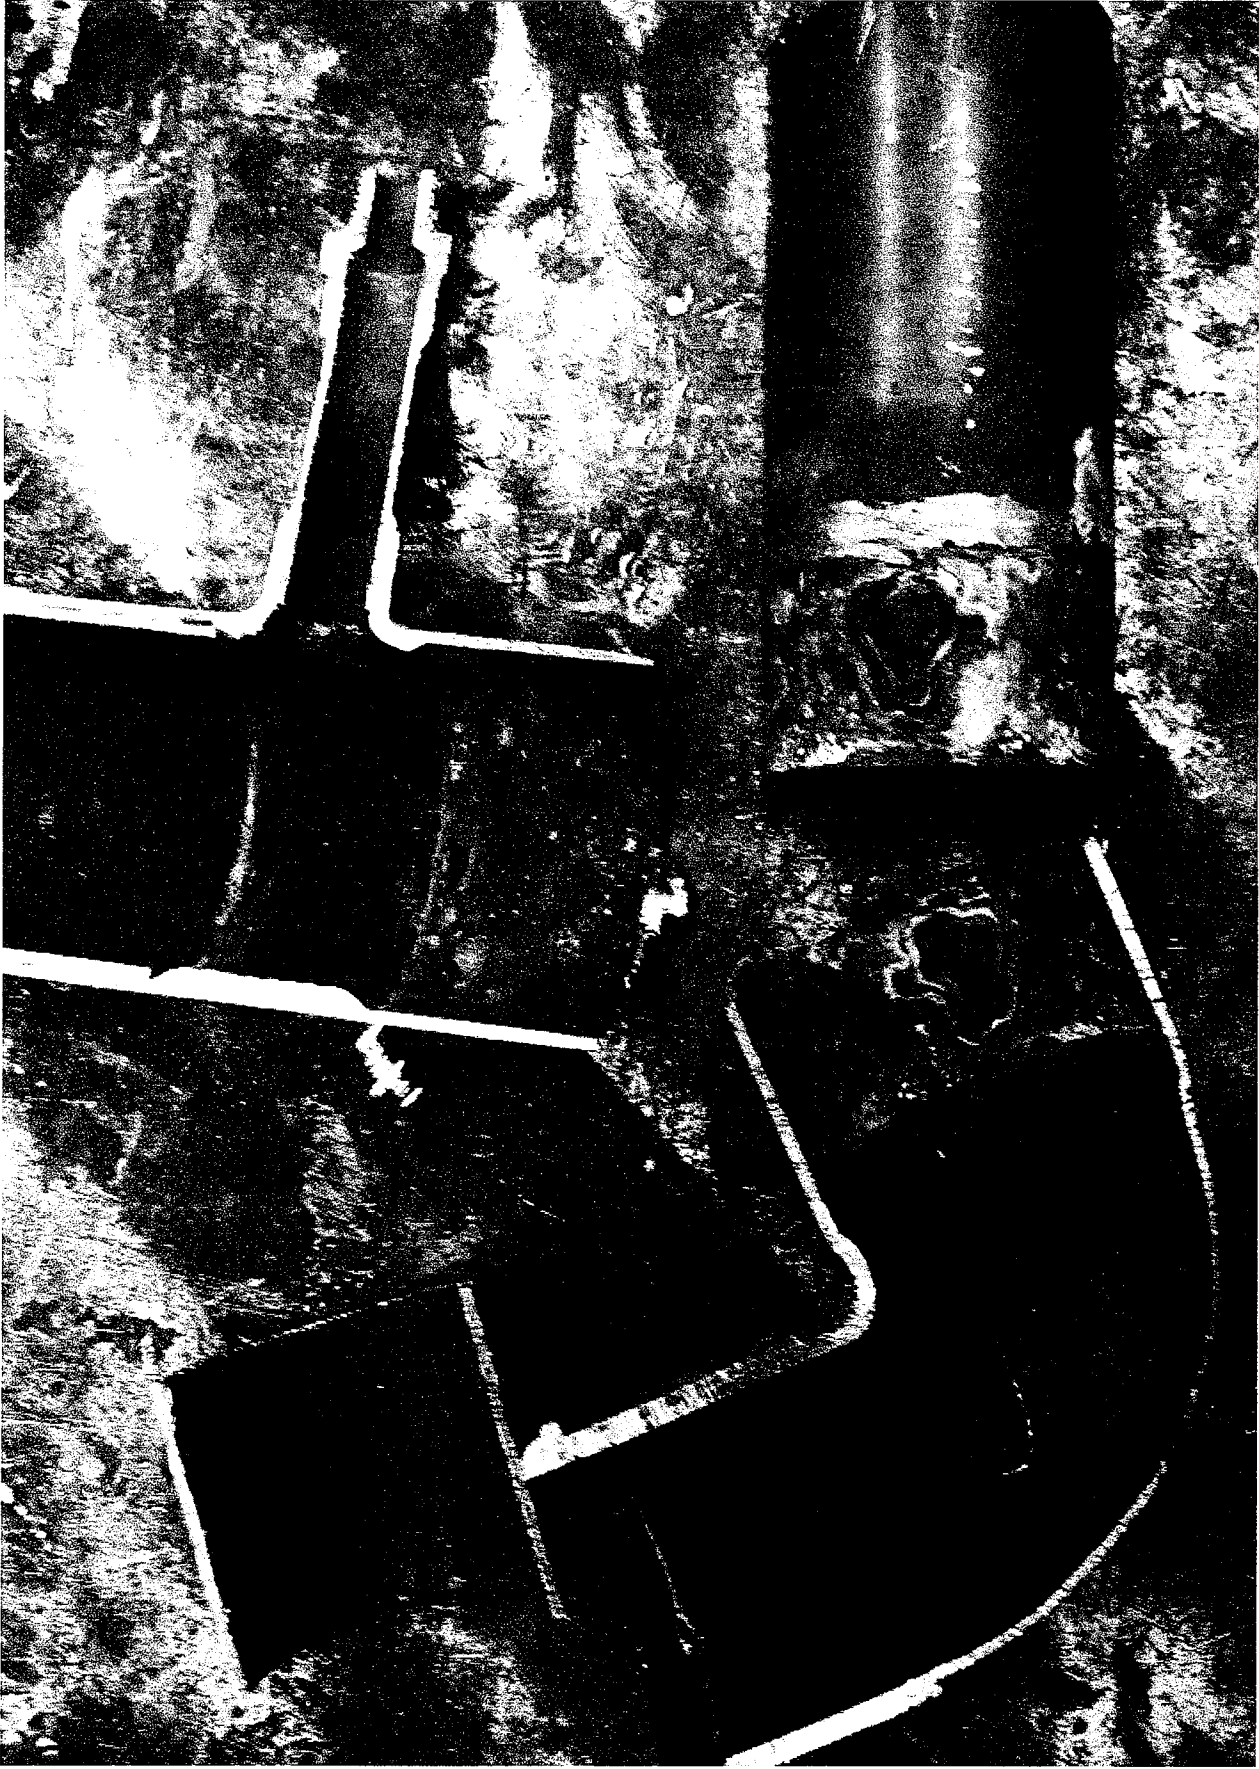
1. NVL: Samples were tested on October 31, 2008 and found to be:
 - a. Old sample: 0.017 % Lead
 - b. New pipe: Less than 1.0 PPM Antimony and 2.8 PPM Lead.
2. MDE Inc: Samples were tested in November 2008 and found to be:
 - a. Tin-antimony solder.
 - b. Joints were poorly made as the solder was uneven in the joints.

P-3 Pipe Joint Samples
Solder is uneven and spotty.

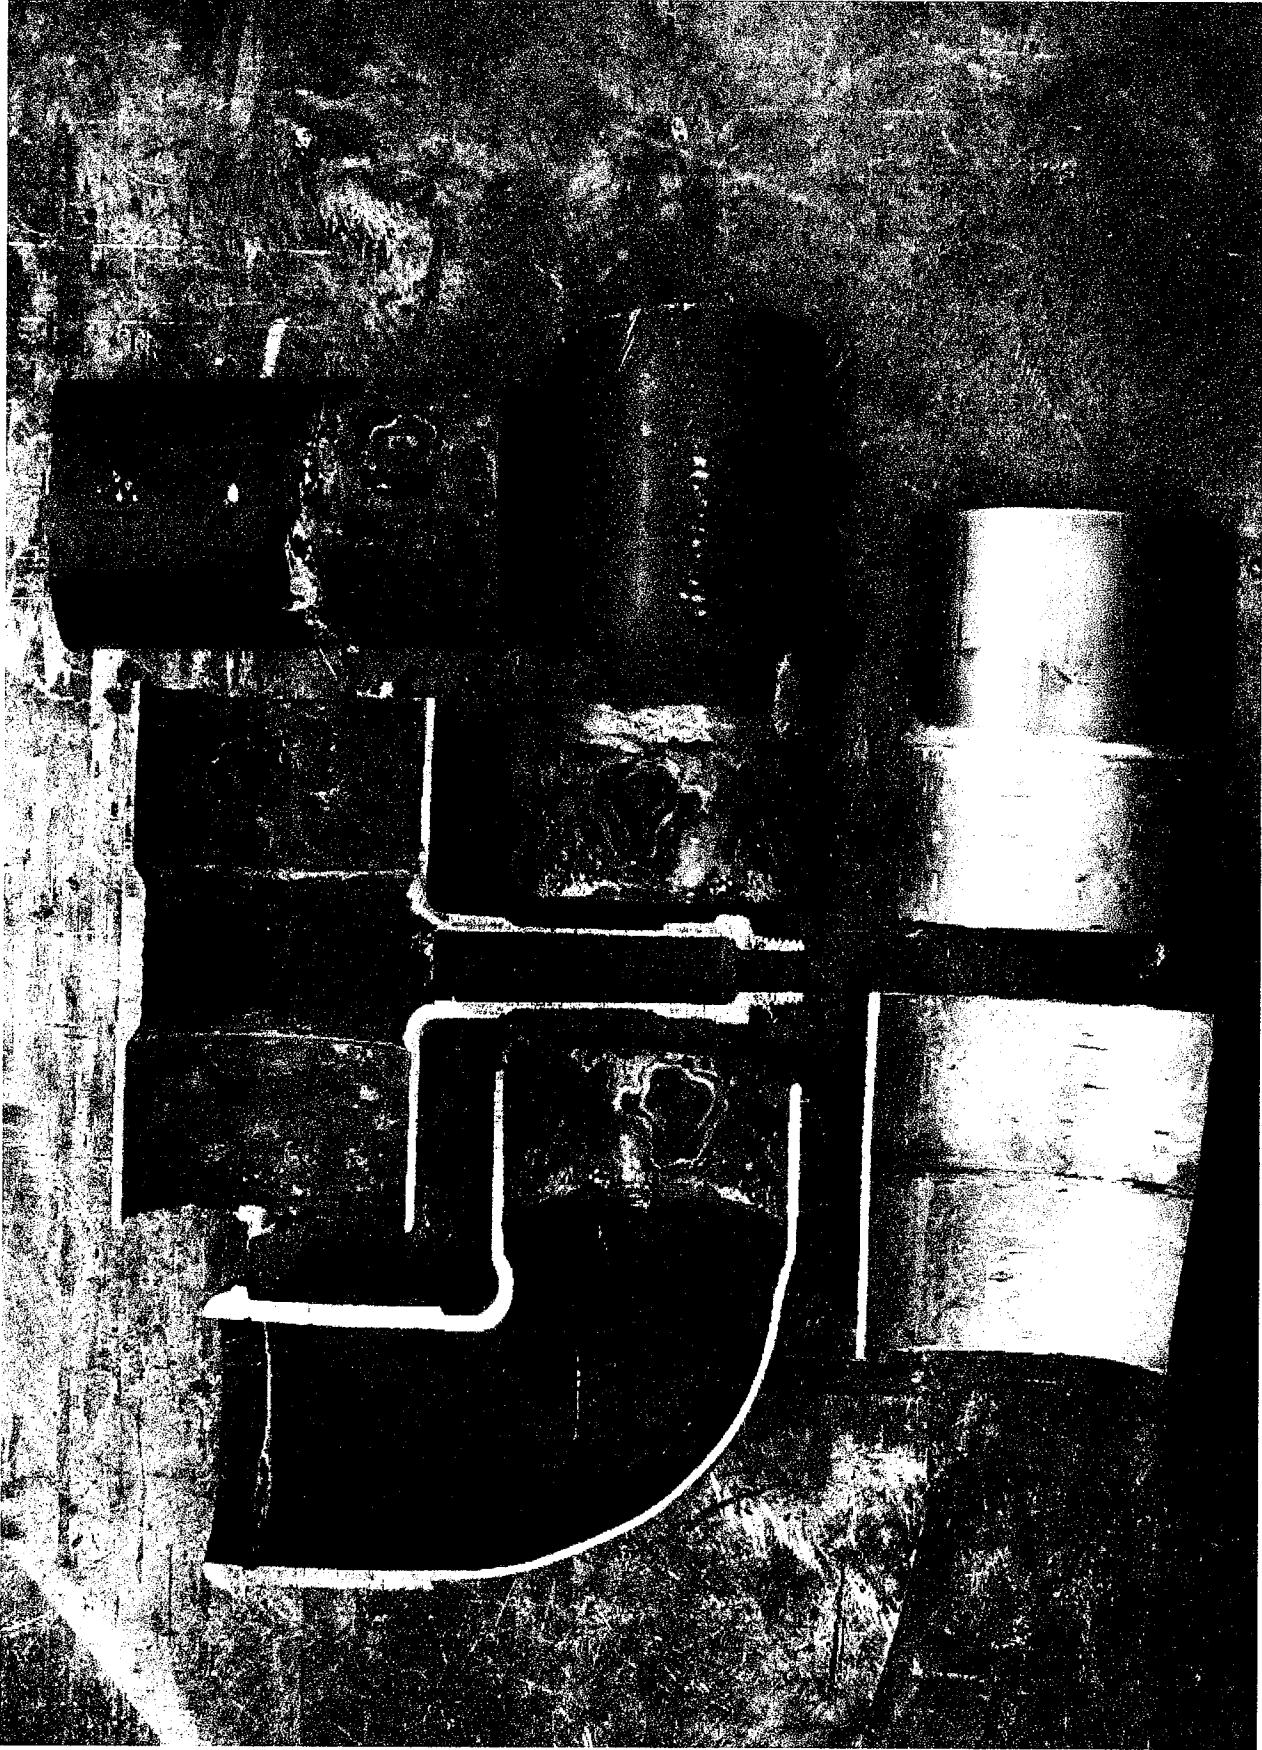
P-4 Pipe Joint Samples
Solder is uneven. For contract, the lower sample is a freshly made joint which was then cut apart.

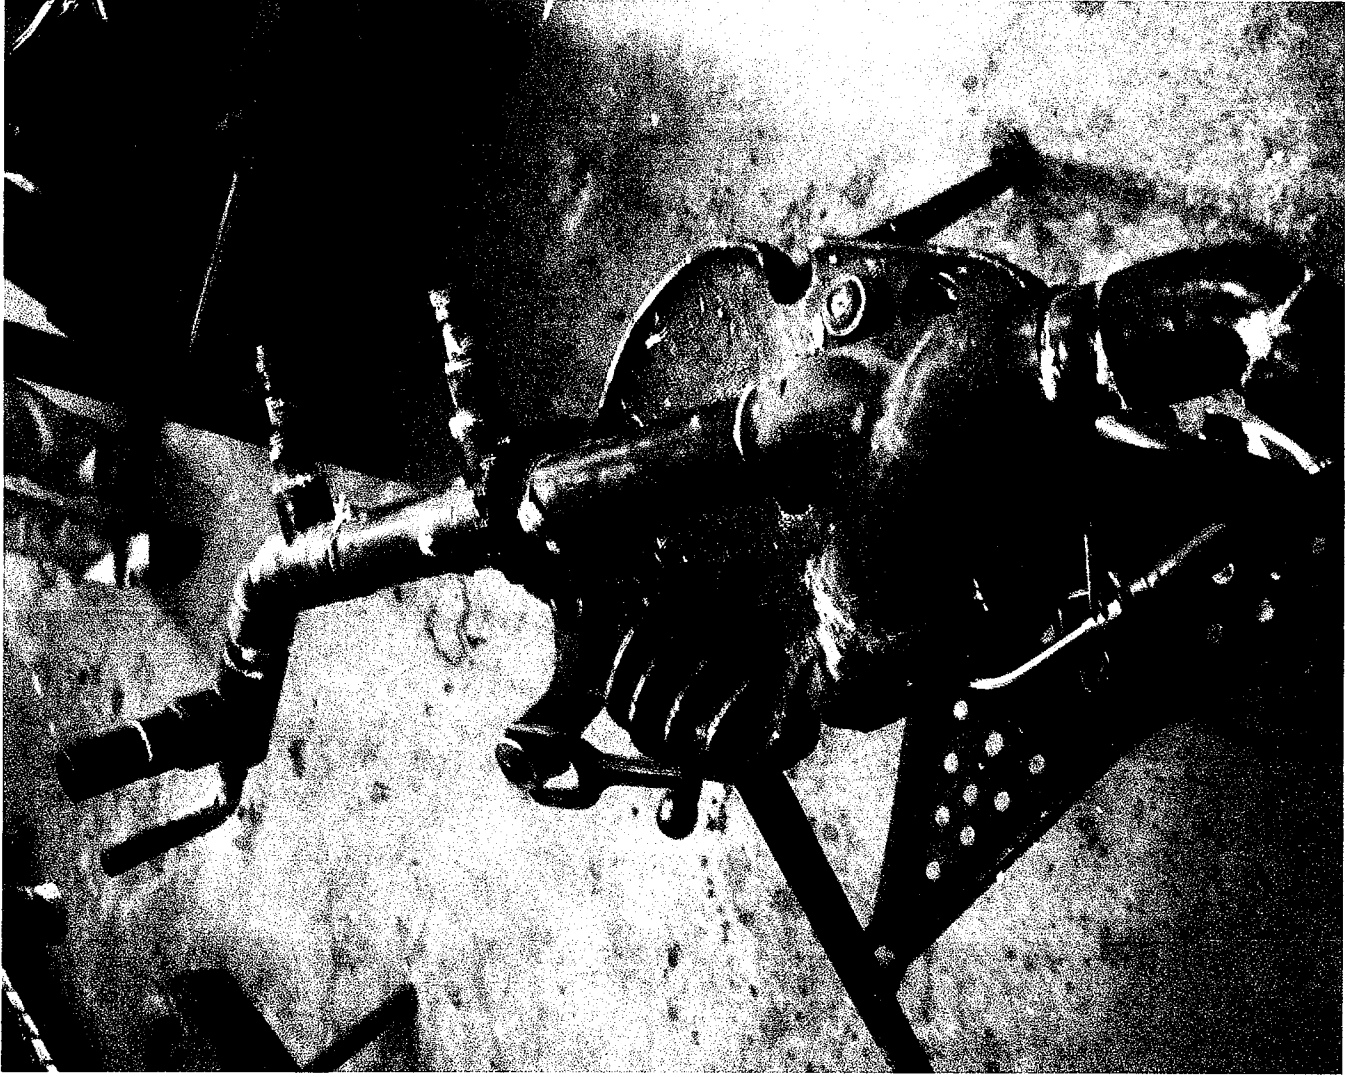
P-5 Pipe Section

This is a 4-foot section of pipe which was removed and mounted on a pipestand in the Plumbing Shop. Note crystalline substance on joints.

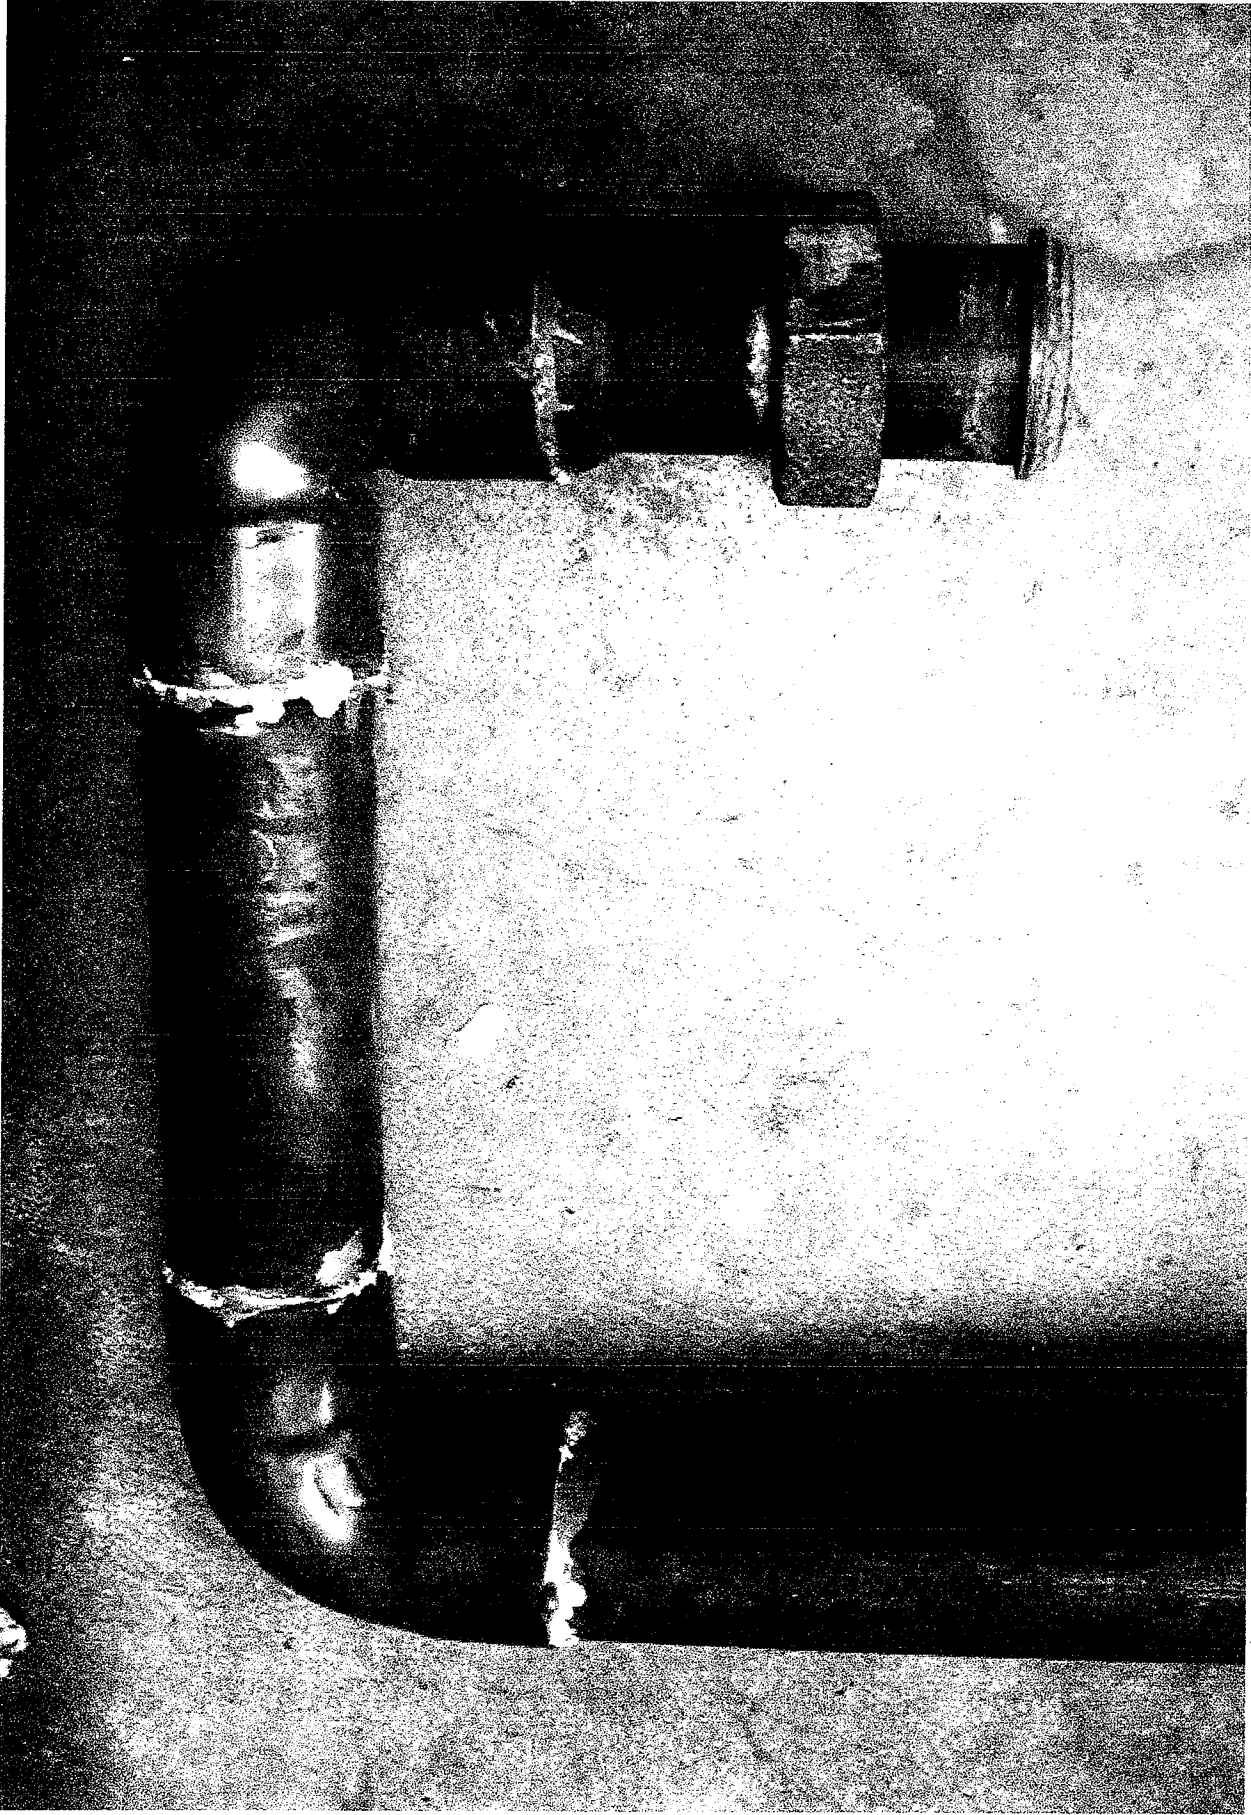
The cause of the problem is soldered joints on the copper pipe. Soldered joints are rated for 250 degrees F and not for 270 degrees F. The boilers are listed for 270 degrees F although they have been operated at 260 degrees F. The pipe should have been welded steel where it was subject to 250 degrees F or hotter.

P-6 Pipe Samples
Sample of a section of 1-1/2" pipe. Each joint looks poorly made.

- A. Replace the at-risk copper pipe with welded black steel pipe. These pipes are in the following areas:
1. The pipes from the mains to the domestic water heaters are located in the housing units. These are typically 1-1/2-inch in size.

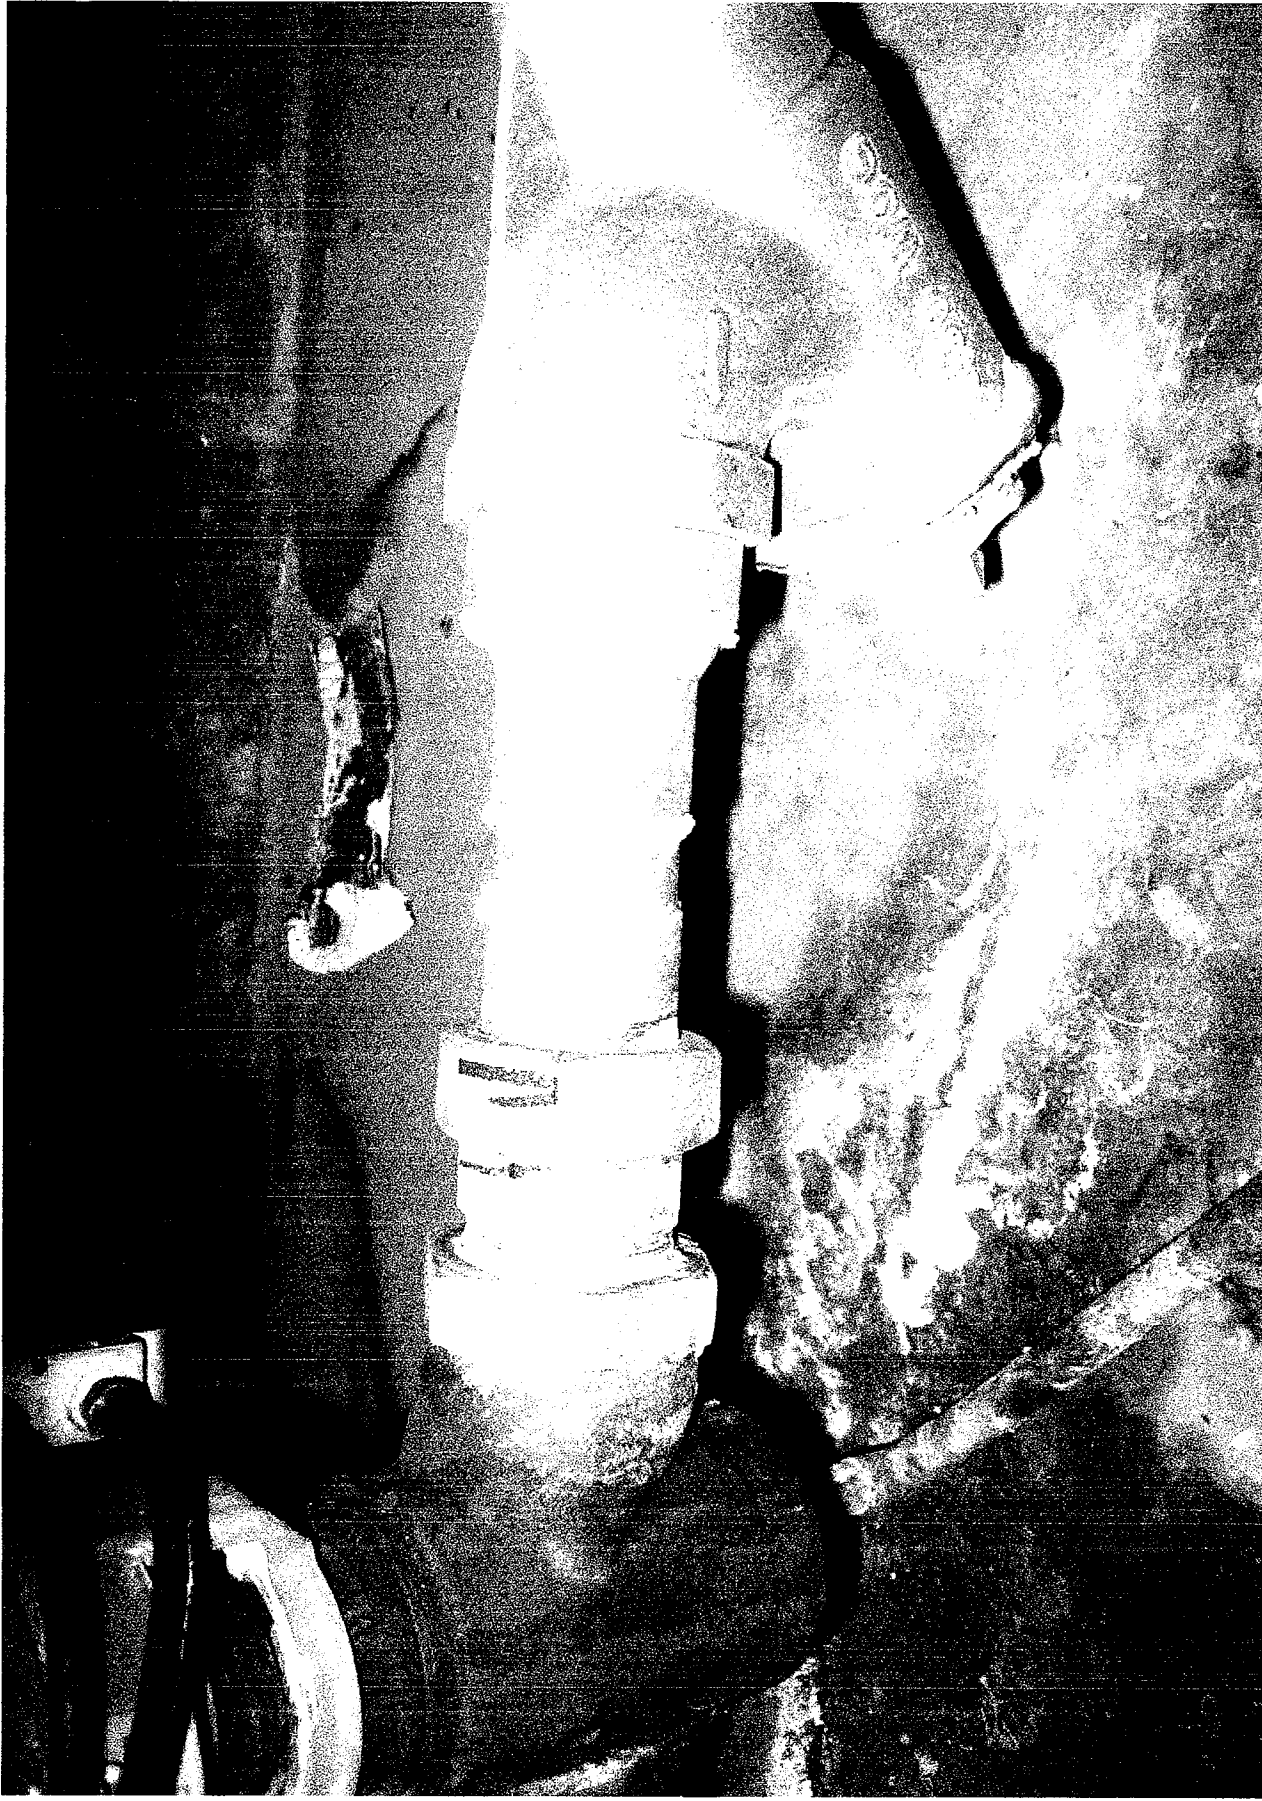
P-8 Pipe
Typical field photo at a water heater.
