TECHNICAL MEMORANDUM

West Point Flooding Investigation

Preliminary Findings Report

Prepared for
King County

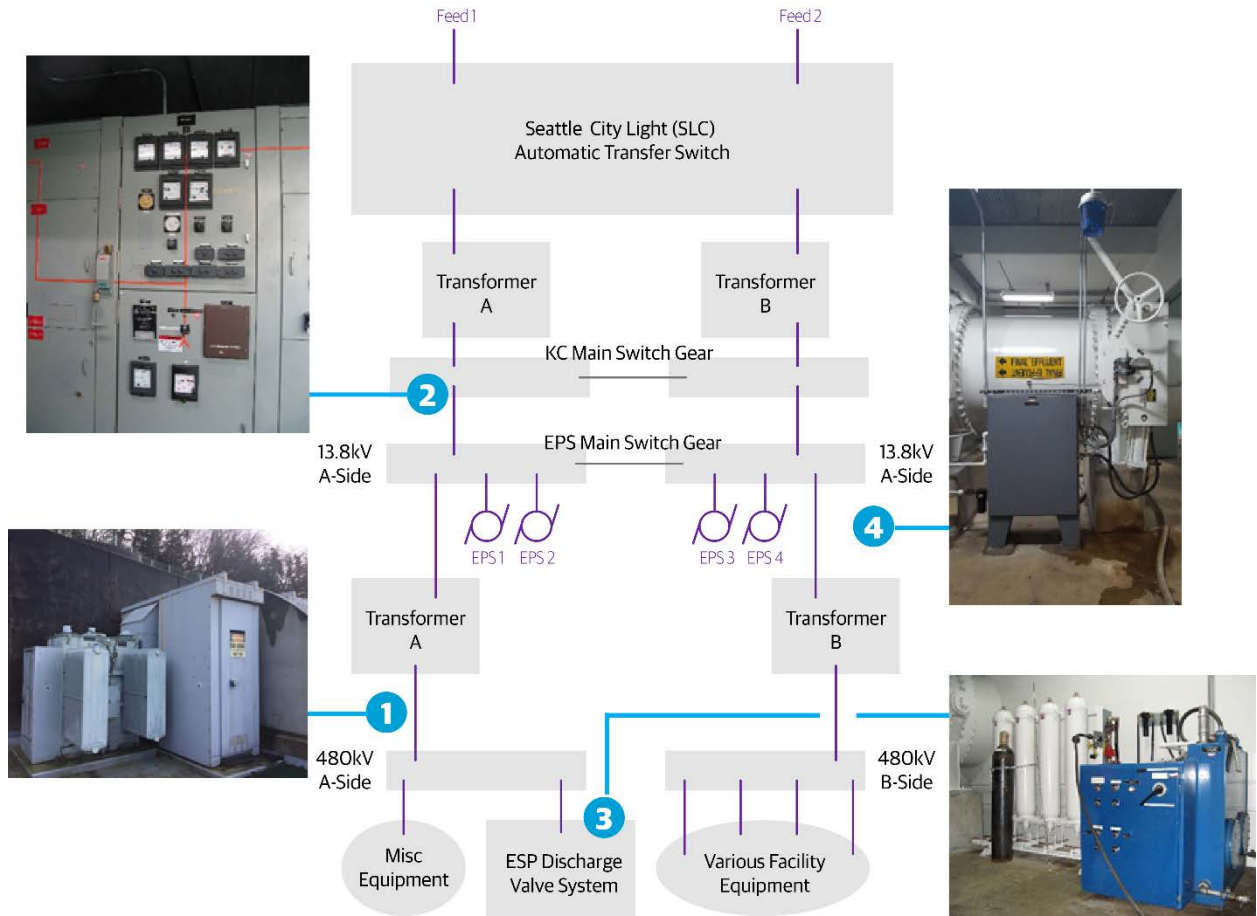
Figure 04. Electrical Fault Diagram

#	Event
1	Possible fault in 480v transformer (707-XFMR01A)
2	Main A side breaker tripped (722-MSG-52-3)
3	A-side equipment loses power including EPS Pumps 1 and 2 and EPS discharge valve hydraulic system
4	Hydraulic system power loss closes all four discharge valves and EPS Pumps 3 and 4 shut down. Pumps are unable to be quickly restarted.

Diagram showing main electrical components where a failure occurred and the effected equipment.

Current information indicates that the cause of the electrical disturbance is in, or associated with, the circuit that feeds equipment 707-XFMR01, a 13.8kV to 480/277V, 2000/2576KVA oil-filled transformer with forced air fan cooling (Appendix B). This transformer sits on the upper deck of the EPS facility. King County maintenance personnel performed a routine noise evaluation of this transformer a few weeks ago, where some sounds emanating from the primary side termination enclosure were investigated.

- Feeder 3 circuit breaker in 722-MSG01 tripped on the protective relay instantaneous element sensing a ground fault.
- Transformer protection circuit breaker 52-A1 in 707-SWGR01 did not trip, which is still under investigation and further tests are planned. This circuit breaker is closest to the suspected transformer described above.
- All of the medium-voltage switchgear transformers have been tested within the past year, and those results indicate they are good working order (Appendix A).

Continued electrical investigation is underway, in a coordinated effort between King County and CH2M. There are no definitive findings of the source of the electrical fault, but investigative efforts continue. To aid in the investigation of the electrical failure, CH2M has also engaged an in-house electrical expert Randall Denton (Electrical Fellow, P.E., WA). Mr. Denton was onsite on February 23-25, 2017, to collect additional information to aid the investigation.

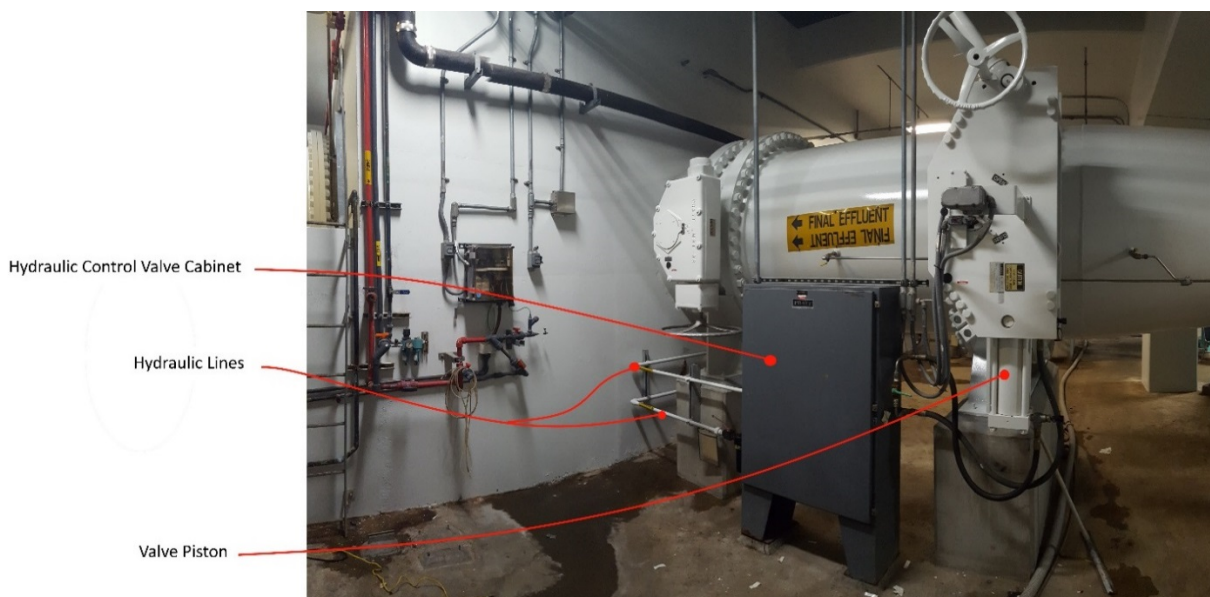
Figure 06. Hydraulic Discharge Valve Assembly

Pumping against closed discharge valves likely caused the high vibration interlock in Pumps 3 and 4 (Figure 06). Available evidence suggests that the interlock caused vibration alarms and subsequent shutdowns when the operation team tried to restart the EPS Pumps 3 and 4 immediately after the initial electric fault (Appendix D).

All the ESP pump discharge control valves are fed from one Hydraulic System.

After the electrical fault on A-side, EPS Pumps 1 and 2 and the hydraulic skid that drives the discharge valves for all four of the pumps lost power. The closure of the discharge valves ultimately prevented operators from bringing EPS pumps back online during the event.

As part of standard operating procedures, a backup portable hydraulic system is available to plug into the hydraulic lines in the event of an emergency. There also is an option to isolate the discharge valves from the hydraulic lines, and manually actuate them with a hand wheel. A more automated solution for EPS pump restart procedures should be evaluated, so that response and corrective actions can occur more quickly during emergencies.

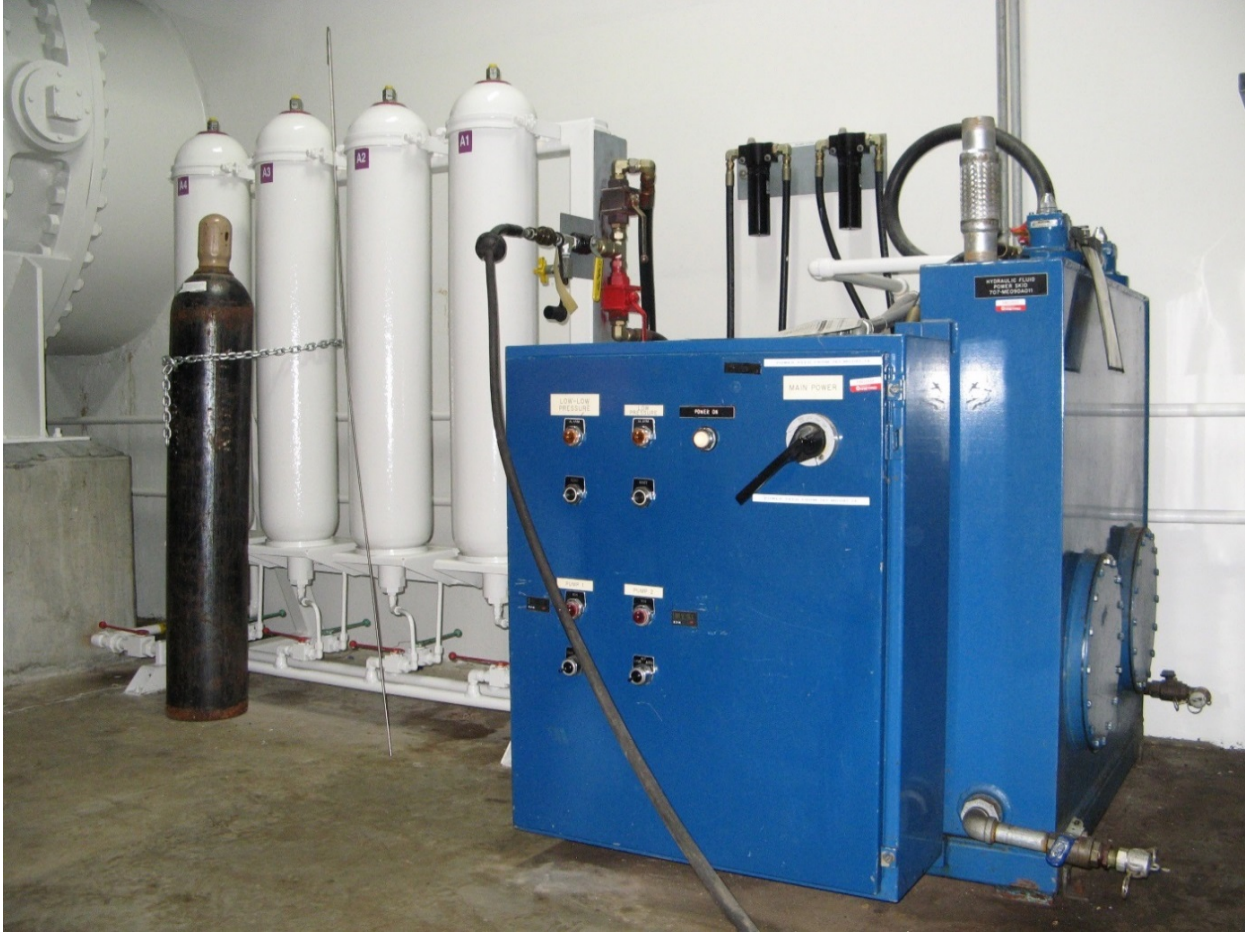
Figure 07. Hydraulic Skid

There is a single hydraulic skid system that supplies pressurized hydraulic fluid to each of the four EPS pump discharge valve assemblies (Figure 07). The hydraulic skid is supplied from the motor control center (MCC), which was fed by the side that lost power. After losing power, the solenoid valves failed and caused the remaining pressure in the hydraulic accumulator bank to drive the discharge valves closed.

There is a mobile backup hydraulic skid that can be connected to the discharge valve system in the event of a failure. As outlined in the valve manual, there also is a method to physically actuate the discharge valves by isolating the hydraulic system and using the actuation wheels (Appendix C), which might have allowed Pumps 3 and 4 to be started. However, the operations team did not have enough time in the 2-minute window of the initial electrical failure before the water level in the EPS wet well reached the HiHi level.

Hydraulic Skid system that drives all ESP pump discharge control valves.

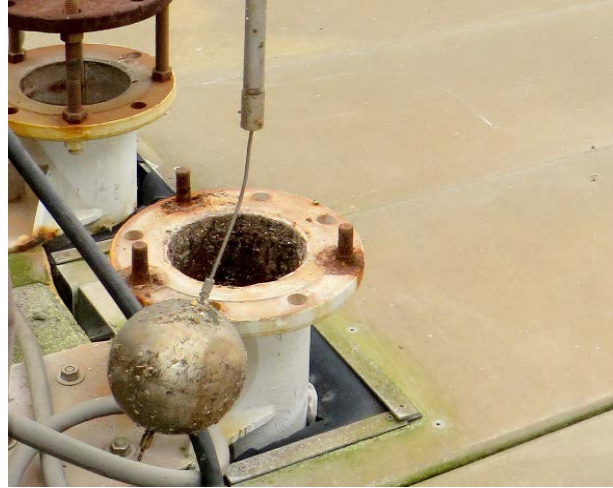
When examined post-event, the float rods were observed to have been bent to such a degree that the 4-½-inch ball would have been in contact with the inner surface of the 6-inch stilling well, causing friction on the float as well as between the rod and guide tube (Figure 08). After removing a float from the stilling well assembly, it was submerged in a bucket to simulate high water level. Due to the physical damage to the rod mechanism, this switch did not activate until the float was fully submerged and the mechanism was shaken. The observed impingement likely inhibited free travel of the float, preventing the RSP interlock circuit from tripping. The RSPs did not automatically stop even though the level was rising in the primary sedimentation tanks.

Figure 08. Float Switch Damage
Bent float support rod.

The float switch mechanism designed to stop the RSPs when the primary sedimentation tank reaches a high-level failed. This is due to mechanical impingement caused by the observed damage to the float and rod system. It is unlikely that the flooding event caused the observed damage to the floats, as damage to these floats have been observed previously (Appendix J). For example, in August 2008, it was observed during a function test that none of the switches in question operated correctly due to damage to the floats and rods. Maintenance personnel repaired the switches based on work orders and the repaired mechanisms passed functional tests. It appears that between the 2008 repair and this event, that the float mechanisms sustained similar damage.

The electrical circuit and control system for the pre-aeration tank float switches appeared to have functioned as designed, but damage to the floats' mechanisms prevented the float to rise with the water level, resulting in no alarms to the control system or shutdown commands to the RSPs. Re-evaluation of testing procedures should be conducted.

Also, it is recommended that the cause of the damage to this style of float switch be further investigated. Other float switches throughout the plant that have a different design functioned as intended during the event (e.g., most notably the EPS wet well high-level floats). The damaged float mechanism should be re-designed to prevent similar damage from occurring again. In addition, alternative methods of level measurement for triggering RSP stoppage and main influent gate closure should be investigated and re-evaluated.

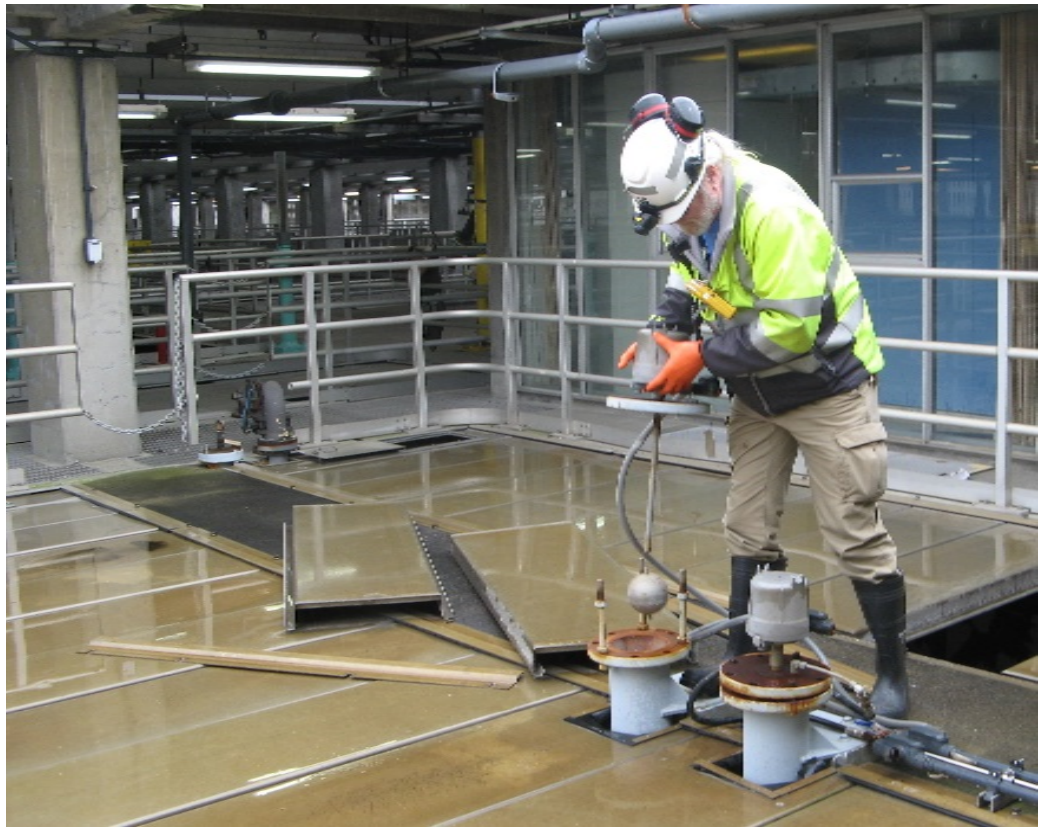
Figure 09. Float Switch Inspection

Additionally, following the flooding event on February 9, 2017, these float switches were inspected again as recorded in the DCS alarm log (Appendix D) (Figures 09 and 10). The condition and operation of the electrical circuit remains functional, yet during the event, the floats did not trigger the switch when submerged. It is unlikely these events caused the observed damage, as similar damage has been observed and recorded in the plant's maintenance records where past repairs have been made.

As part of this investigation, the floats were visually inspected after the flooding event on February 9, 2017. All showed the similar damage to the rod, preventing proper operation.

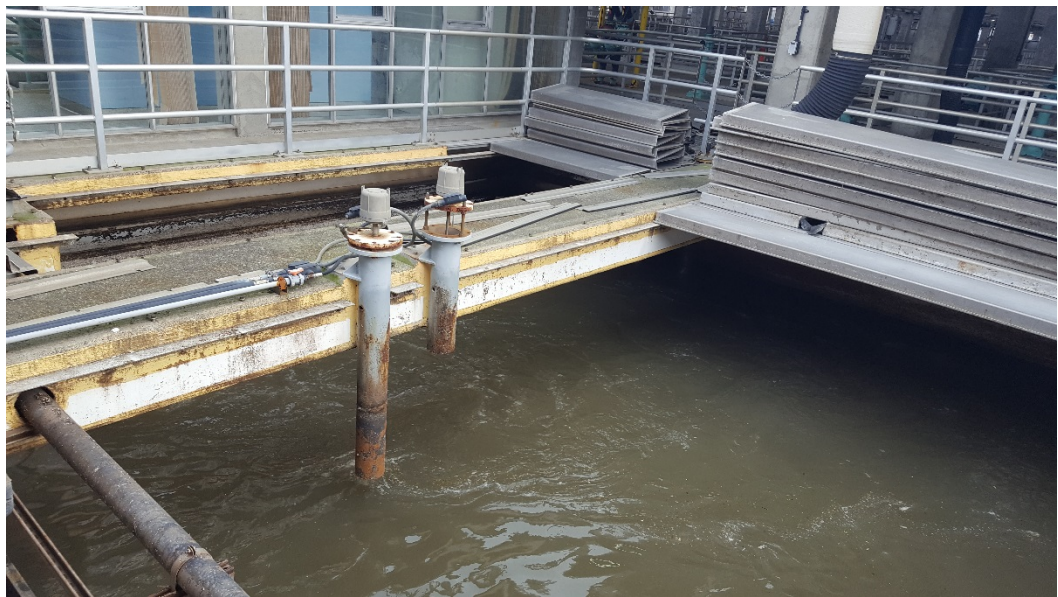
Figure 10. Float Switch Location

After the flooding event, covers of the pre-aeration tank were removed, allowing full view of the Hi and HiHi float switch mechanisms. This is one of four sets of switches in the primary sedimentation area.
