MEDTOX – HERRERA HAZMAT SURVEY 2013

HAZARDOUS BUILDING MATERIALS SURVEY

King County Youth Detention Facility
Spruce Wing
1211 East Alder Street
Seattle, Washington 98122

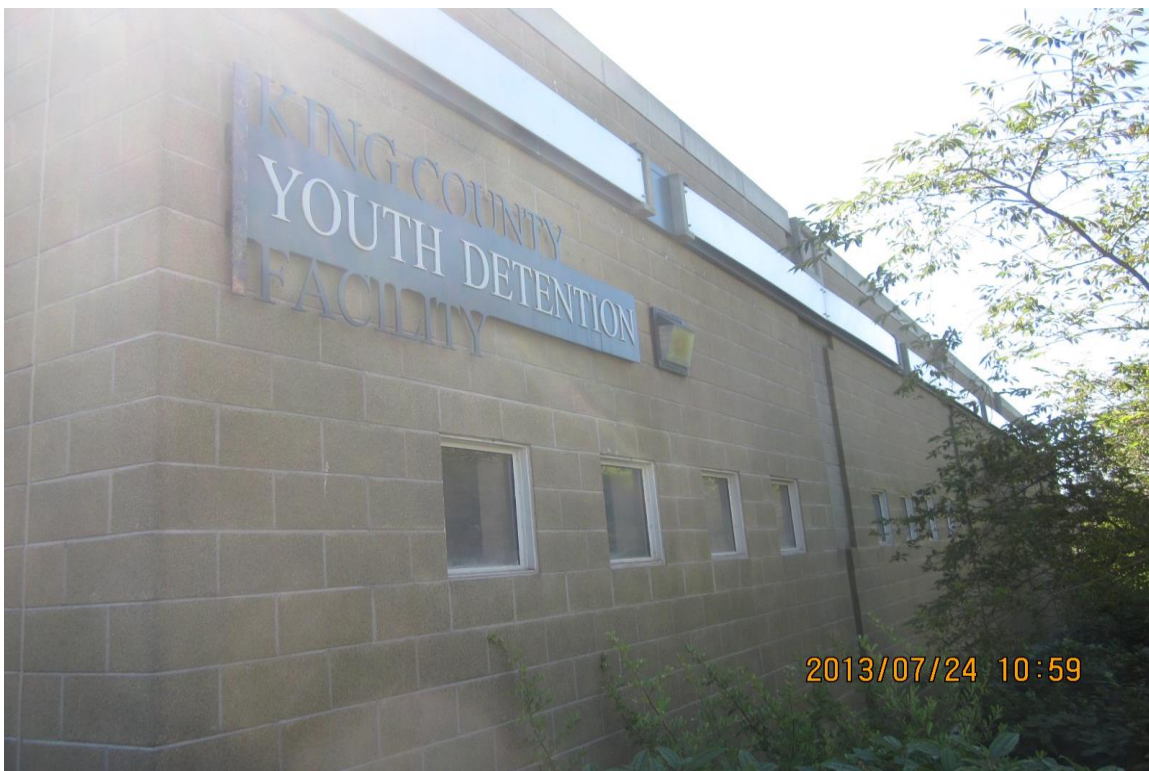
Photo 1. Spruce Wing of King County Youth Detention Facility in Seattle, WA.

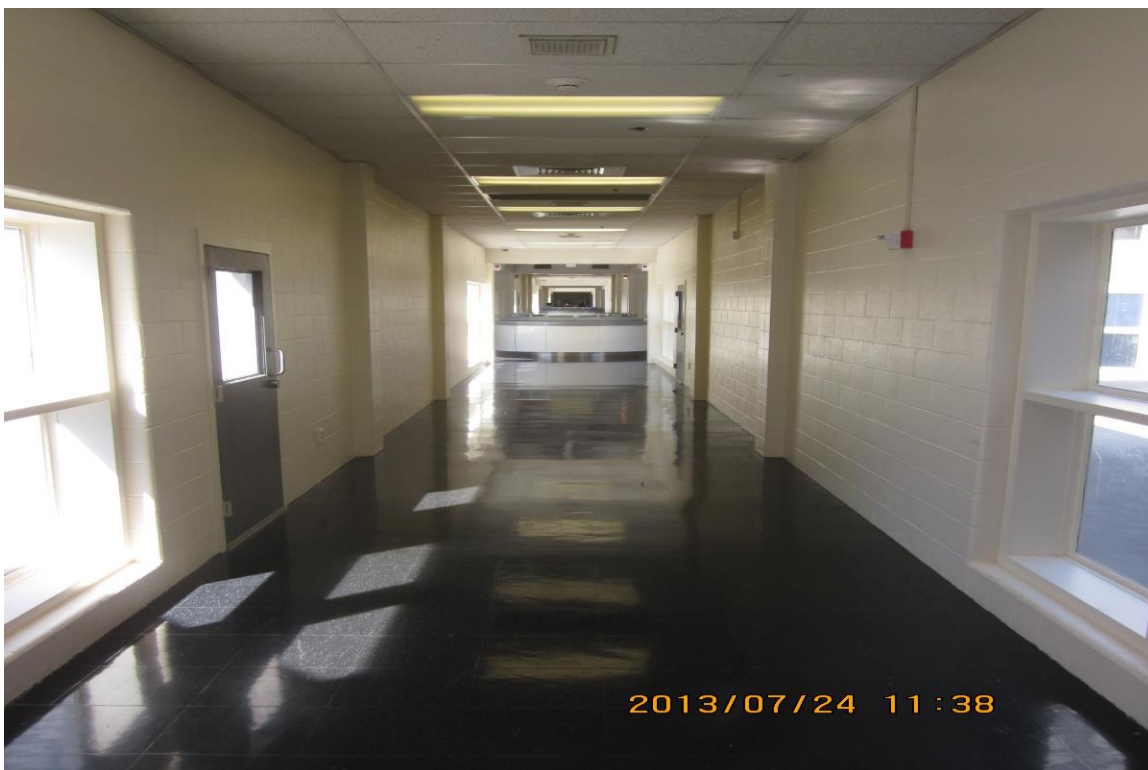
Photo 6. Non-ACM 12-inch black with white flecks vinyl floor tile and mastic.

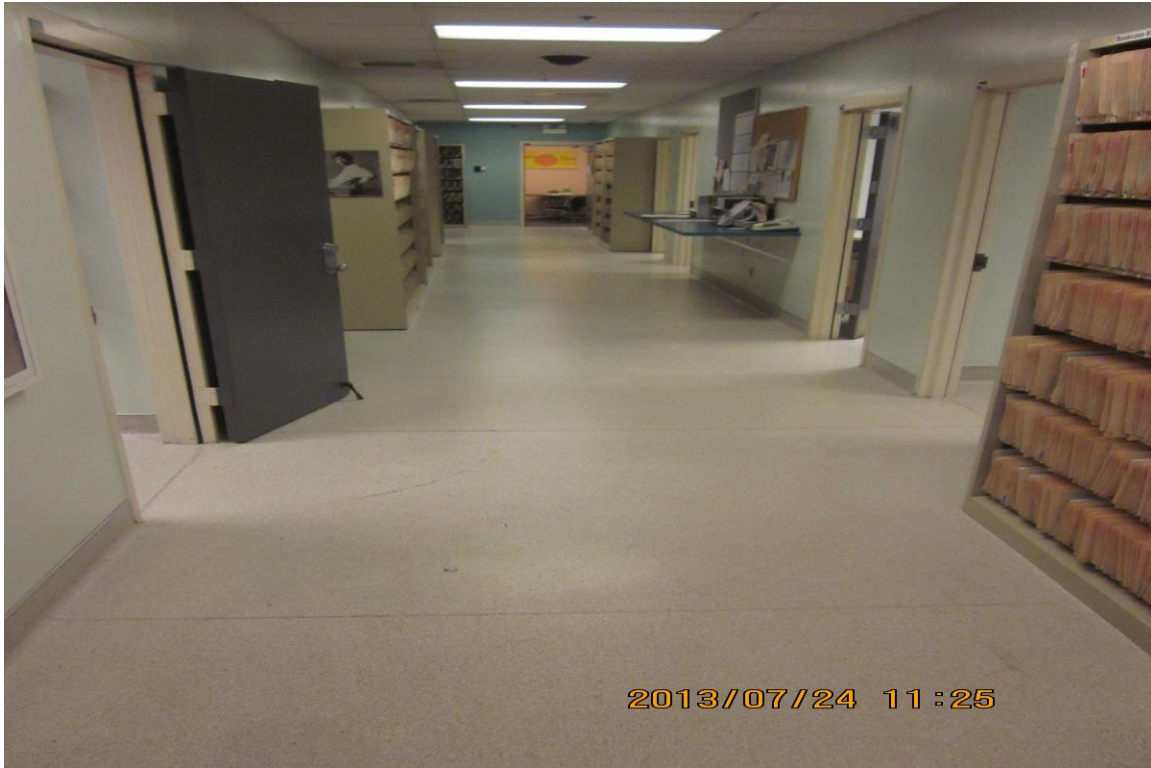
- Terrazzo pattern sheet vinyl flooring (HM18). This flooring can be found in the Health Center of Spruce Wing. Two samples were collected and analyzed for asbestos content; this material is negative for asbestos.

Photo 7. Health Center with Non-ACM terrazzo pattern sheet vinyl flooring.

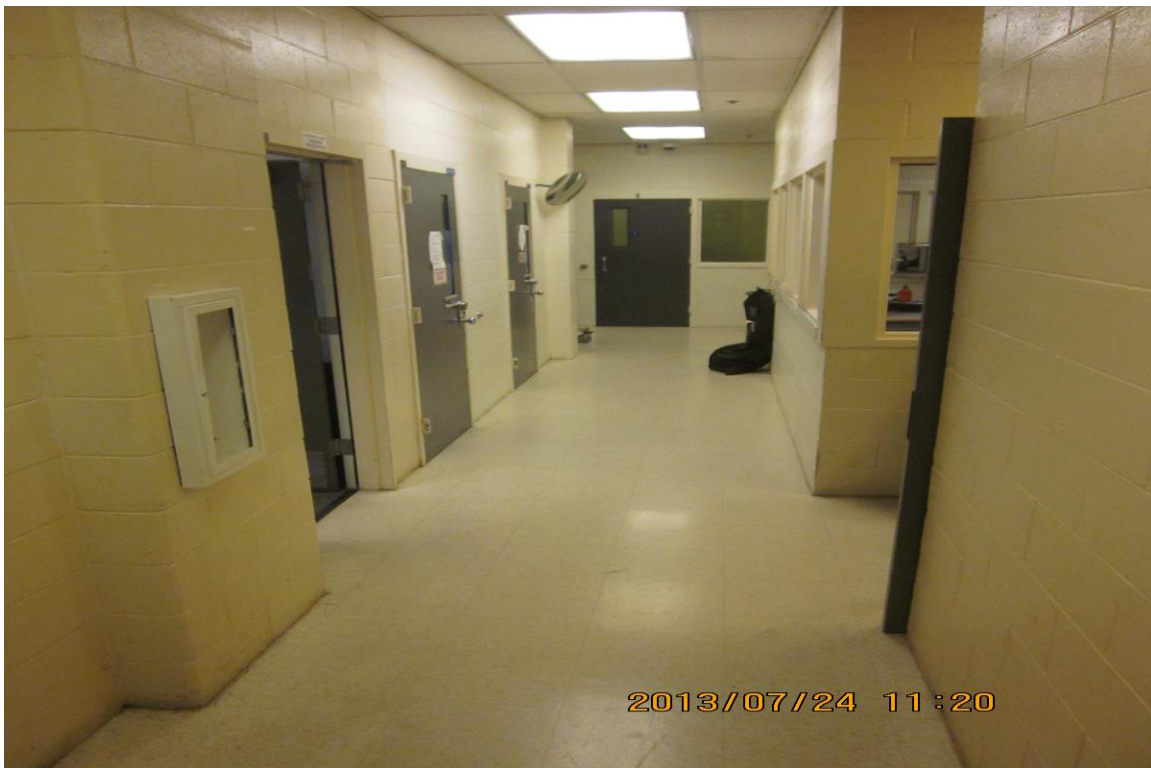
Photo 8. Non-ACM 12-inch beige floor tile and mastic.

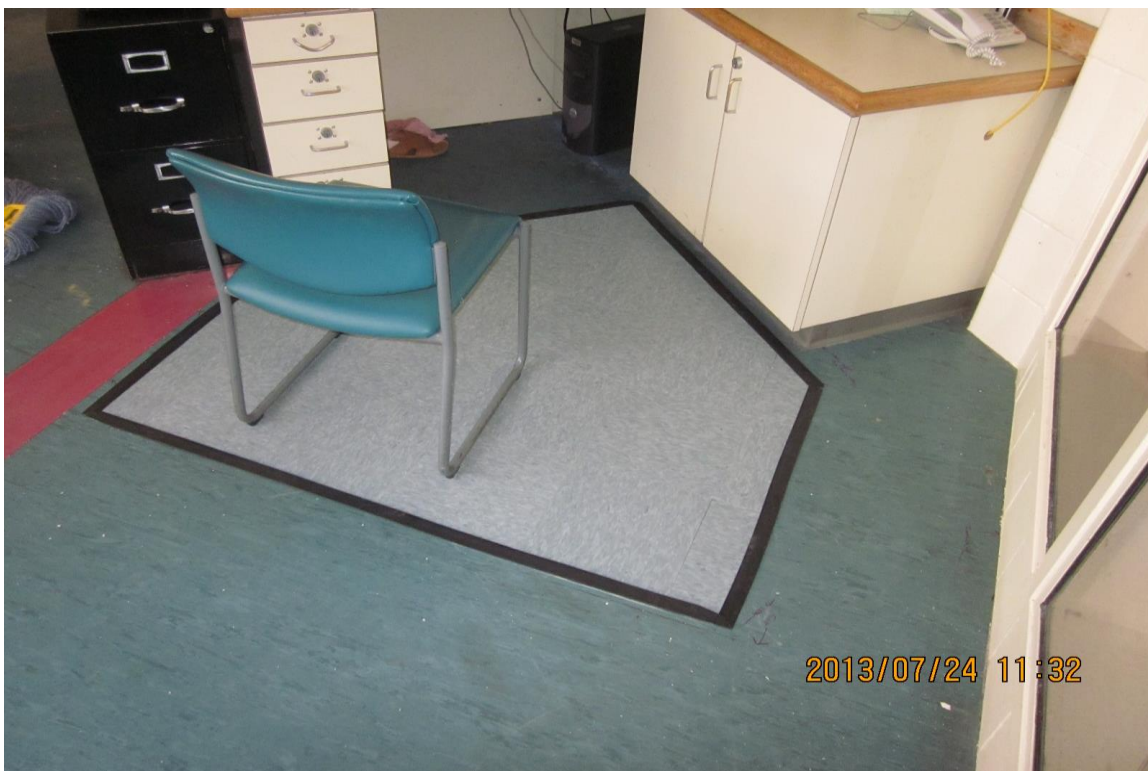
- Green rubber flooring mastic (HM19). This flooring can be found in the hallways of Spruce Wing. Two samples were collected and analyzed for asbestos content; this material is negative for asbestos.

Photo 9. Non-ACM green rubber flooring mastic.

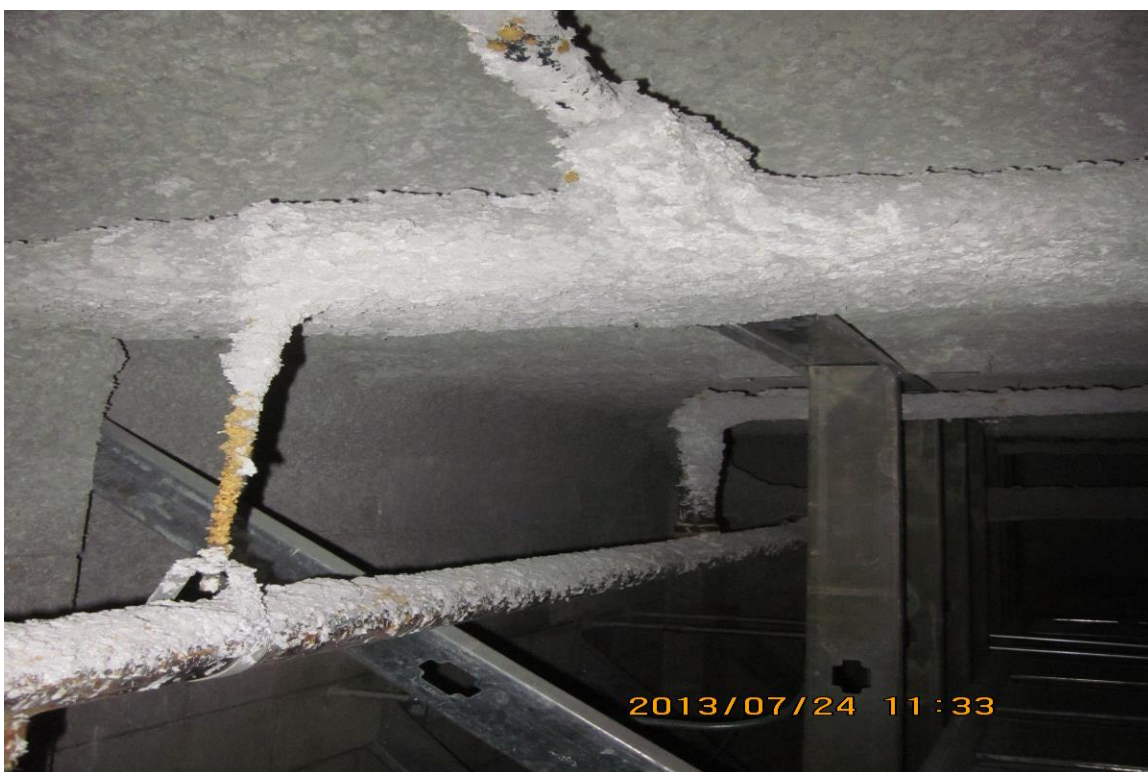
Photo 10. Non-ACM spray-on fireproofing on concrete and steel beams.

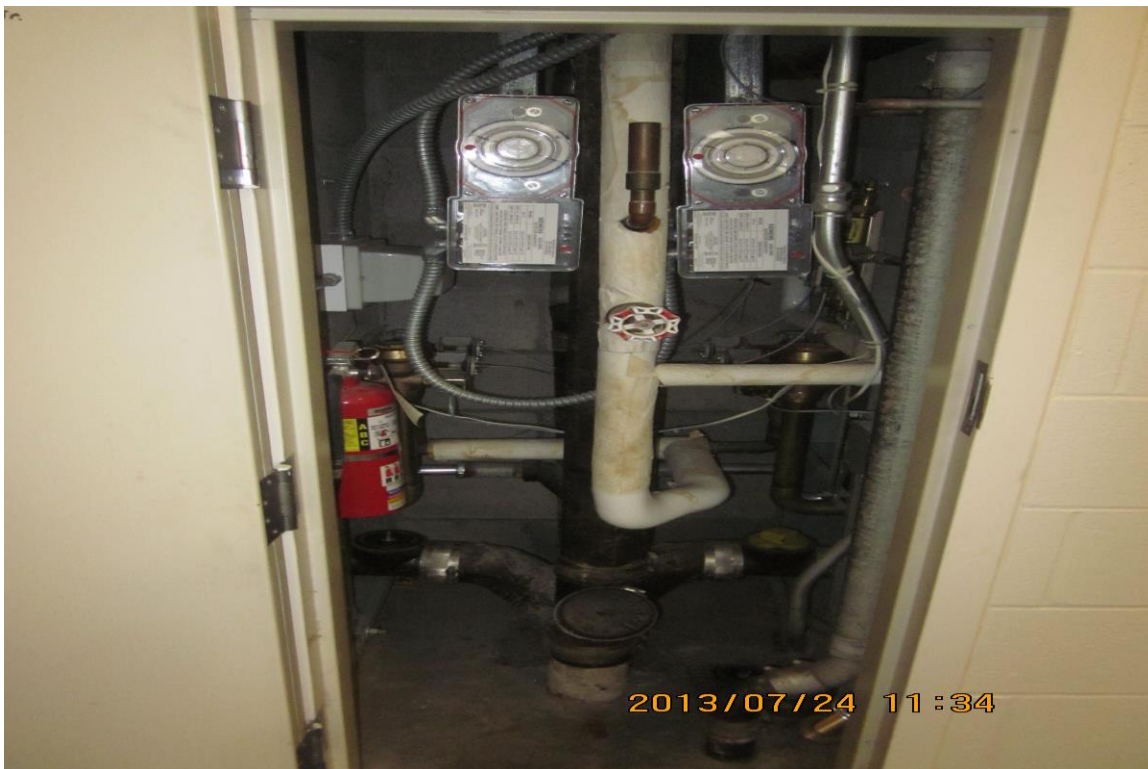
- Fiberglass pipe insulation with PVC fittings. This material was found on piping throughout Spruce Wing. Fiberglass insulation was visually determined non-asbestos-containing.

Photo 11. Fiberglass pipe insulation with PVC fittings found throughout Spruce Wing.

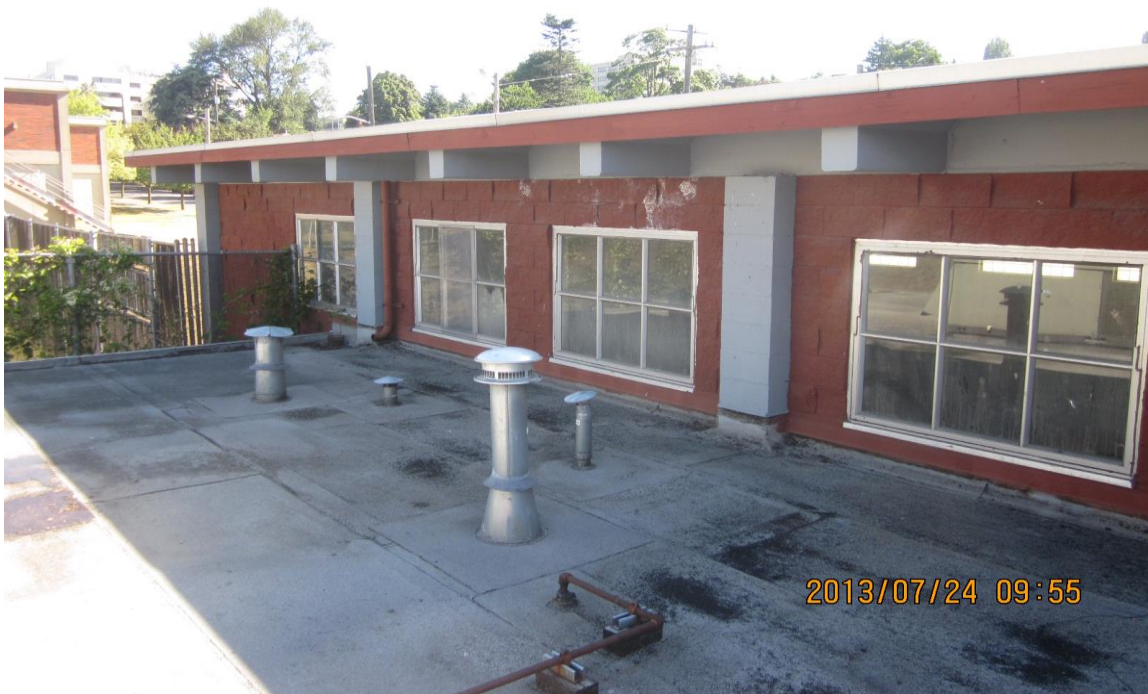
- **Window frame caulk (HM68).** This material is found around exterior upper metal in-laid windows in the pool area. Two samples were collected and analyzed for asbestos content; the window frame caulk was negative for asbestos content; however, **the black mastic under the window frame caulk was determined to contain 3% Chrysotile asbestos.**

Photo 12. Exterior metal windows on upper pool roof have an ACM black mastic under non-ACM window frame caulk.

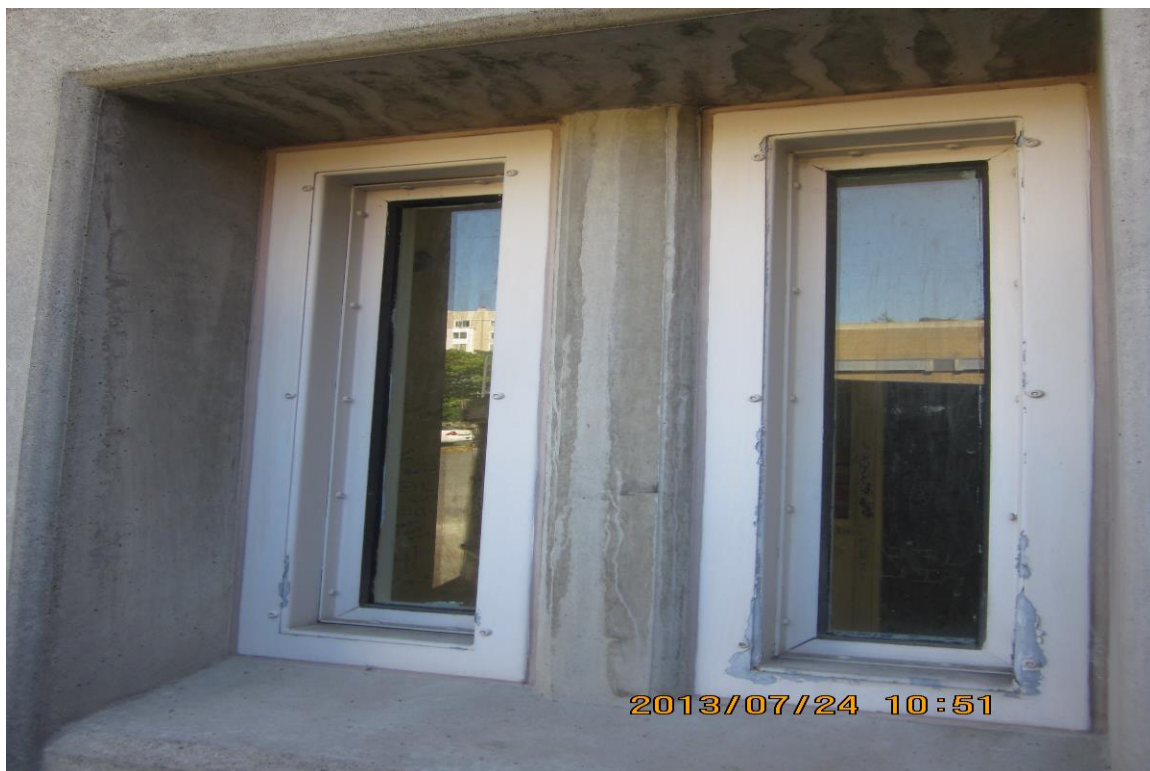
Photo 13. Exterior non-ACM gray window frame caulk.

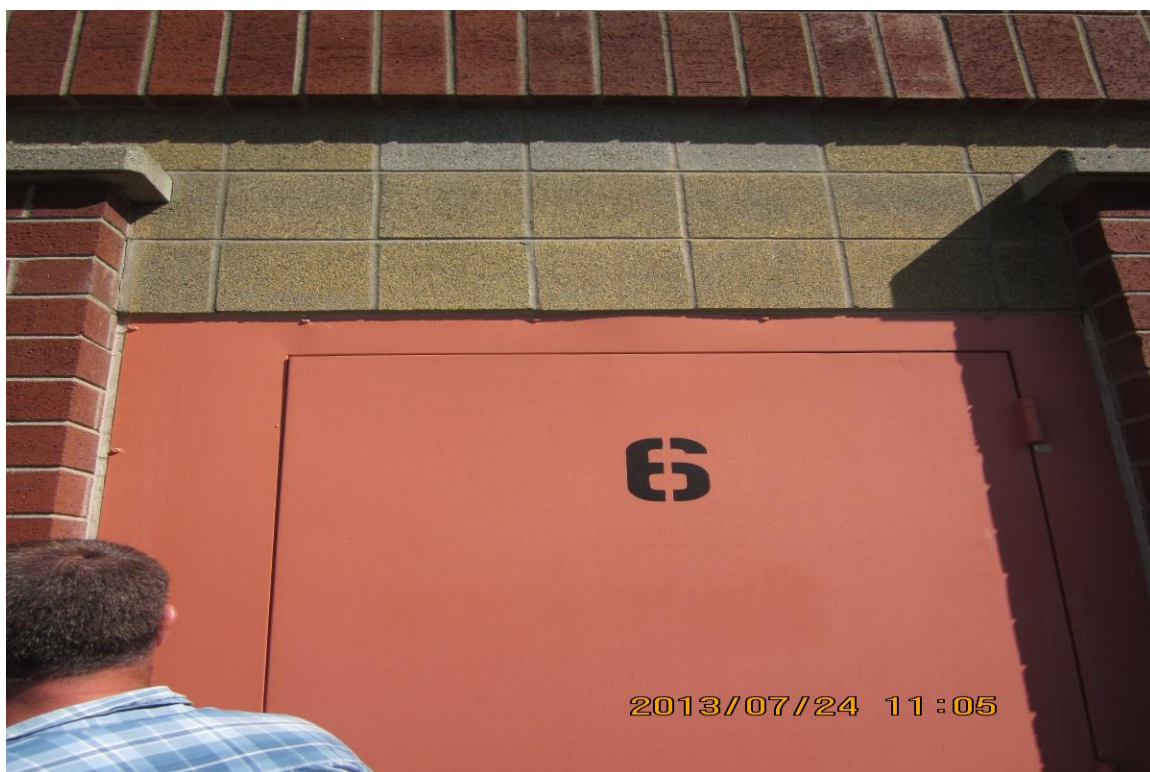
Photo 14. Exterior gray door frame caulk is non-ACM.

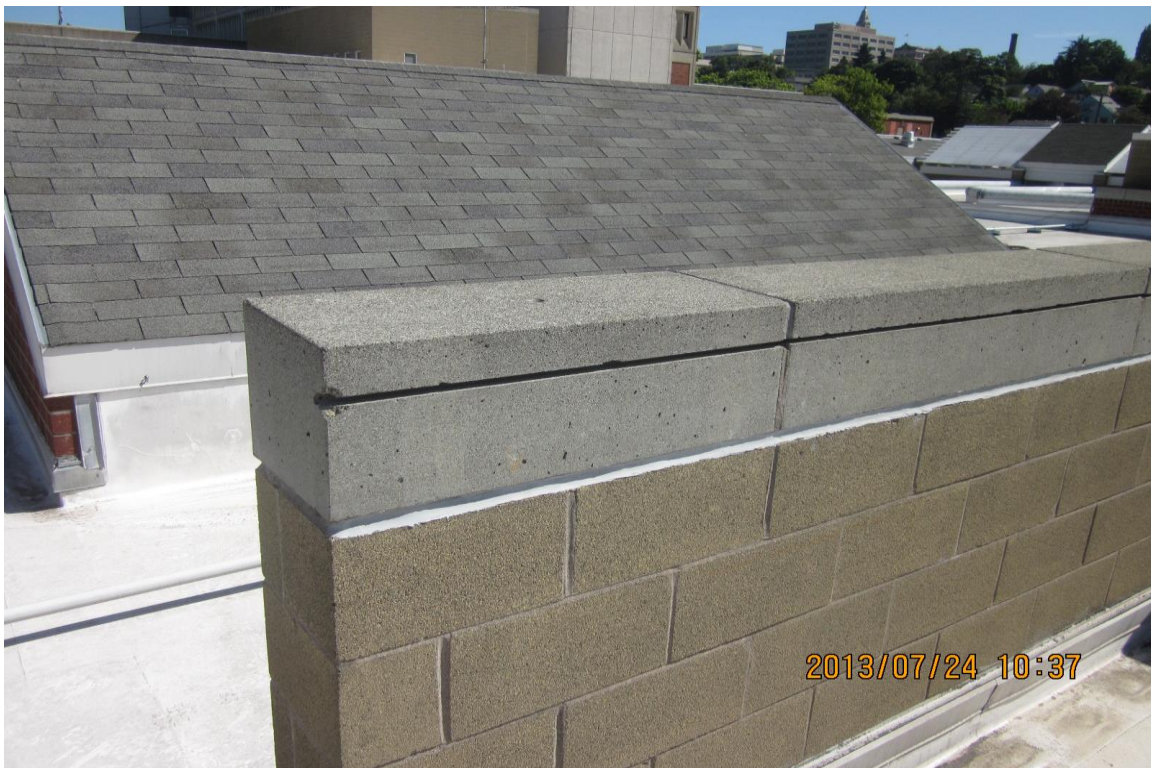
Photo 16. Concrete to CMU wall cap caulk is non ACM. Three-tab composition roofing and vapor barrier is also non ACM.

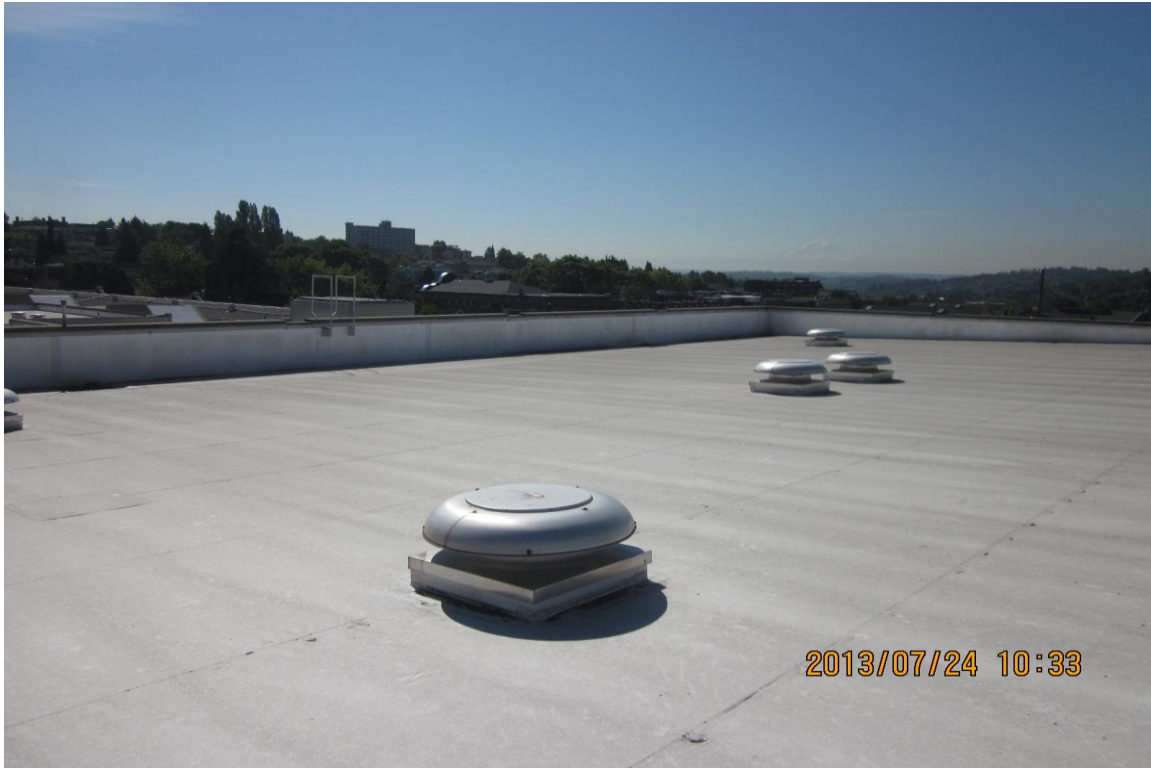
Photo 17. White rubber membrane roofing, tan and gray flashing sealant are non-ACM.

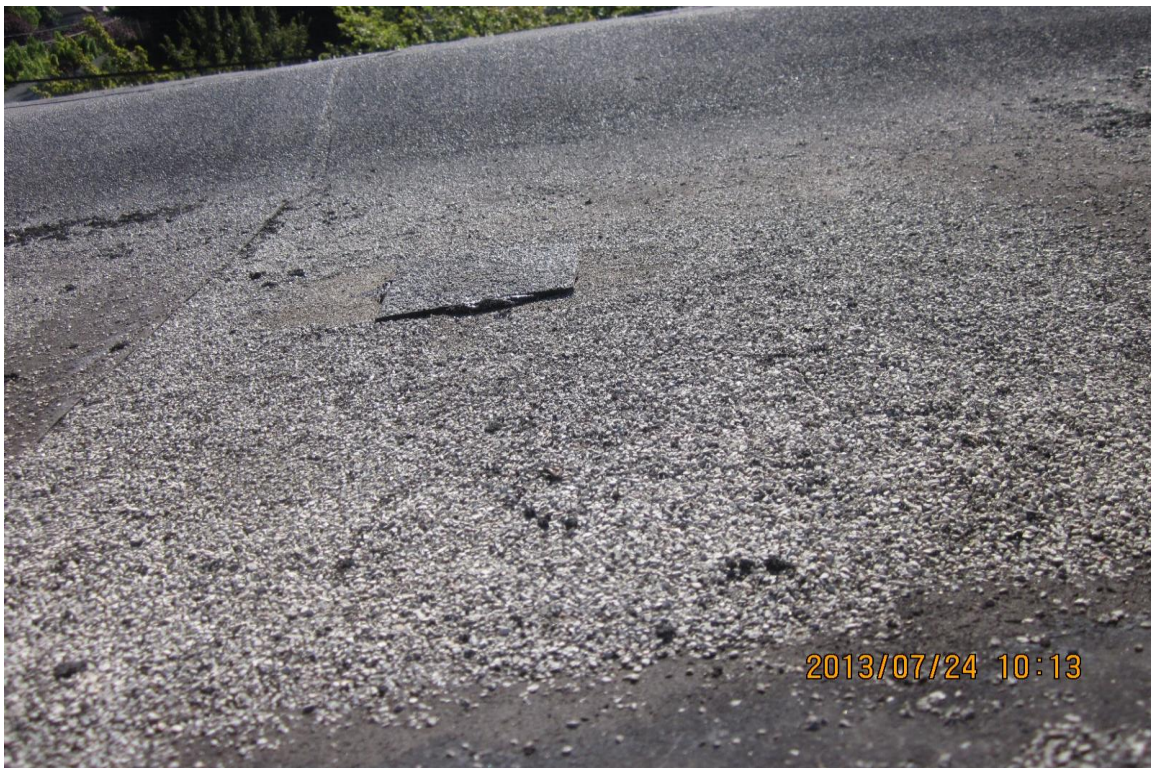
Photo 18. Non-ACM rolled composition roofing on the pool roof.

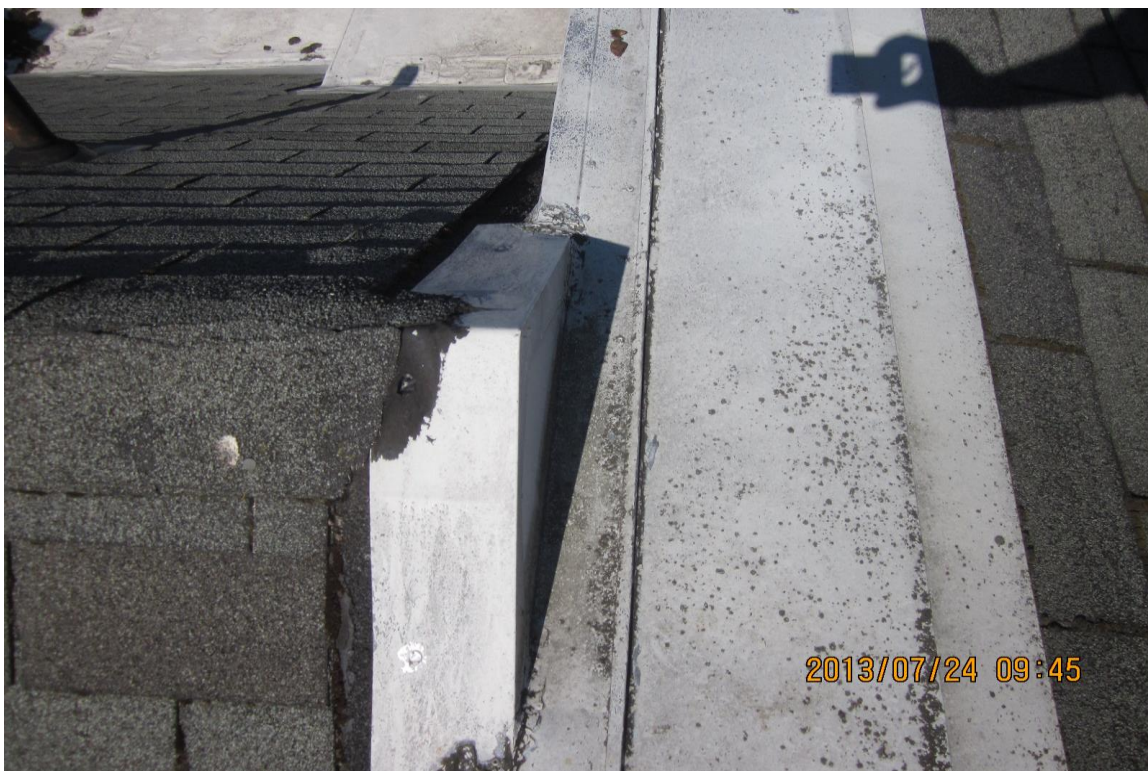
Photo 19. ACM black tar sealant patch on peaked roof.

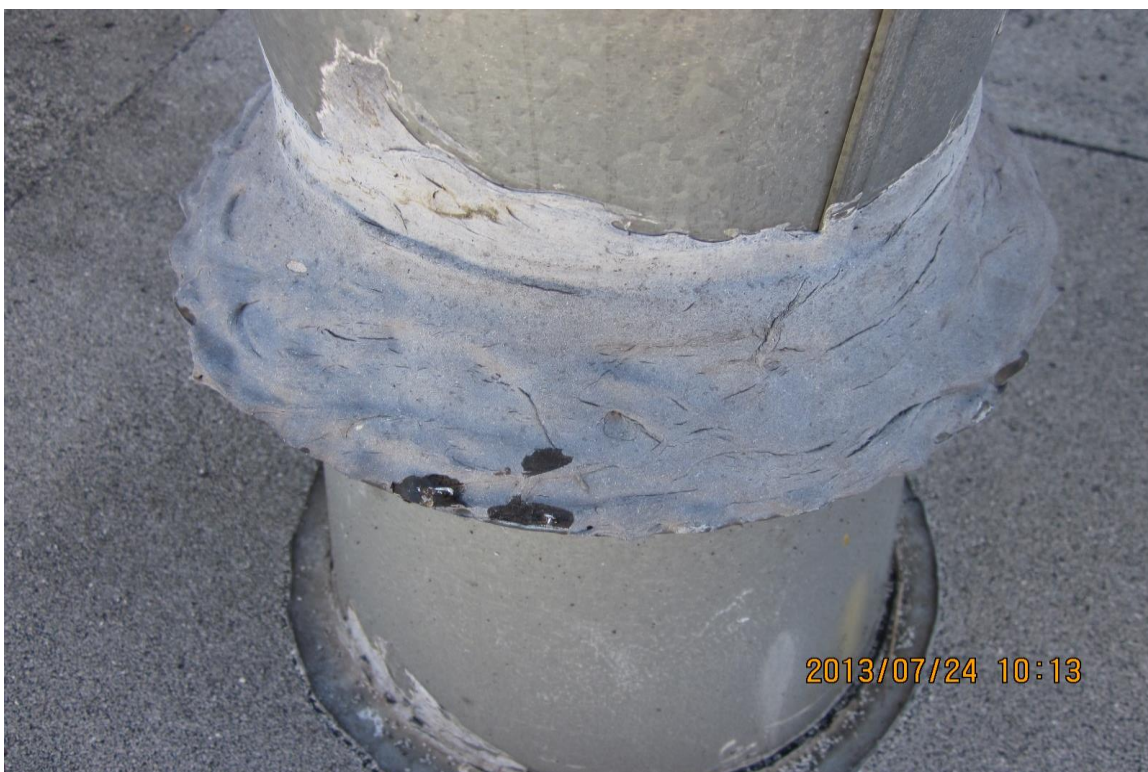
Photo 20. ACM black vent sealant on pool office area roof.
