**PHASE I ENVIRONMENTAL SITE
ASSESSMENT REPORT**

**Youth Service Center
Seattle, Washington**

**Tax Parcels
2908700085
7949300095**

April 23, 2010

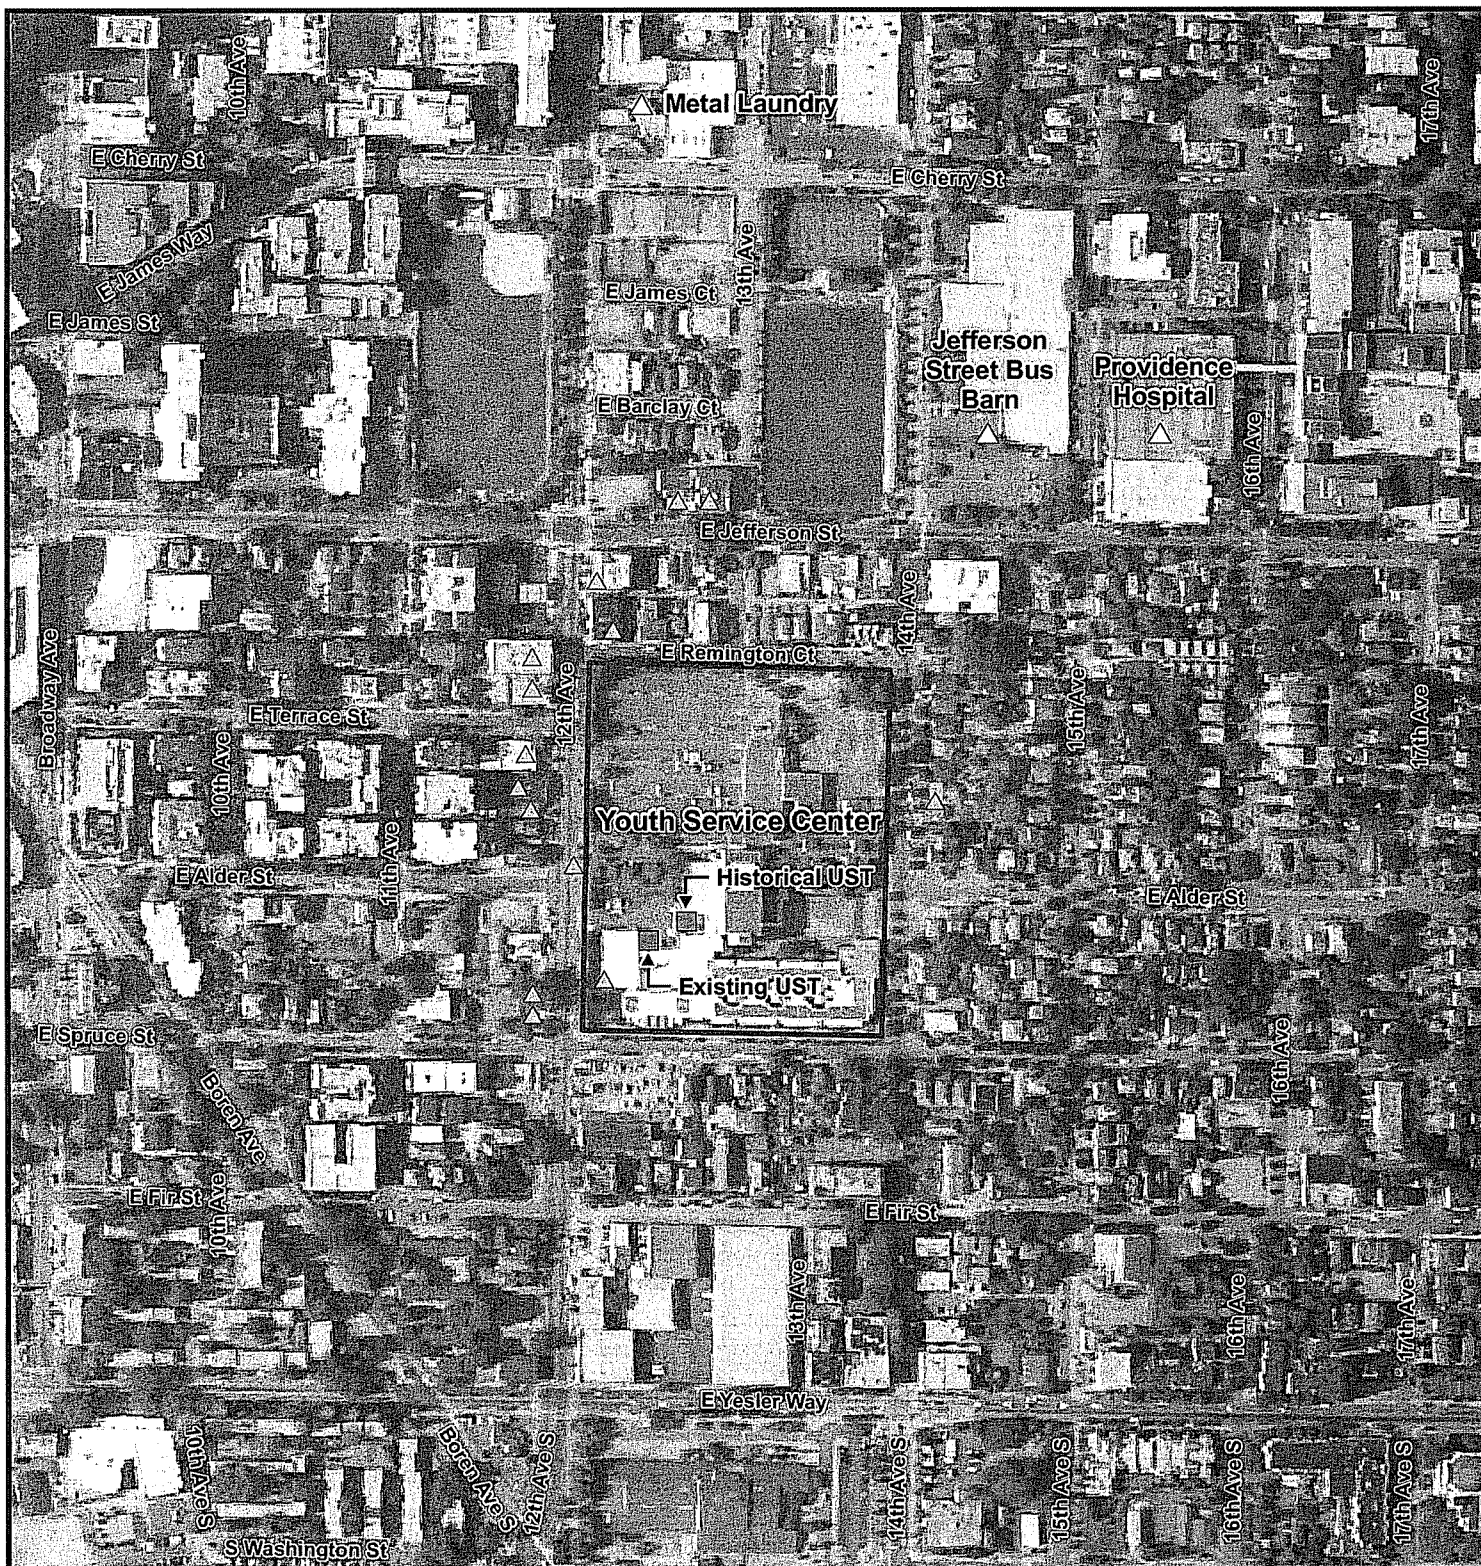
Figure 2.
Site map, Youth Service Center, Seattle,
Washington.

Thirteen sites of concern were identified as historical auto stations or historical cleaners (Table 3 and Figure 2). These sites operated in the past, prior to release reporting requirements. It is possible that any of these historical sites have released chemicals to the environment; it is unknown whether they have impacted the YSC. These sites are considered RECs; however, the chance of impacts to the subject property is minor. It is also possible that homes located on the YSC property prior to development may have used heating oil stored in USTs.

Based on the results of this Phase I ESA, there is a low likelihood of contamination present on the site; however, it would be prudent to collect soil samples from areas prior to excavation that coincide with activities related to historical hazardous substance use (e.g. historical UST, Lasalle Oil Burner Company, and auto repair facility).
