**KING COUNTY COURTHOUSE REVITALIZATION  
BUILDING SYSTEMS REPORT**

# King County Courthouse Revitalization

## Building Systems Report

Ordinance 18239 Section 41 Proviso P5 Response  
Project No. 1124472

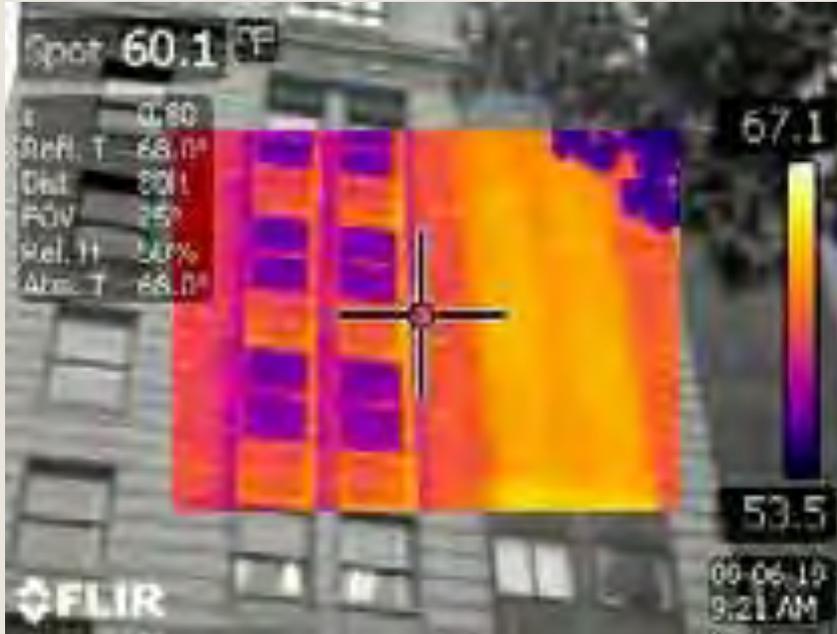
**Figure 8 Infrared photo shows heat loss (yellow) through panel section on right compared to high efficiency windows on the left. Outdoor Temp is 53 degrees in this picture.**

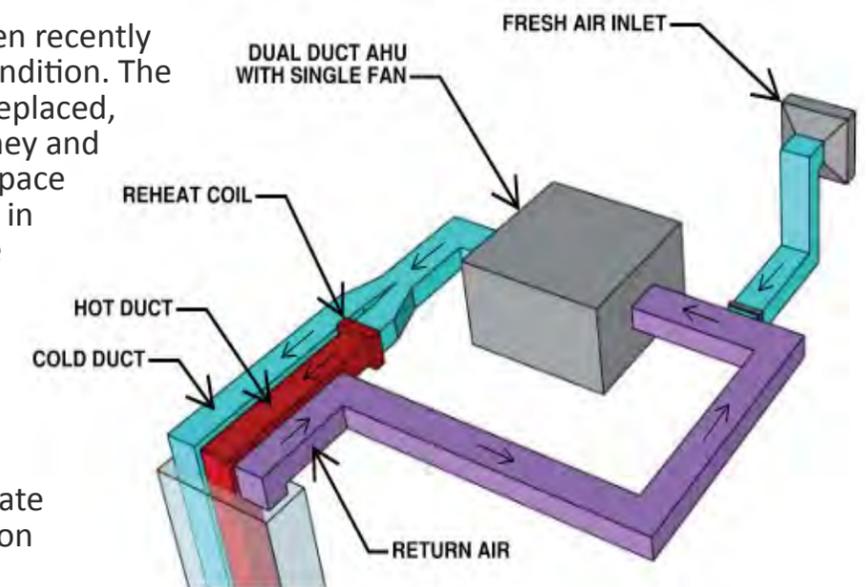
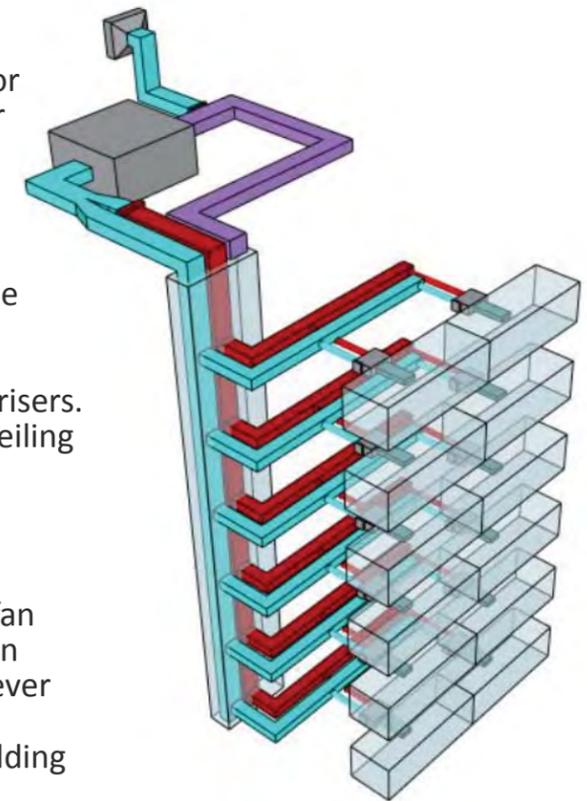
These units are in poor condition due to age. The supply fan drives are worn and the fan casings have cracked and been welded back into place. The motor bearings have likely never been replaced and are at risk of failure. Failure of these components could result in significant portions of the building not being conditioned or ventilated.

The sheet metal casing for the air handling units is no longer sealed properly and is extremely leaky. This accounts for a significant increase in energy and cost required to supply the required airflow to each floor and zone.

It is recommended that the systems serving the interior zones be converted to dual-duct/dual-fan systems. In this configuration, these units are to be replaced with new variable air volume air handling units of the same available capacity. Each unit will have two supply fans: one (1) fan serving the hot duct and one (1) fan serving the cold duct. This will eliminate the simultaneous heating and cooling associated with the existing system.

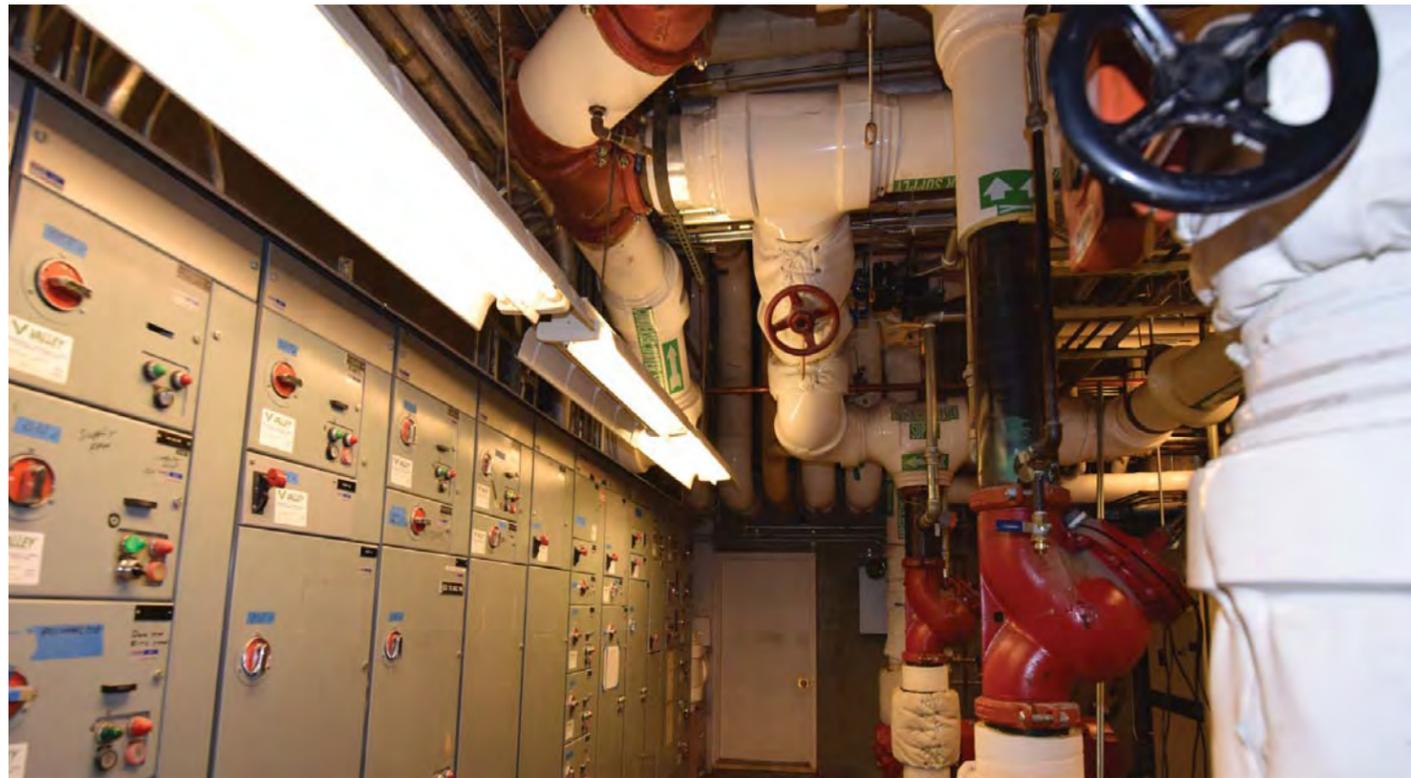
One of the existing motor control centers is located beneath an existing waterline as well. A water leak could potentially occur and cause the motor control center to malfunction.

*One of the existing motor control centers*

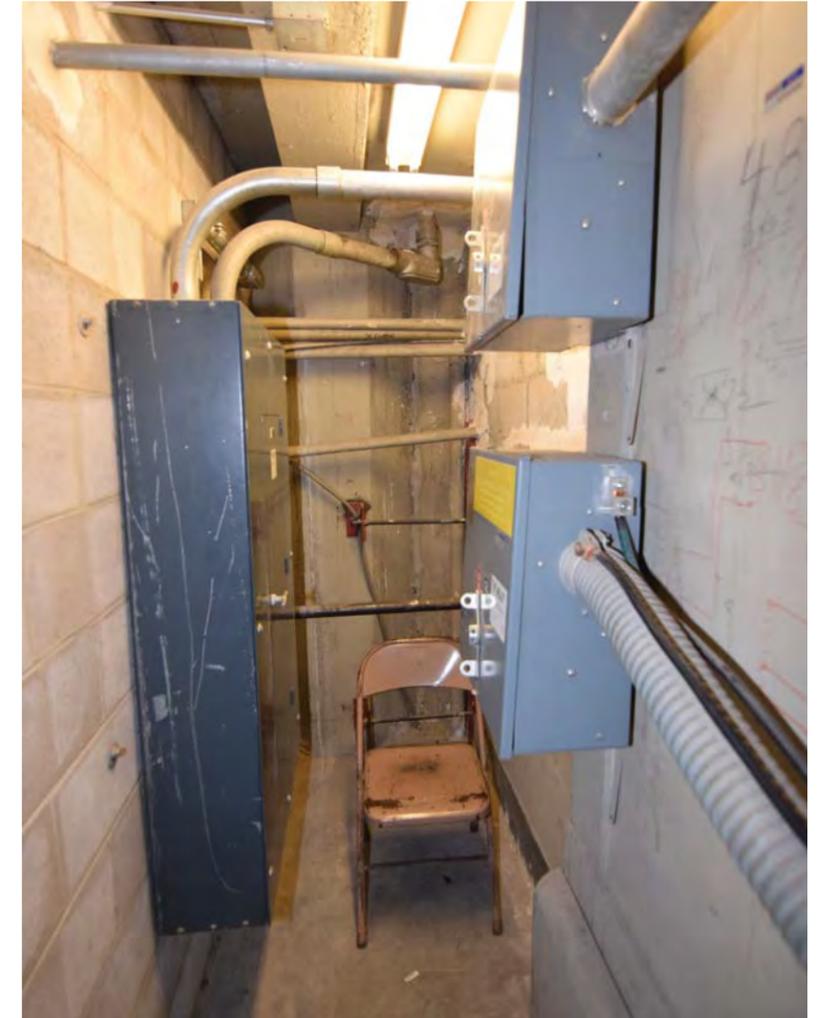
The lack of arc flash labels is a safety hazard for electricians. These labels inform an electrician of the proper safety equipment to wear when working on a piece of equipment. It is possible that an uninformed electrician may not wear the appropriate level of protection, and if an incident occurred, he may be seriously **injured** or **killed**.

*Electrical closet on upper level*

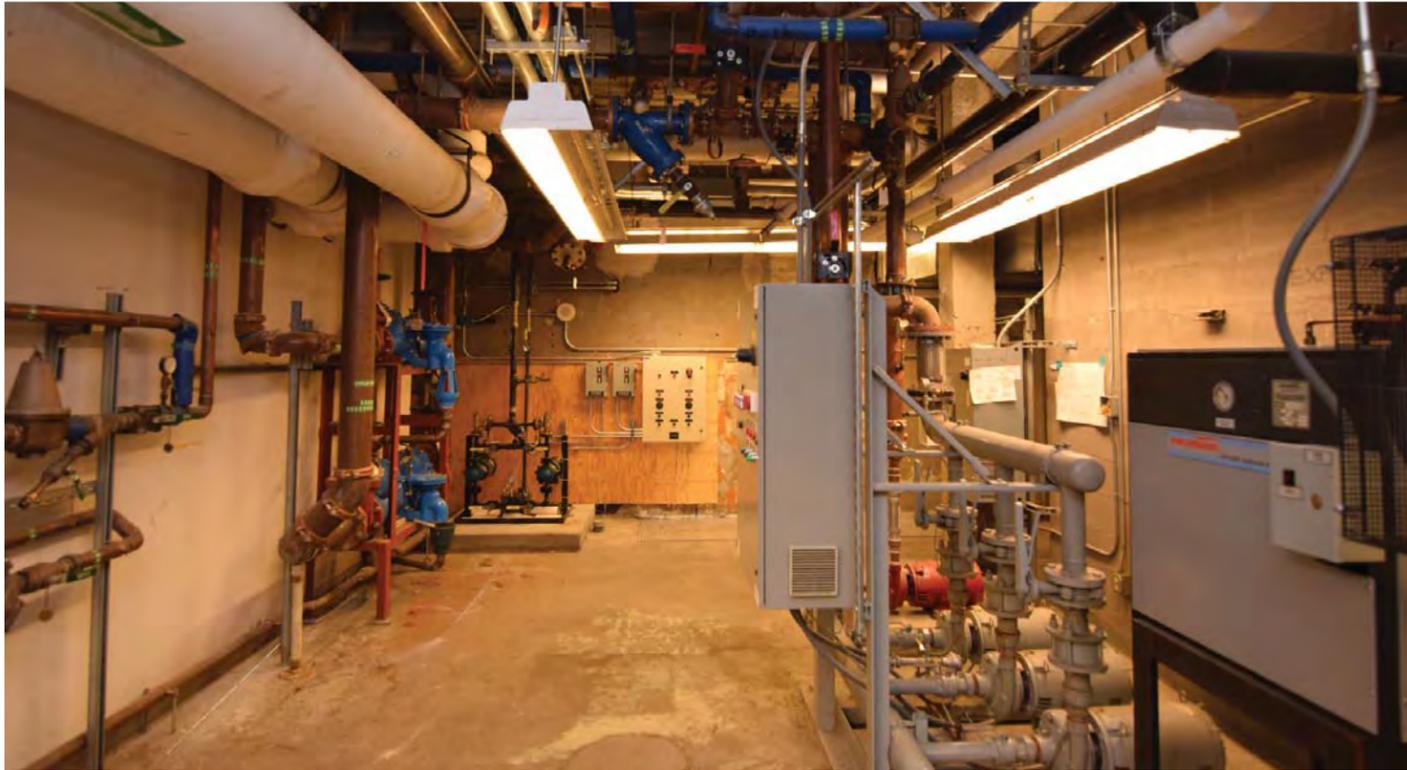
The booster pumps and associated fixtures and fittings appear to be in fair operating condition but are not delivering water appropriately throughout the building.

*Domestic Cold Water Booster Pumps*

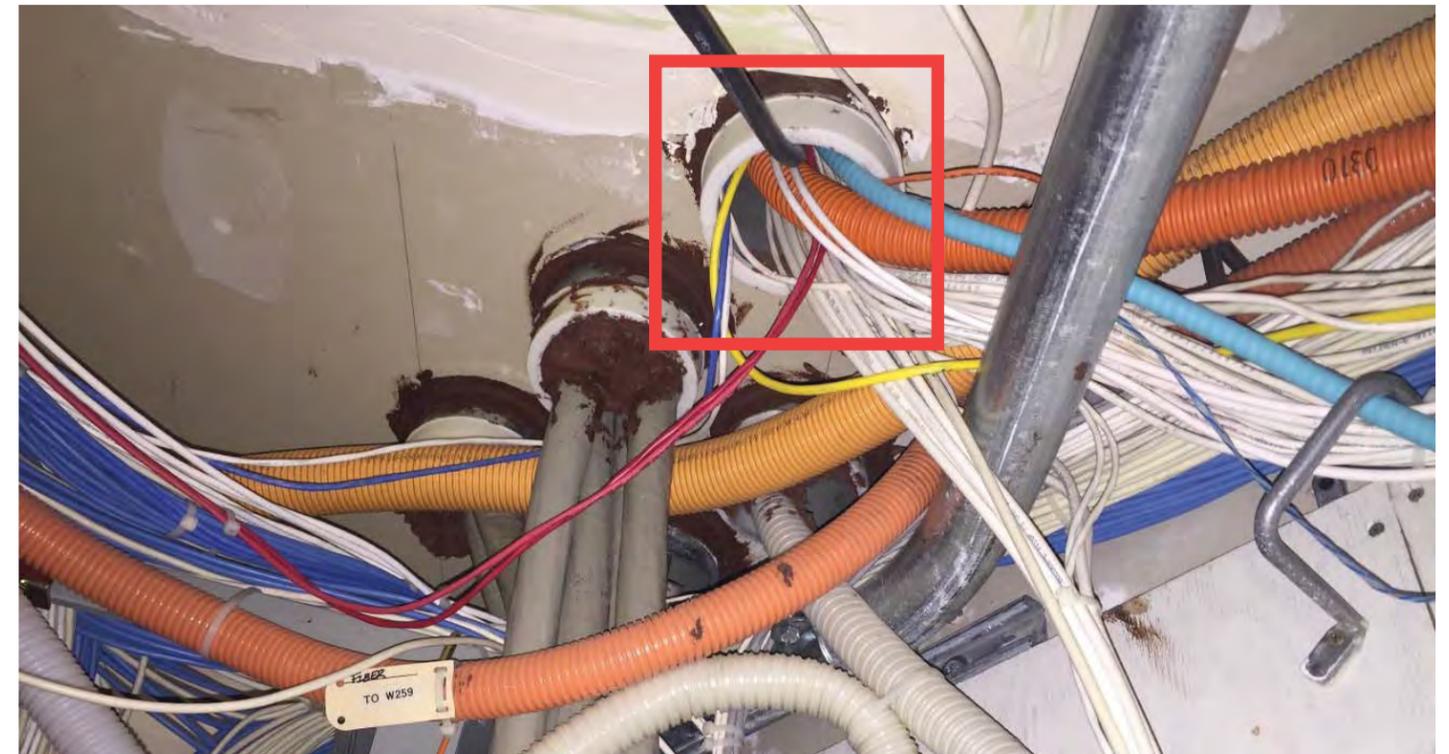
**FIGURE 5** Level 1 Intermediate Distribution Frame (IDF) - An example of typical floor penetrations. The two sleeves on the left have intumescent putty installed for firestopping. The sleeve on the right is missing firestopping on this level

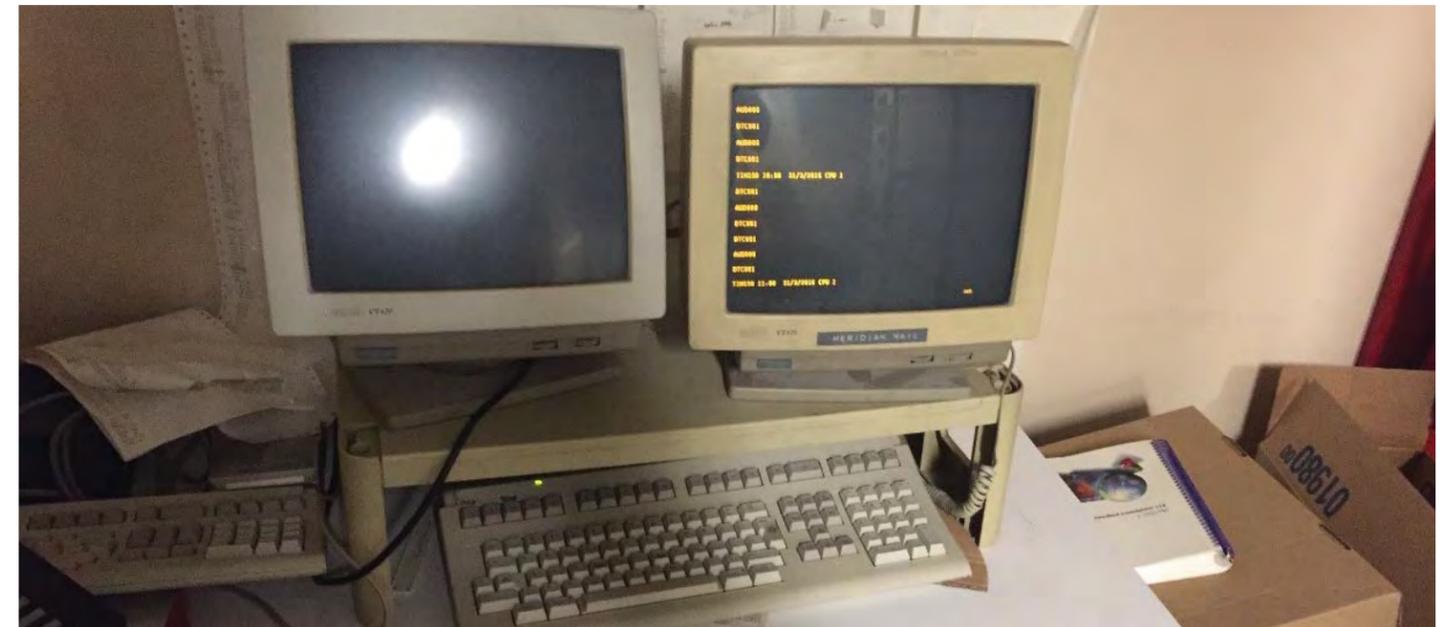
**FIGURE 6** Obsolete voice-mail server terminal, consuming power and generating heat

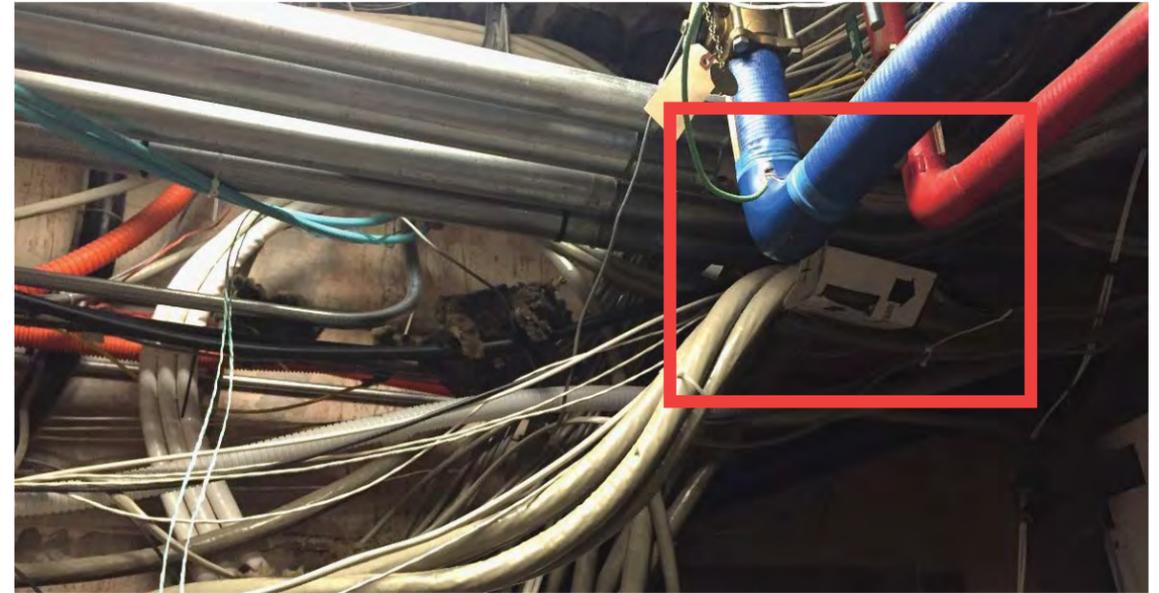
**FIGURE 10** Communication cables are supported by electrical conduit

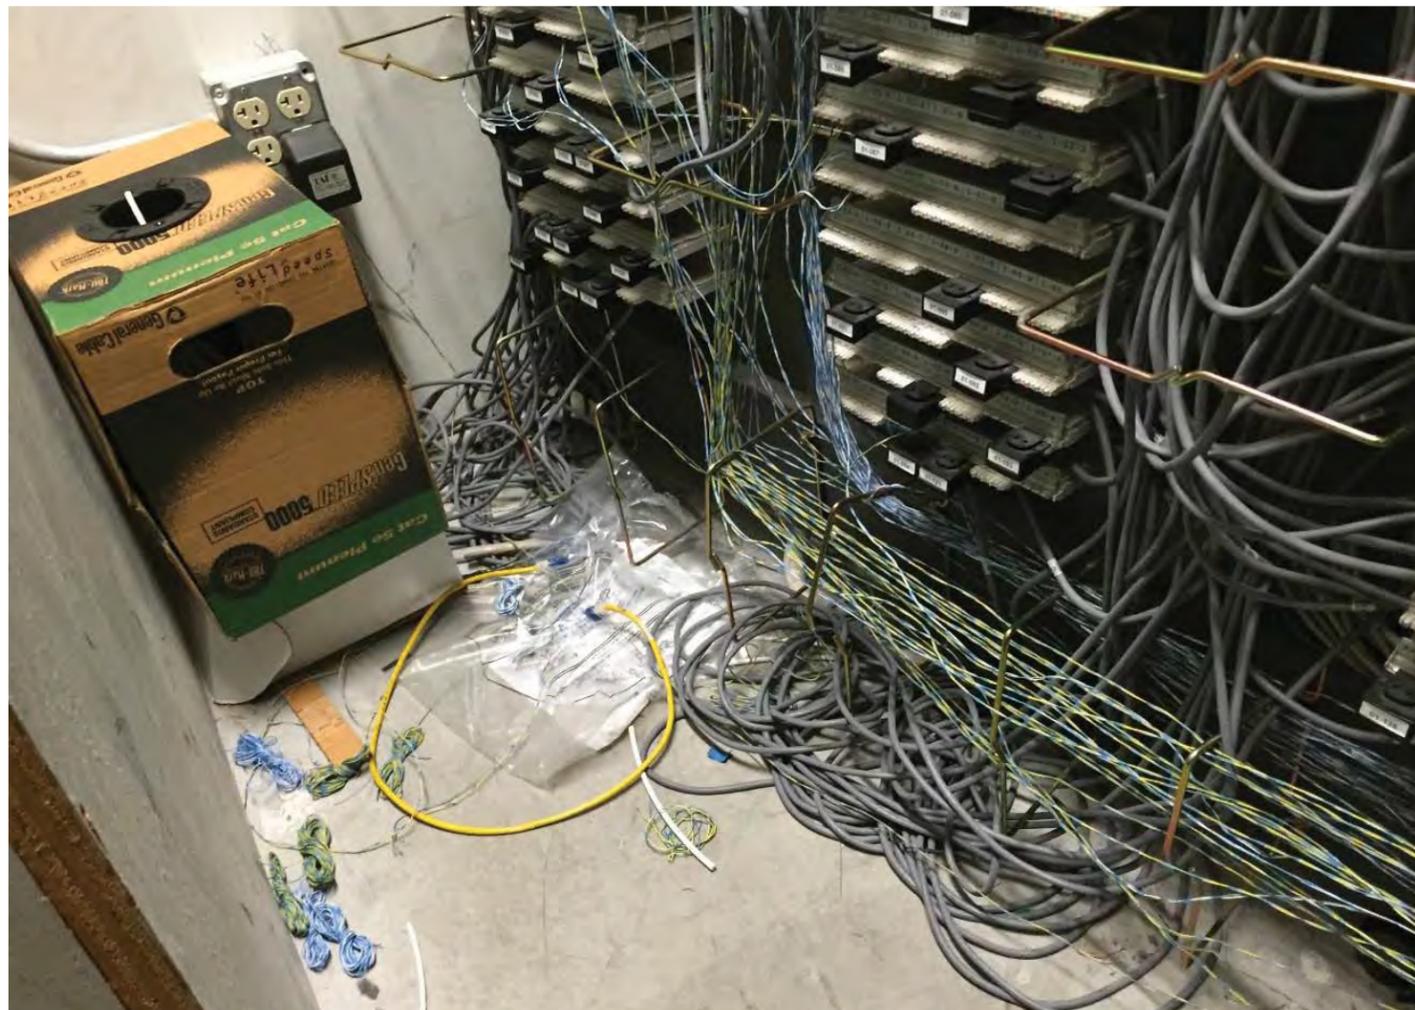
**FIGURE 12** Proprietary low-density cable patching system. Debris from construction and maintenance has been allowed to accumulate in communication spaces

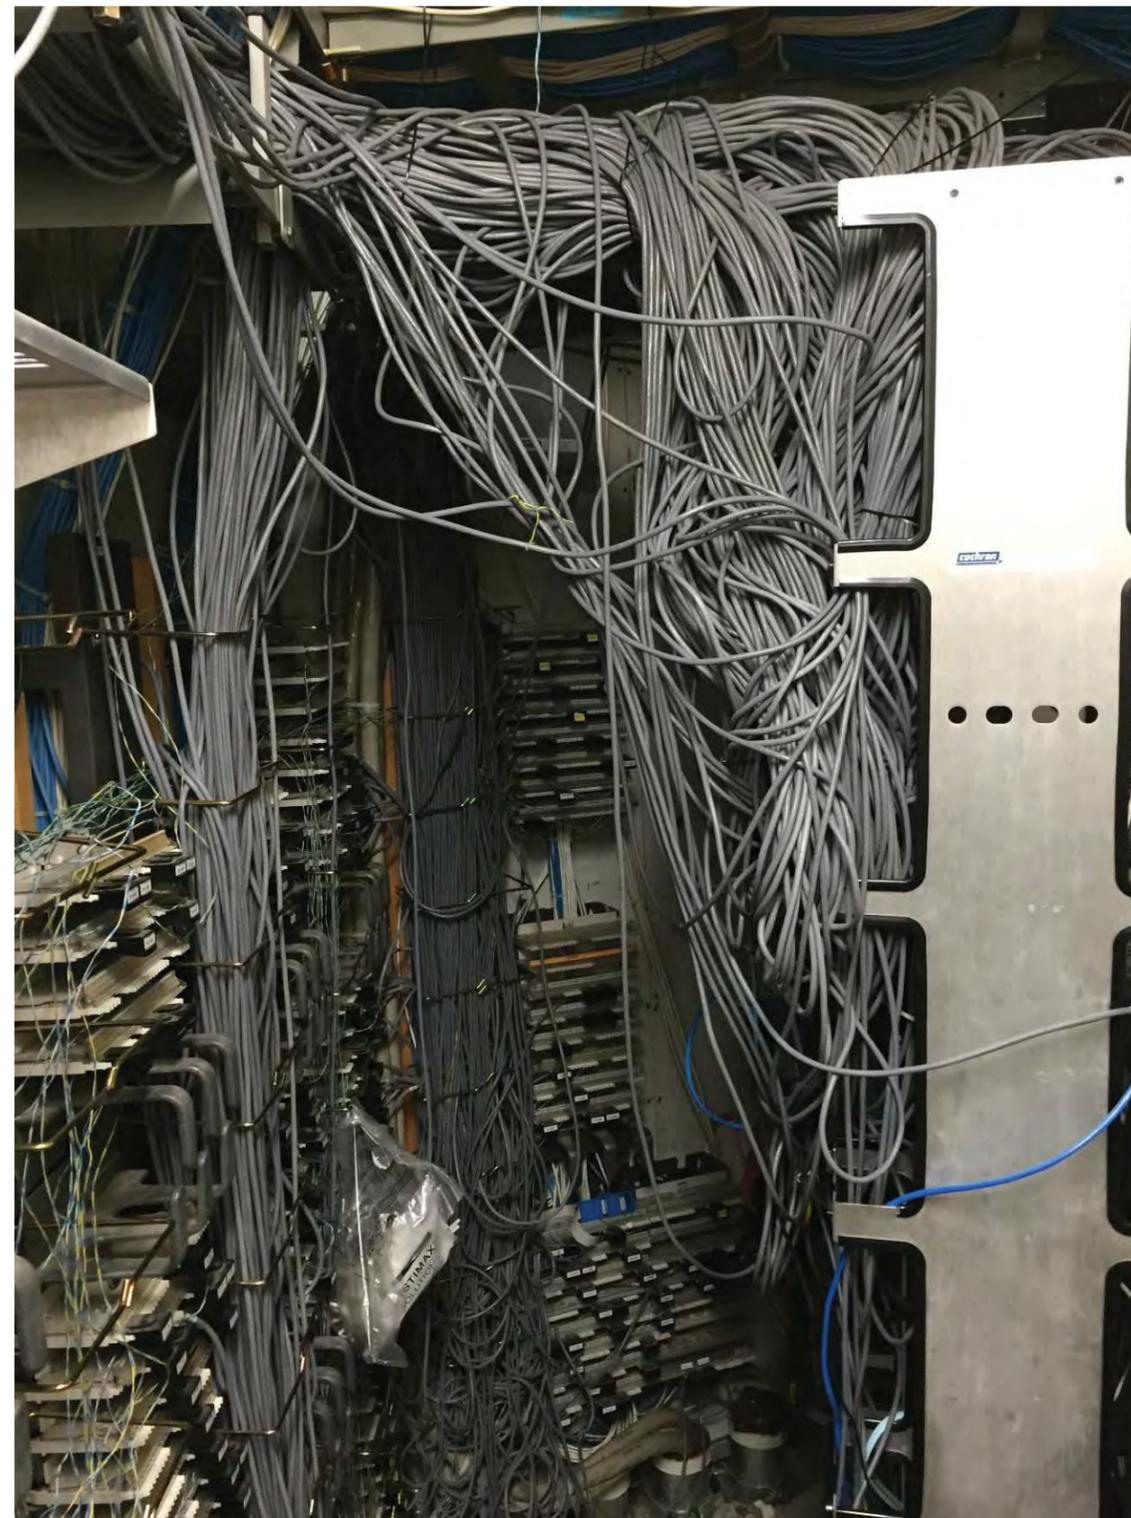
**FIGURE 13** Unmanaged cabling has been allowed to accumulate into a tangled mess, blocking access to equipment and increasing maintenance times

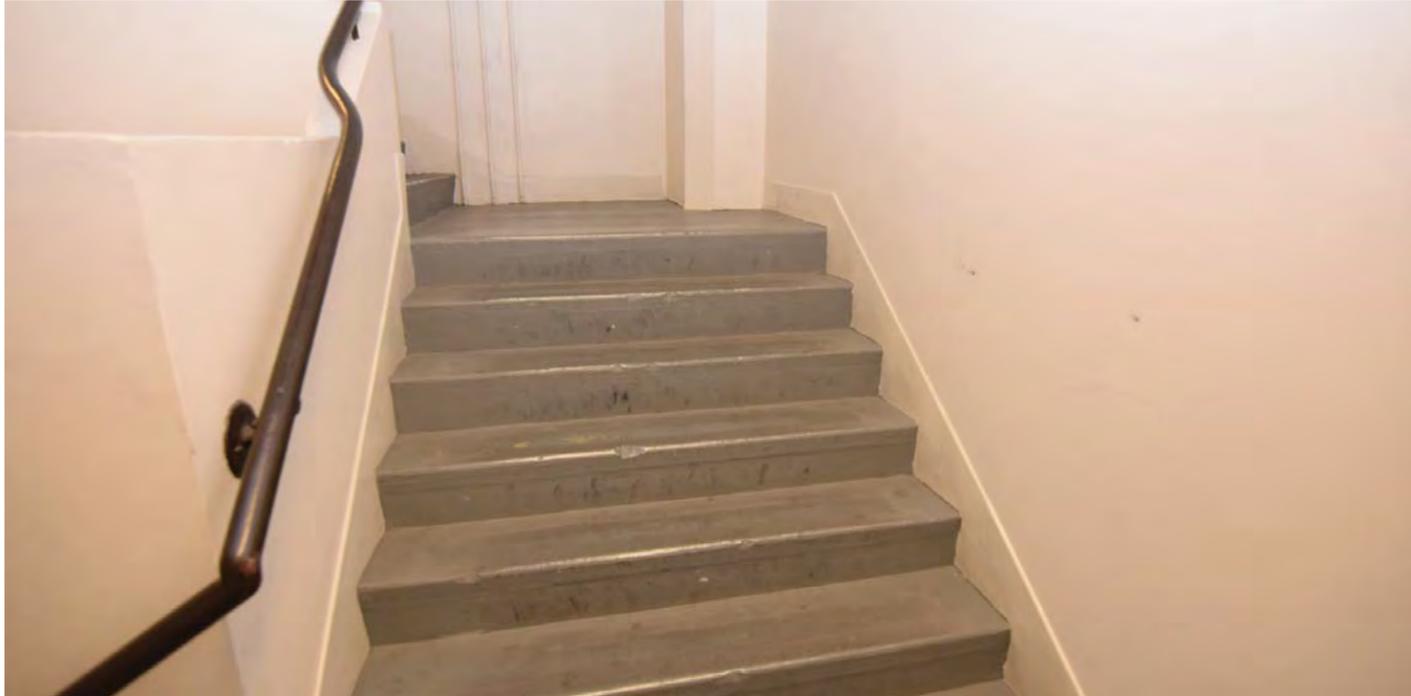
Photo of Stair 4 at level 10. A handrail would need to be added to the stair if the building is substantially altered. CDG photo, May 7, 2016.

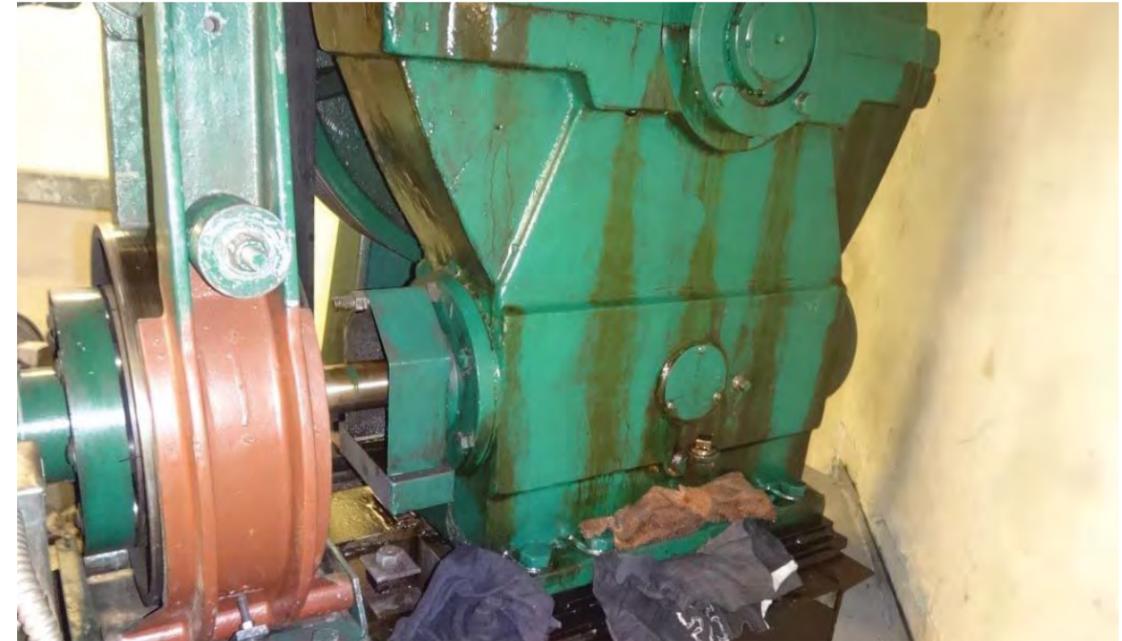
Figure 5 – Geared elevator machine for Cars 11 and 14 is leaking oil.

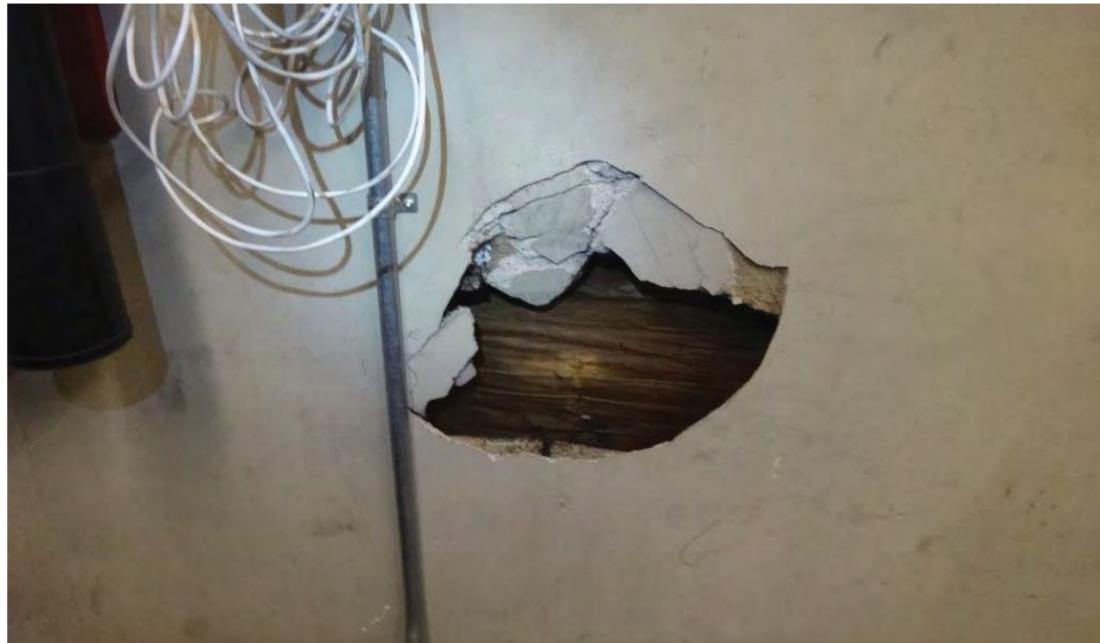
Figure 4 – Hole in the wall of the elevator machine room.

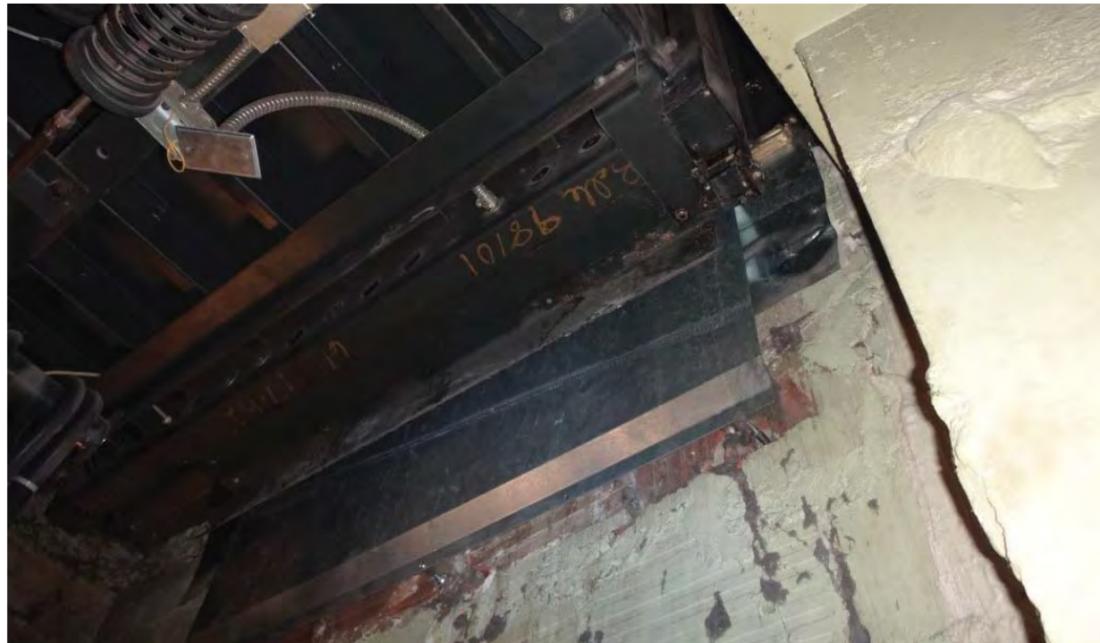
Figure 12 – Car aprons are missing from most of Cars 1 to 10.

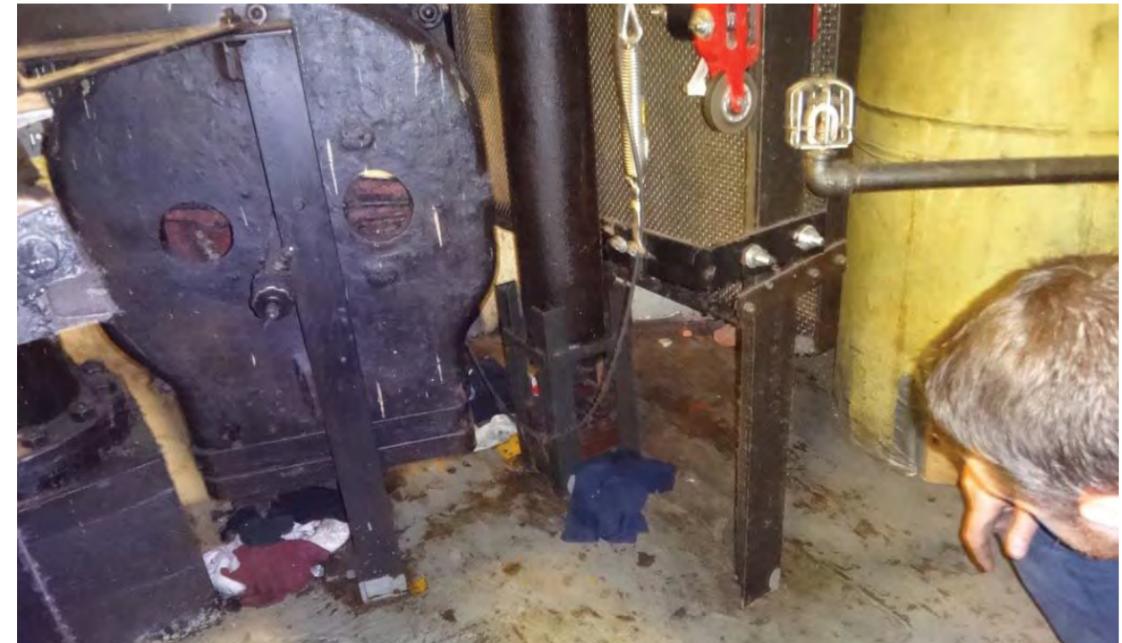
Figure 14 – Typical pit with rags and dirty floor.

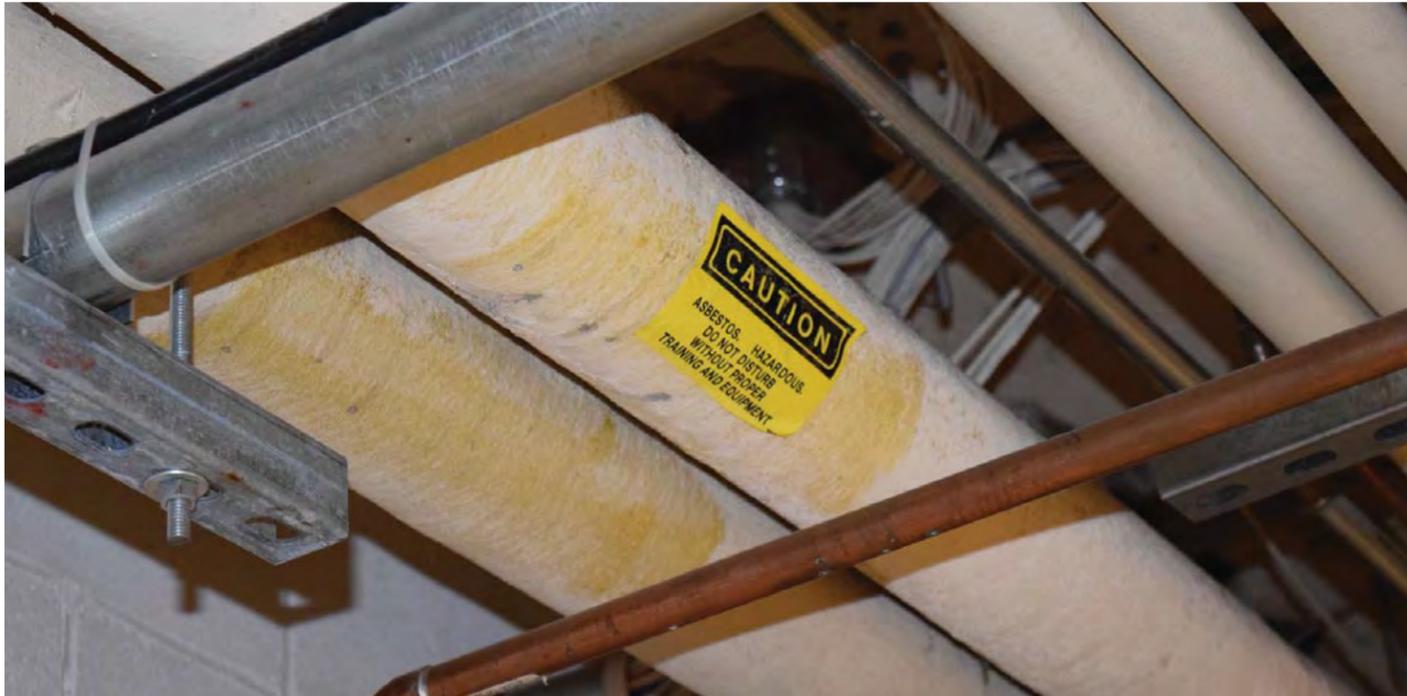
View of label identifying asbestos pipe insulation. CDG photo, May 24, 2016.

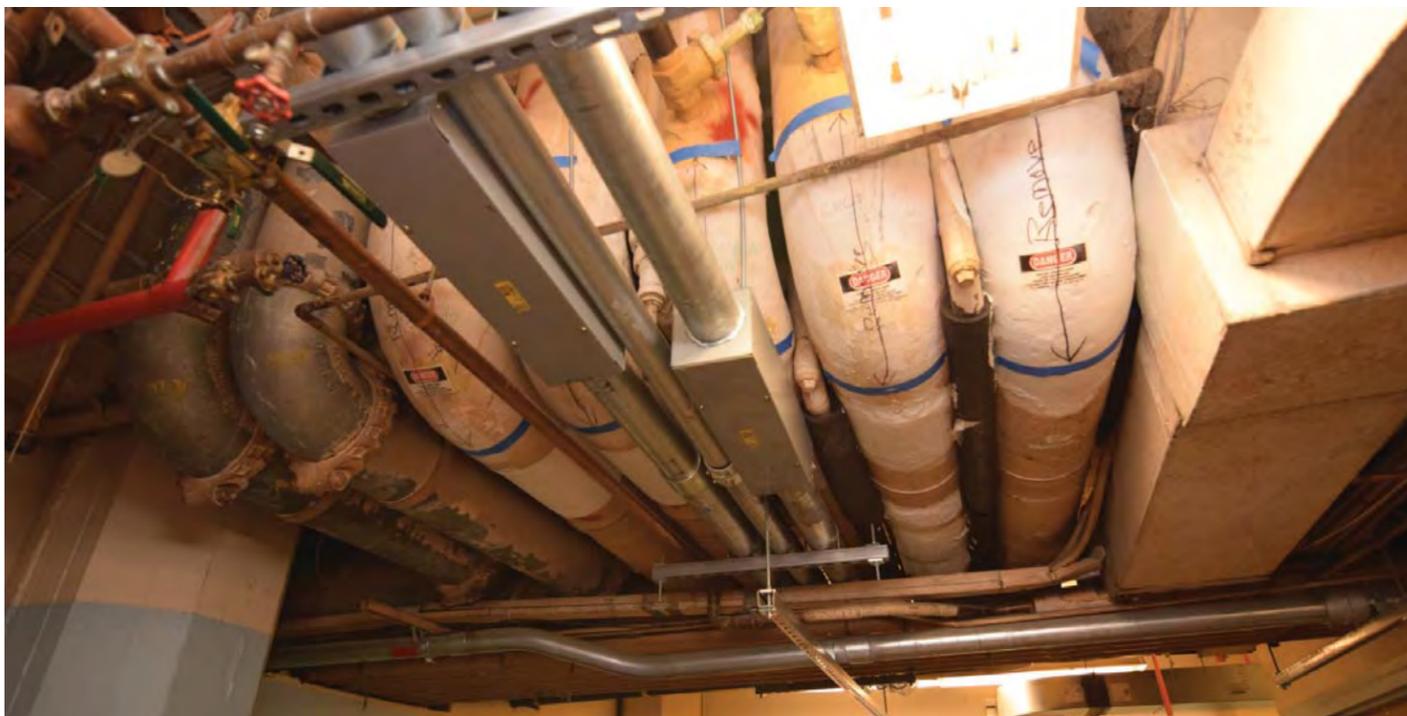
View of labels identifying asbestos pipe insulation. CDG photo, March 18, 2016.

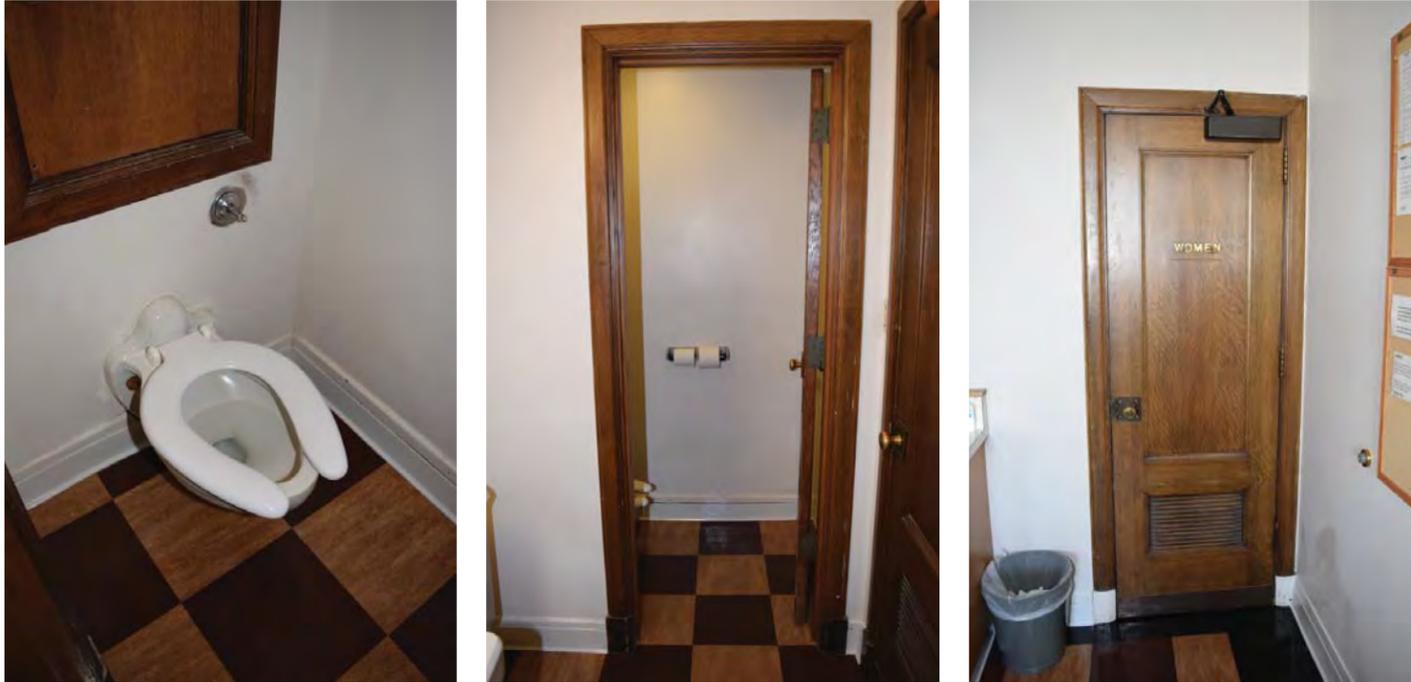
King County Courthouse typical non-ADA compliant jury deliberation room restroom and door. CDG photos, May 20, 2016.
