King County Department of Natural Resources and Parks Water and Land Resources Division 2019-2020 Flood Season Report

May 1, 2020

Department of Natural Resources and Parks
Water and Land Resources Division
River and Floodplain Management Section
201 South Jackson Street, Suite 600
Seattle, WA 98104
<http://www.kingcounty.gov/wlr>

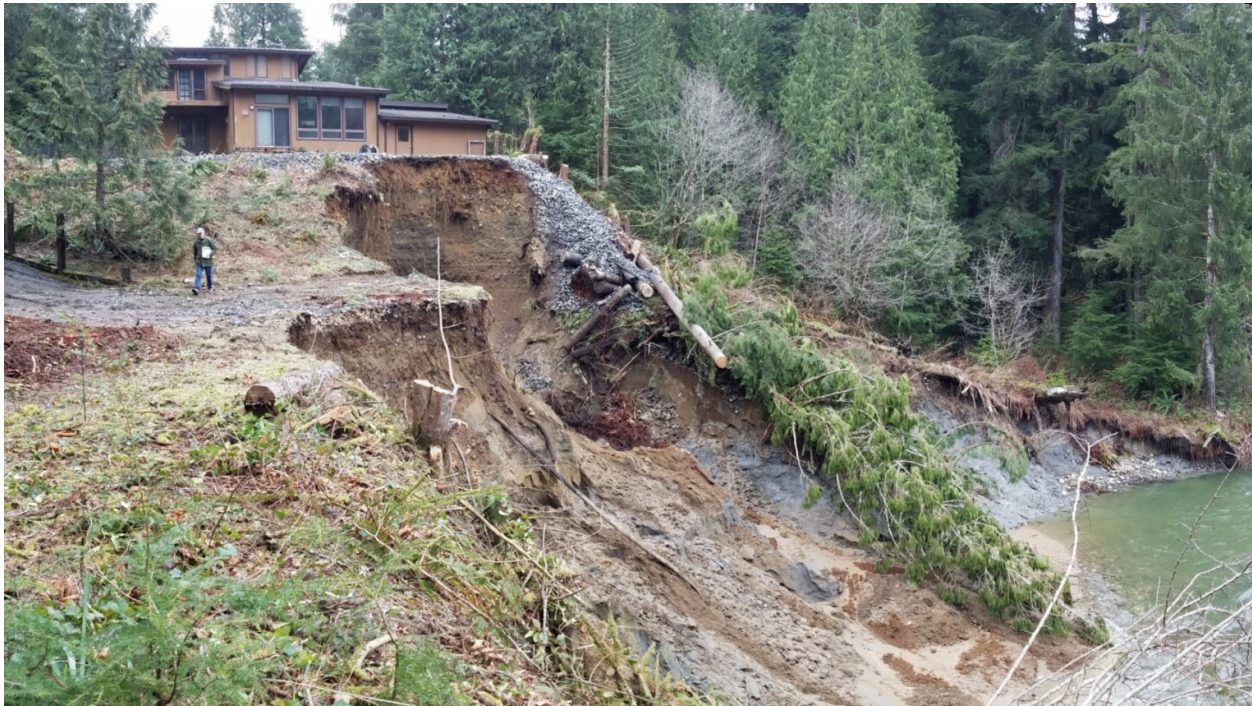
The significant seasonal precipitation and high antecedent soil moisture conditions also contributed to landslide prone conditions. Landslides were widespread in the Snoqualmie River basin during the February 5-11, 2020, flood. These conditions, combined with erosive flood flows on the Raging River, led to a landslide at river mile (RM) 7.14 that threatened a private residence and led to its evacuation and designation as uninhabitable.

Figure 1. Landsliding and bank erosion along the Raging River.

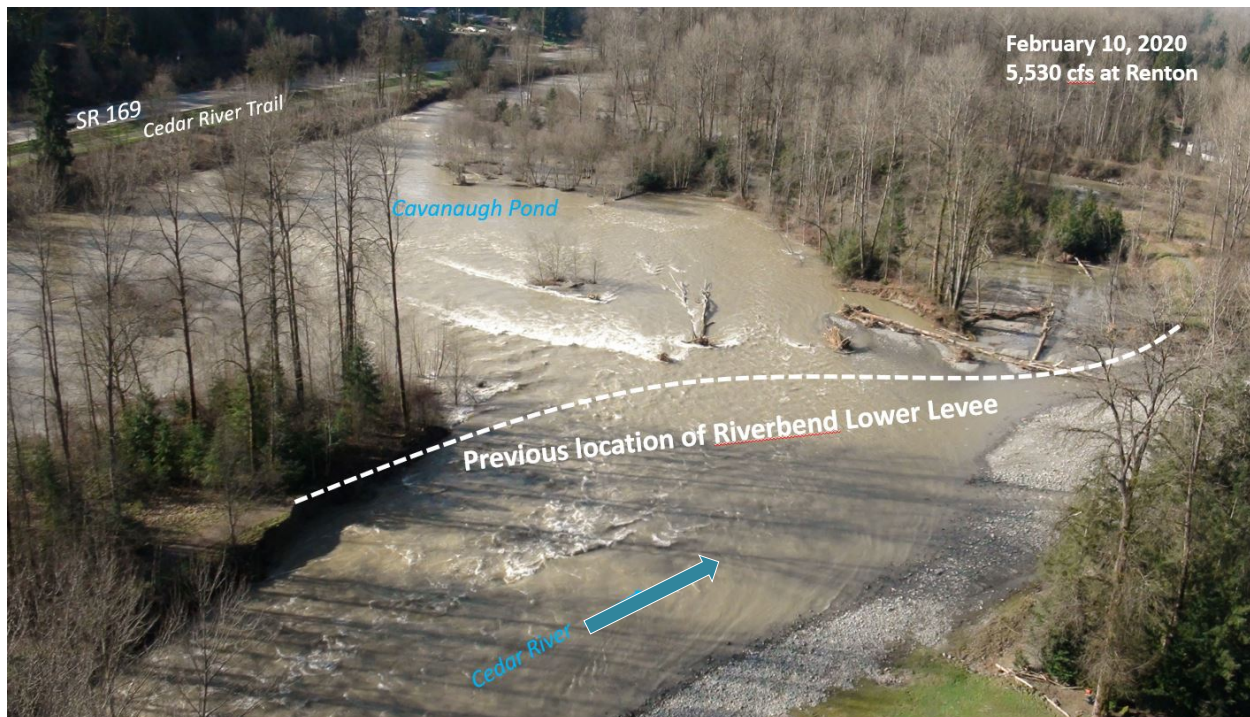
- Damages to 31 river facilities ranging from complete loss to small areas of eroded rock facing.
- Flooding of homes and roadways.
- Two emergency actions authorized by the Flood Control District.
- Flooding and closure of SR 169 west of Cedar Grove Road due to poor stormwater conveyance through a blocked culvert under SR 169 and the Cedar River Trail.
- Channel migration and bank erosion recruited hundreds of trees, some of which remain in the channel to create valuable habitat for salmonids and safety concerns for river recreational users.

Figure 3. Cedar River avulsion through Riverbend Lower revetment and Cavanaugh Pond.

- Emergency action completed in February to repair and extend the CRT 2 Revetment at the Cavanaugh Pond avulsion to protect the Cedar River Trail and buried regional fiber optic line.
- Emergency action during the flood event to place temporary super sacks upstream of the Byers Curve Levee to reduce neighborhood impacts and flooding of a sole-access road.
- Emergency action during the flood event at the site of the SR 169 flooding to deploy pumps, clean out the clogged culvert, and install additional culverts under the Cedar River Trail.

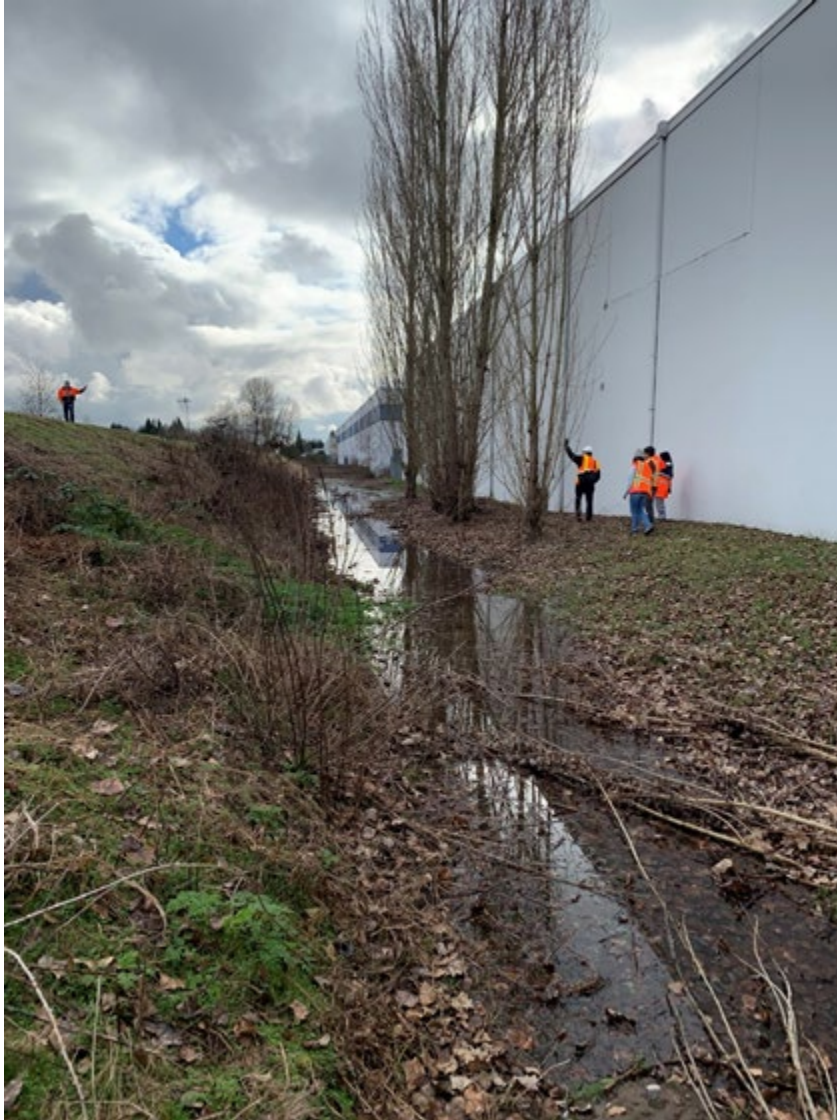
Seepage was observed through the Desimone levee on the right bank of the Green River at several locations between RM 14.8 and 15.2 in Tukwila (Figure 4); boils developed at the landward toe at RM 15.1. In addition, there was significant damage to the Tukwila Trail revetment on the left bank at RM 10.88 and the Fort Dent levee on the right bank at RM 11.0.

Figure 4. Seepage through Desimone Levee in Tukwila.

The most important issue the team observed was at the Desimone levee, RM 14.8-15.2. The February 5-11, 2020, flood resulted in seepage boils on the landward toe and water seepage through the levee to nearby properties. The observed evidence suggests that water seeped through the levee prism in at least three locations. The team proposed a levee condition analysis study. In April the King County Flood Control District approved a study contract with an on-call consultant and provided funding through the emergency contingency fund. The study is expected to provide a wide range of information that will assist in providing recommendations to the District.

A cooperation agreement between the USACE and King County was signed for a potential emergency repair at Desimone Levee during the flood season. In addition, USACE is undertaking the production of a Project Information Report (PIR) to determine if this damage would qualify for a repair through the PL 84-99 levee rehabilitation program. Two viable approaches to reducing Desimone Levee flood risk are anticipated. The PL 84-99 levee rehabilitation program will likely repair only the damaged areas. The other alternative will likely involve a larger effort to repair or replace the entire reach.
