**KING COUNTY COURTHOUSE REVITALIZATION
BUILDING SYSTEMS REPORT**

Building Systems Report

Ordinance 18239 Section 41 Proviso P5 Response
Project No. 1124472

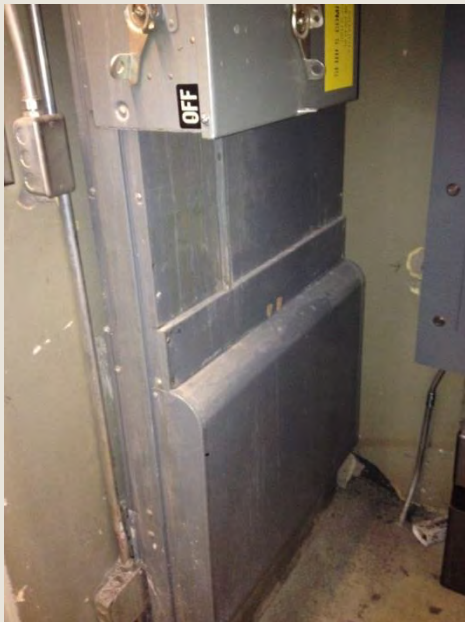
The electrical power in the building is delivered to the upper floors via two buss ducts, one for the west side of the building, and one for the east side. The buss ducts were installed in the 1967 system upgrade project and have a recommended life cycle of twenty years⁹. This system requires replacement as soon as possible, particularly if the decision is made to remain in the Courthouse for the foreseeable future. A failure of a section of this system would shut down the building for occupancy until repairs could be affected.

Figure 1 4000 amp buss electrical buss duct (East Riser)

“As electrical equipment ages, the insulation inside of it becomes brittle. Any motion or contact with the equipment can cause brittle insulation to break, which allows for electrical arcing (sparking) to occur, which ultimately can lead to explosions and/or fires. (Glumac)¹⁰”

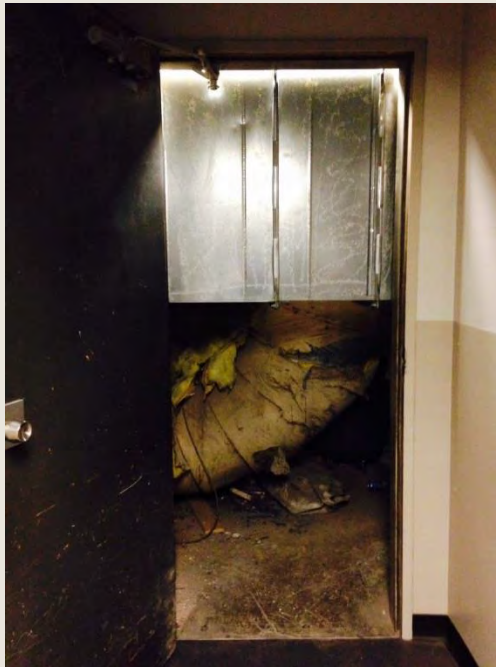
interference from ductwork and piping risers (figure 2 and 3 below). Also, there is no Arc Flash warning system in place. Due to this worker risk, no work should occur in this space until clearances are corrected, out of service date equipment is replaced, and adequate labeling and warning systems are in place. A Selective Coordination Study should be performed to insure that coordination exists at all levels from the Service Switchboard down to branch circuit before an Arc Flash study is performed. This study should be performed by a registered electrical engineering firm whose specialty includes the performance of Arc Flash reports.

Figure 2 Access to floor 1A east electrical room by crawling under ductwork, a serious safety hazard and code violation

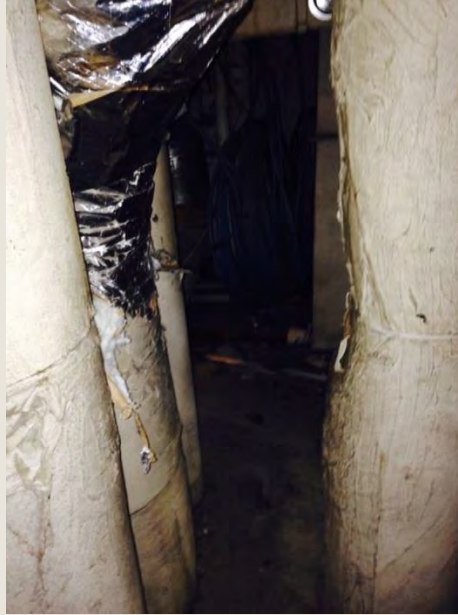
Figure 3 Access to floor 1A east electrical room (part two) by crawling through an 8” wide space between heating riser pipes. Extracting an injured worker from behind here would be next to impossible.

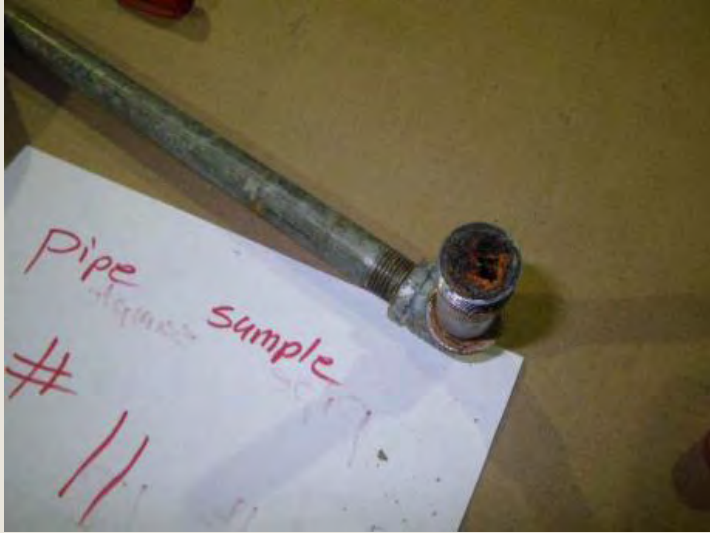
The Domestic Water system remains a problem and still utilizes some piping dating from the 1929 addition. Approximately 5% of the domestic system water piping is original galvanized piping dating back to 1930. This piping is badly rusted and should be replaced immediately

Figure 4 Pipe Sample from Courthouse domestic water system

Other problem noted include missing backflow prevention that should be installed to meet current code. Recirculation lines for heated domestic water lines should be replaced, and balancing valves should be installed. Redundant pipe risers and recirculation dead piping legs should be removed and consolidated. Once circulation and piping problems are eliminated, the main riser supply pumps should be moved up the building to the 9th floor to reduce pump energy use.

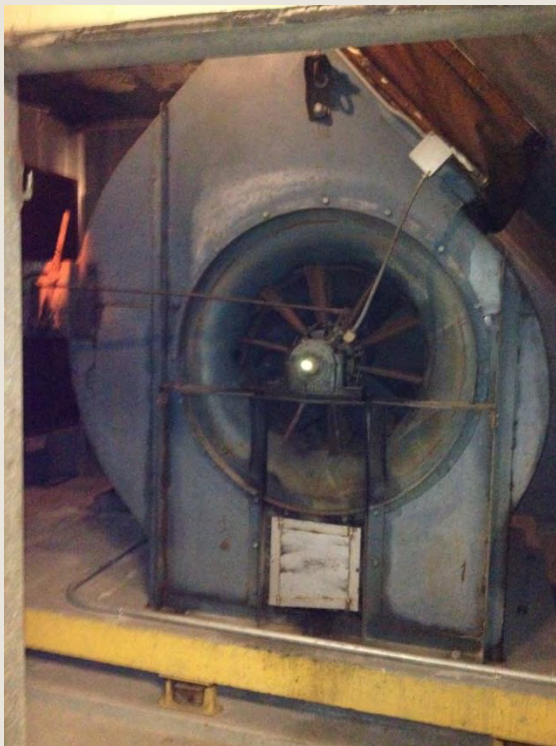
Figure 6 1965 era Dual Duct Single Fans

The recommended project for this area is total replacement of all Fan Floor equipment, plenums, controls, and associated works.

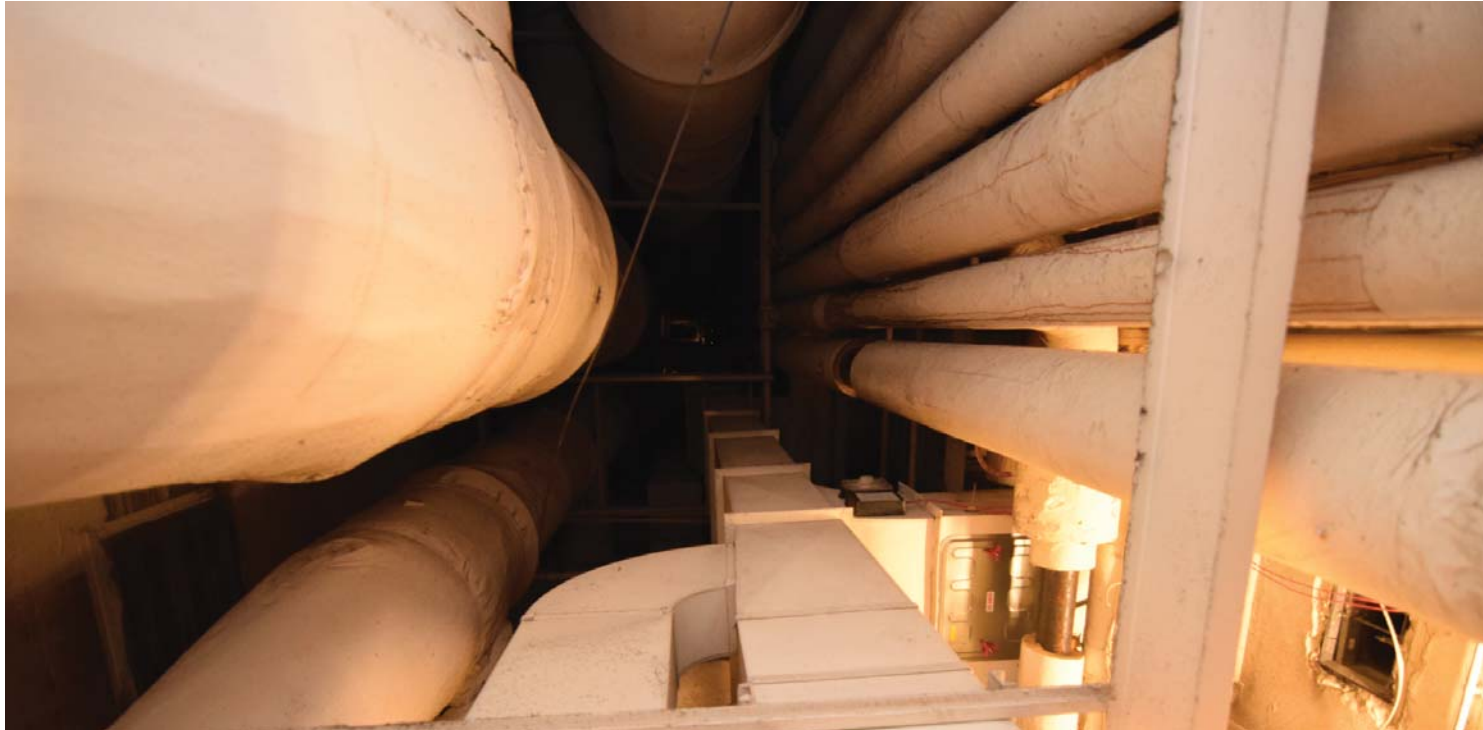
View of ducts and piping inside vertical mechanical, electrical, and plumbing shaft. CDG photo, March 31, 2016.

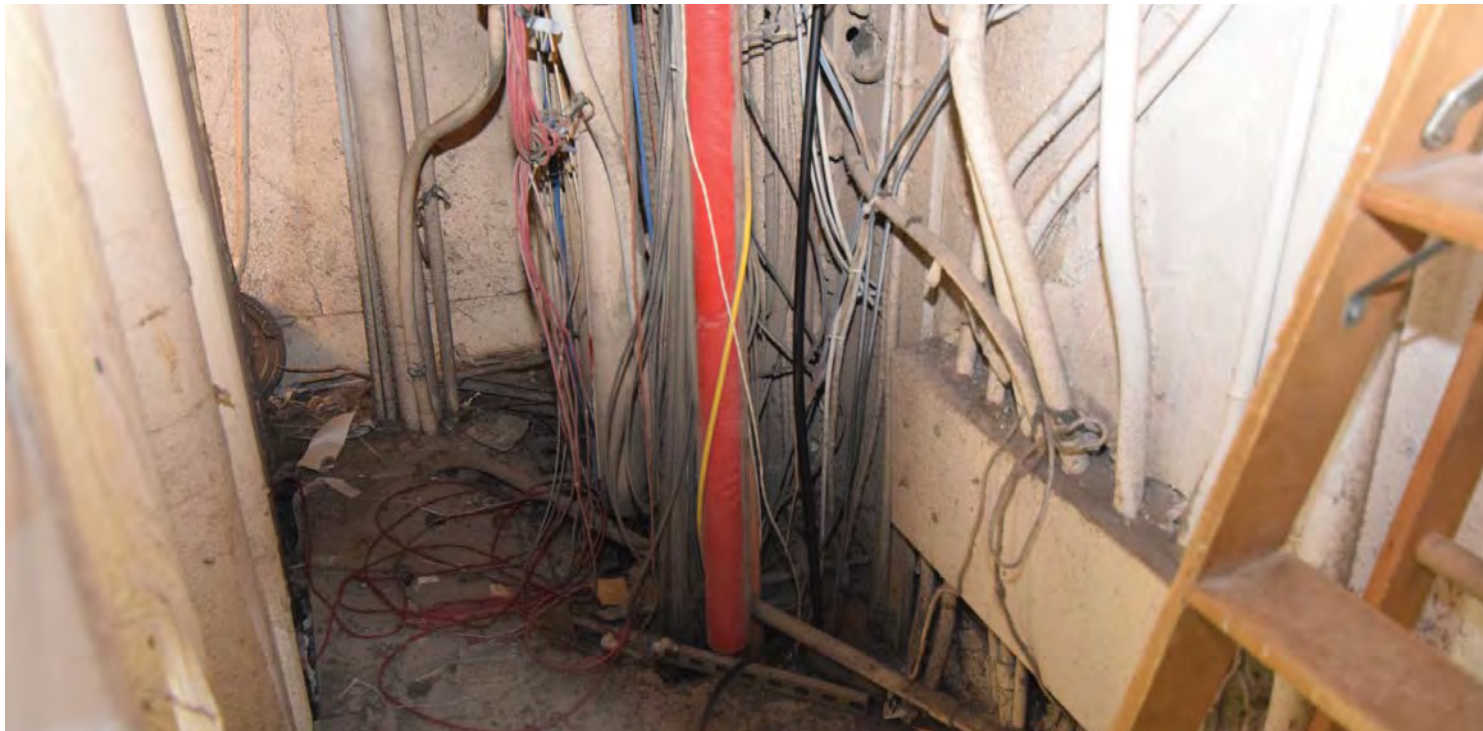
View of space inside vertical mechanical, electrical, and plumbing shaft. CDG photo, May 31, 2016.

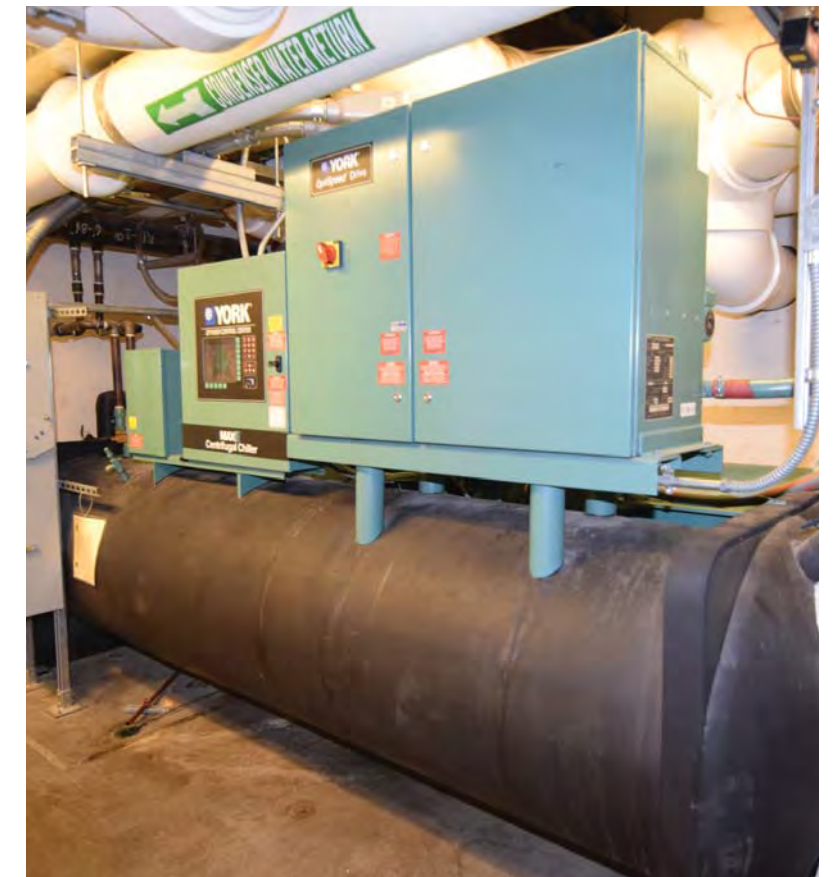
Chiller

All chillers are in good operating condition and are working properly during all times of the year. However, many of the variable frequency drive (VFD) controls for the compressor motors within the chillers are not functioning properly, which has a negative impact on the chiller efficiencies.

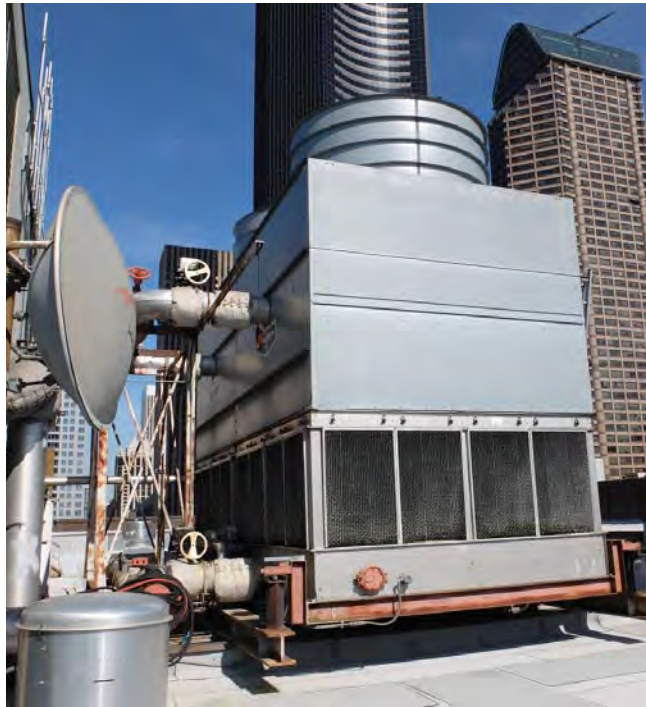
Cooling Tower

Both cooling towers are past serviceable equipment life and are in poor operating condition. Each tower shows significant signs of the typical wear and tear for cooling towers over 40 years old. There is significant corrosion of pipes and cooling tower components, which could cause complete system failure if left untreated. There is also substantial scaling, or calcium and magnesium deposits, on the heat transfer media. Scaling dramatically reduces the efficacy of the heat transfer and results in higher energy and operating costs.

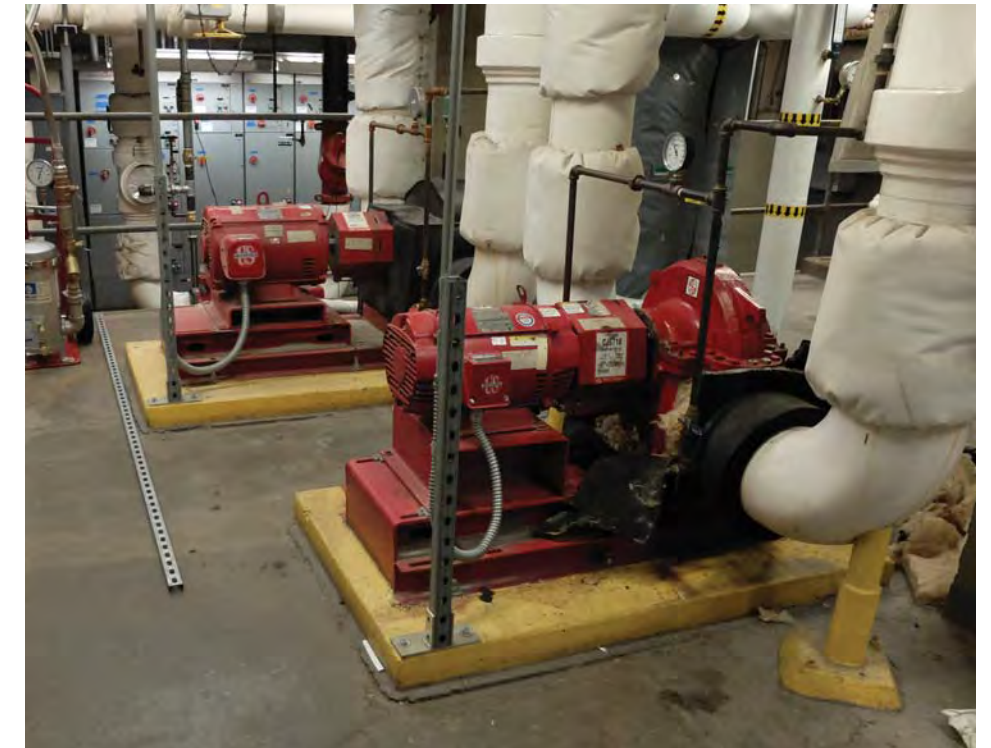
Water Pumps

Each of the pumps appear to have been serviced most recently in 2013. There are indications on various pumps that motor bearings were sealed in October of 2013 and some motors appear to have been completely rebuilt in February of 2013. However, through conversations with the operating engineers, it is apparent that many of the pumps are wearing out and all will need to be replaced. The motor bearings have been sealed, meaning that these bearing cannot be frequently lubricated. In addition, variable frequency drive and pump controls in general are not operating properly.

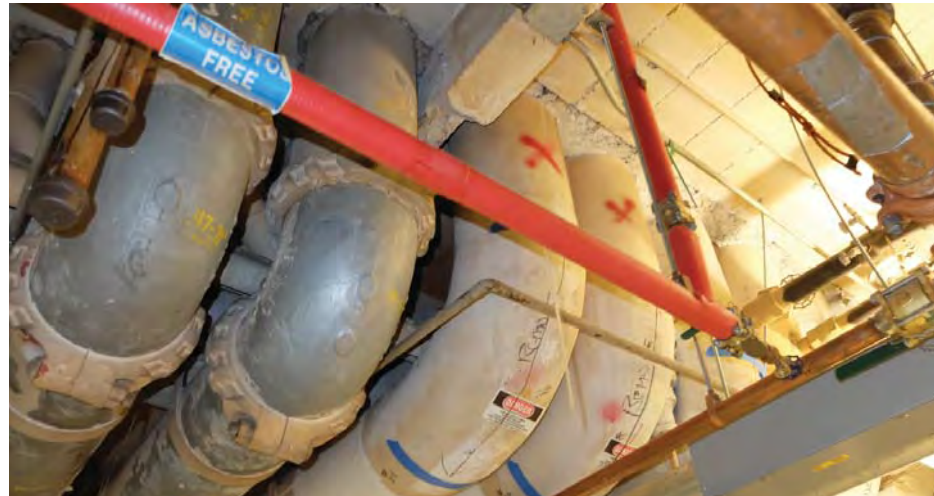
Water Piping Example

Chilled and condenser water is distributed vertically through the building within the two (2) core utility shafts. Chilled water supply and return piping is stubbed out to each floor of the building and distributed horizontally as required by the fan coil unit locations. Chilled water is also supplied to the air handling units on the Fan Floor. Condenser water is expressed directly to the roof, where it is run through the cooling towers and returned to the chillers in the basement.

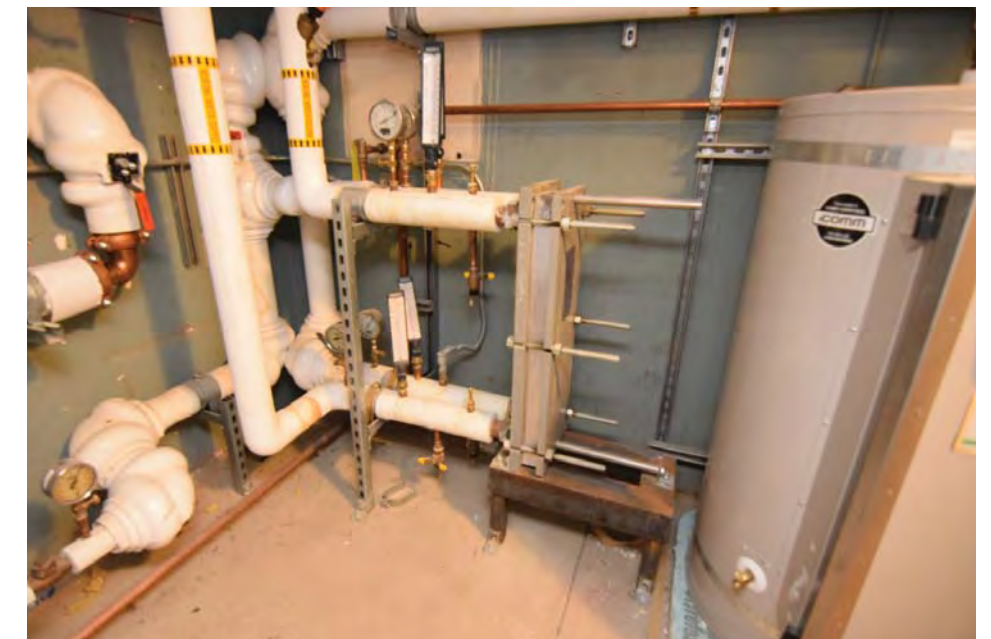
Heat Exchangers

Hydronic heat exchangers are used in conjunction with the two electric water heaters in the basement in order to heat the domestic hot water system. The heat exchangers are the primary heating source of the domestic hot water system. These heat exchangers were upgraded from the previous steam heat exchangers in 2009.

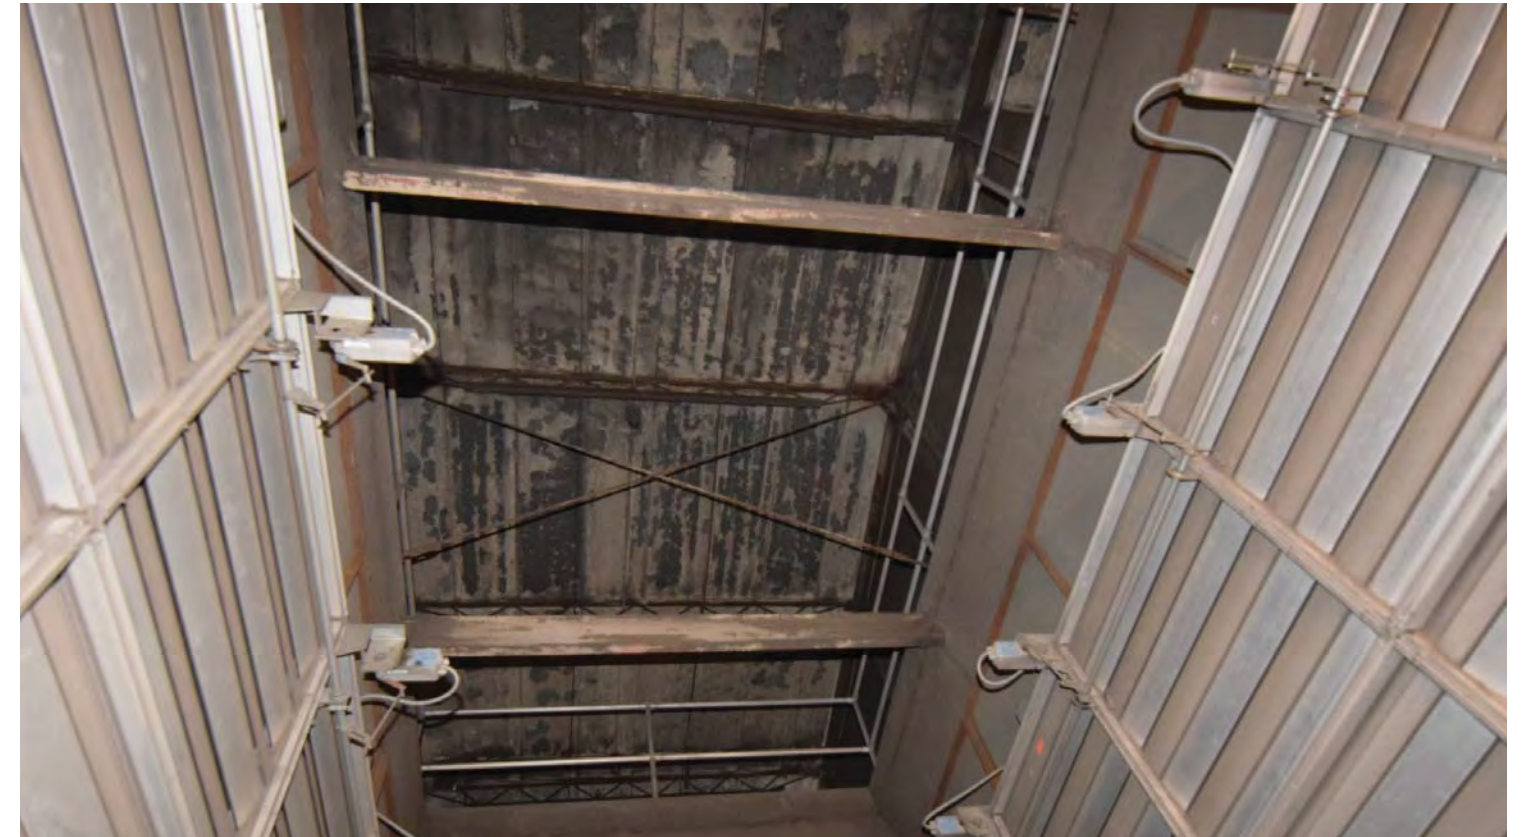
Outside Air Intakes

In all operation modes, at least the code-required minimum outside air levels are being supplied to each interior and perimeter space. However, the outside air dampers for the interior zone air handling units are barely open, meaning that ventilation to these units, and thus to the dual duct terminal units, cannot be appropriately increased. This increase of outside air delivery in periods where the outside air temperature is appropriate to provide free cooling is called airside economizer mode and is required by the Washington State and Seattle Energy Codes. This is not being met by the current outside air damper design for the interior zones.

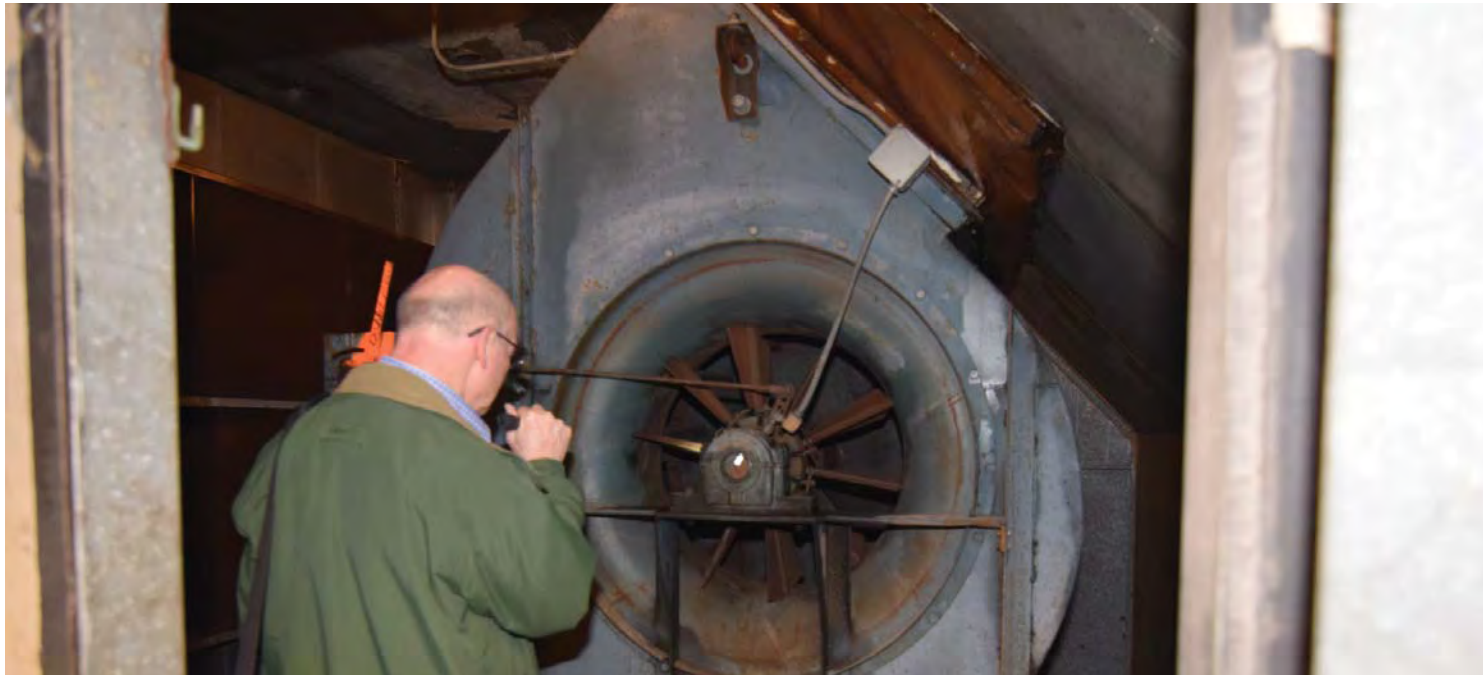
Air Handling Unit

The exhaust fan on the Fan Floor draws un-ducted return air from the shaft risers. This return air enters the shaft at the plenum above the ceiling on each floor. Return airflow into the central shaft is not measured or controlled on a floor-by-floor basis. Unlike the interior zones, this return air does not return to the unit to mix with the outside air, rather it is exhausted straight to the exterior of the building.

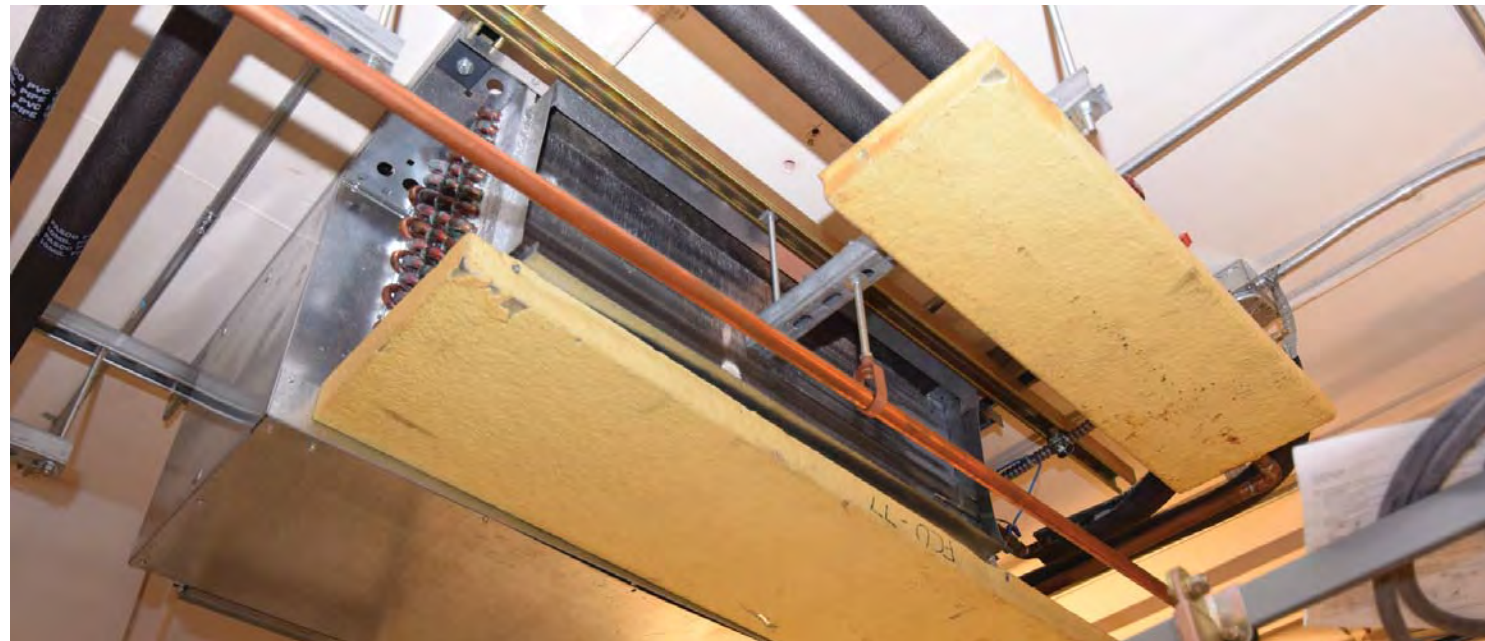
Fan Coil Terminal Units

Because there is no condensate drainage for many of the fan coil units, chilled water is supplied to the fan coil units at 58°F, thereby eliminating condensation on the cooling coils and preventing excess moisture from damaging the ceiling and nearby property. However, the cooling coils cannot properly dehumidify the space in this configuration, which can cause significant occupant discomfort as well as potential property damage in historic or otherwise sensitive spaces. These types of units are designed to utilize chilled water around 44°F and operate most efficiently with entering chilled water in that temperature range.

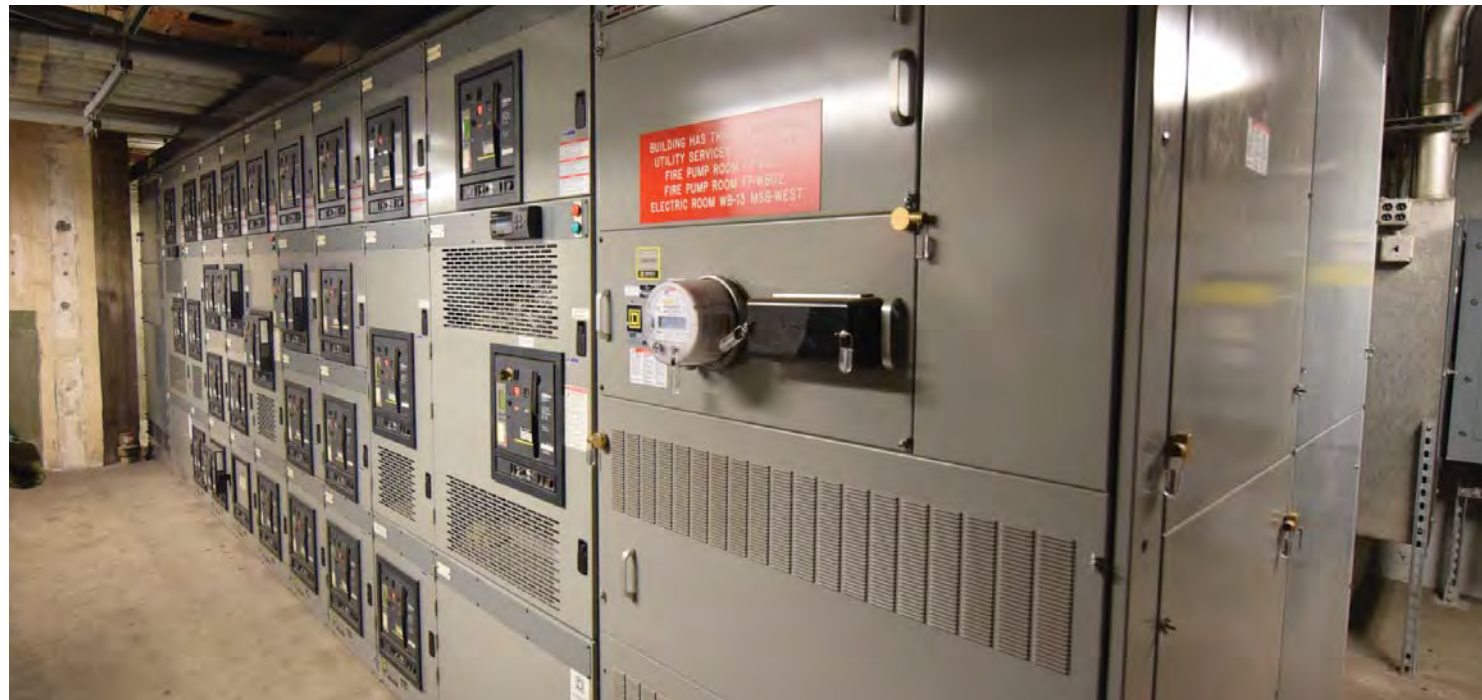
The existing electrical distribution system is typical, in that 480V power is provided from a local utility vault into the Main Electrical Room in the basement, where a Main Switchboard is located. The Main Switchboard distributes 480V power to the rest of the building. Where necessary on the individual floors, dry-type transformers are provided to step the 480V power down to 208V power. See *Figure 1* for a high level conceptual sketch illustrating this.

Main switchboard photo

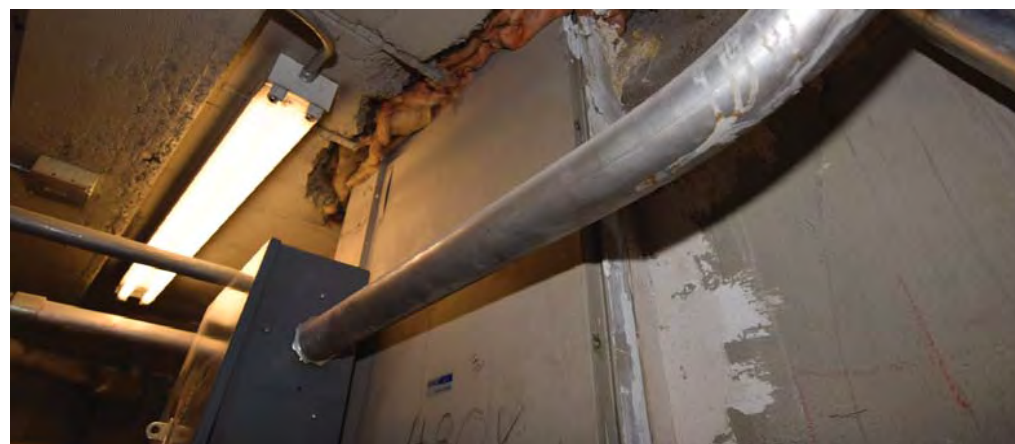
Similar to *Figure 1*, the Courthouse has 480V and 208V panels on each level, and normal power is provided to upper levels of the building through a large power trunk called a **bus duct**. Each side of the Courthouse (the west and the east) has its own dedicated bus duct and associated panels that tap off of it.

Bus duct photo

A foreseen challenge in replacing the bus ducts is that the new bus ducts will require a significant amount of new space throughout upper floors. Similar to the existing bus ducts, the new ones will require an accessible electrical closet on each floor they run through, and current code clearances (2014 National Electrical Code 110.26) will be required in these new spaces, which the existing closets do not provide. Glumac estimates each of these closets may need to be approximately 6'x10' in size, as conceptually illustrated in [Figure 2](#). Mechanical cooling will also be required in these closets. While the space requirement is significant, providing a larger space for electrical equipment will help to resolve the safety issues identified in [Section 1.1.5](#).

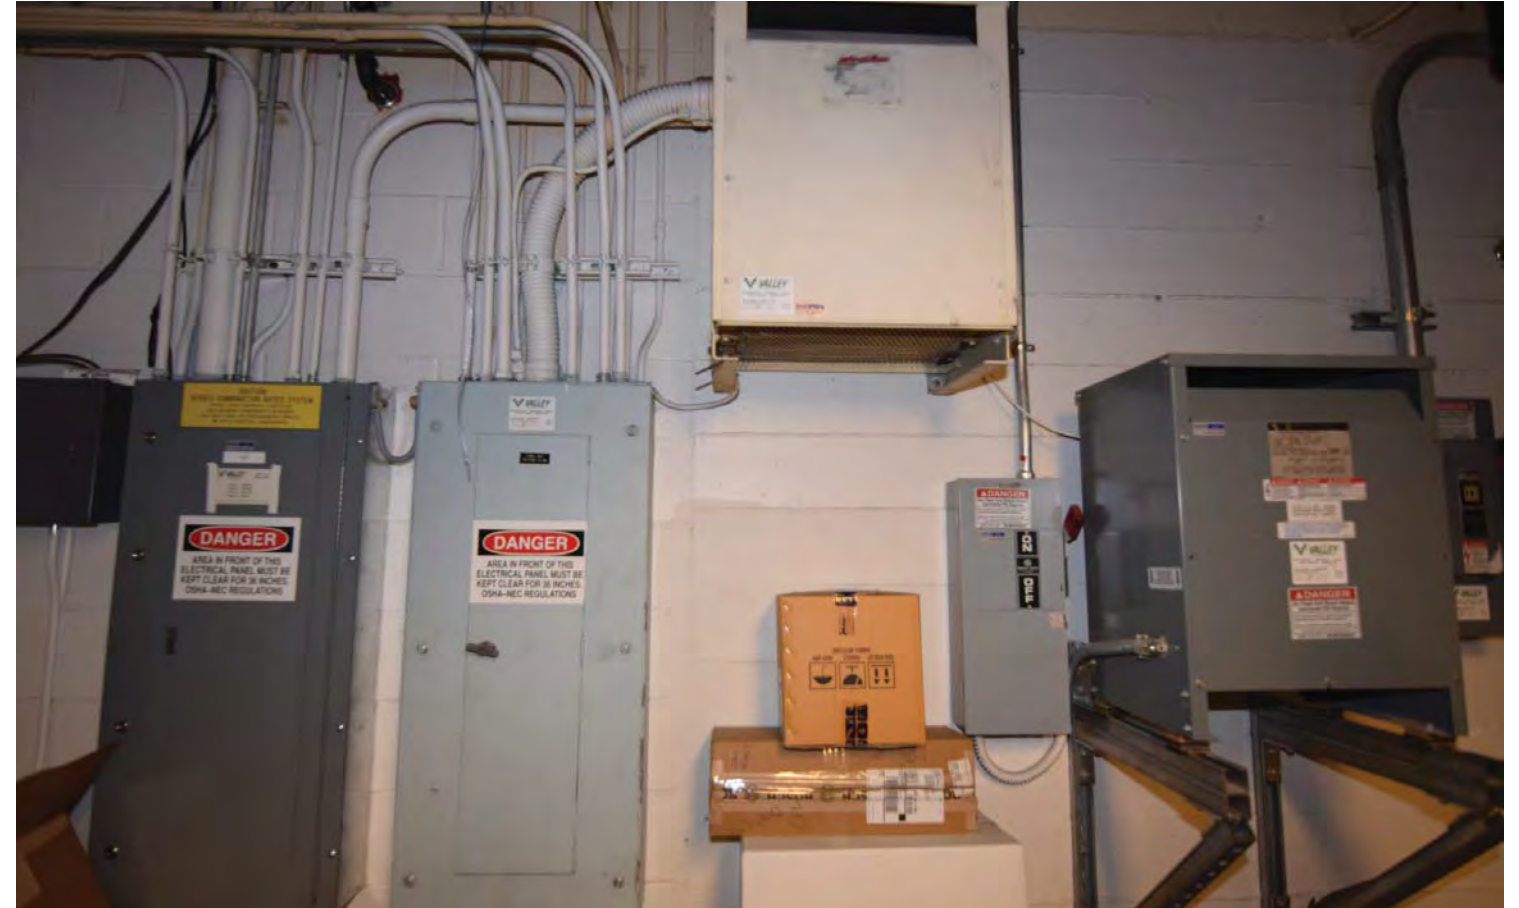
Similar to the bus duct discussed in [Section 1.1.2](#), the 208V panels and associated transformers are dangerously old, with the potential of creating explosions and/or fires. **Injury** and **death** are possible results.

208V circuit breakers

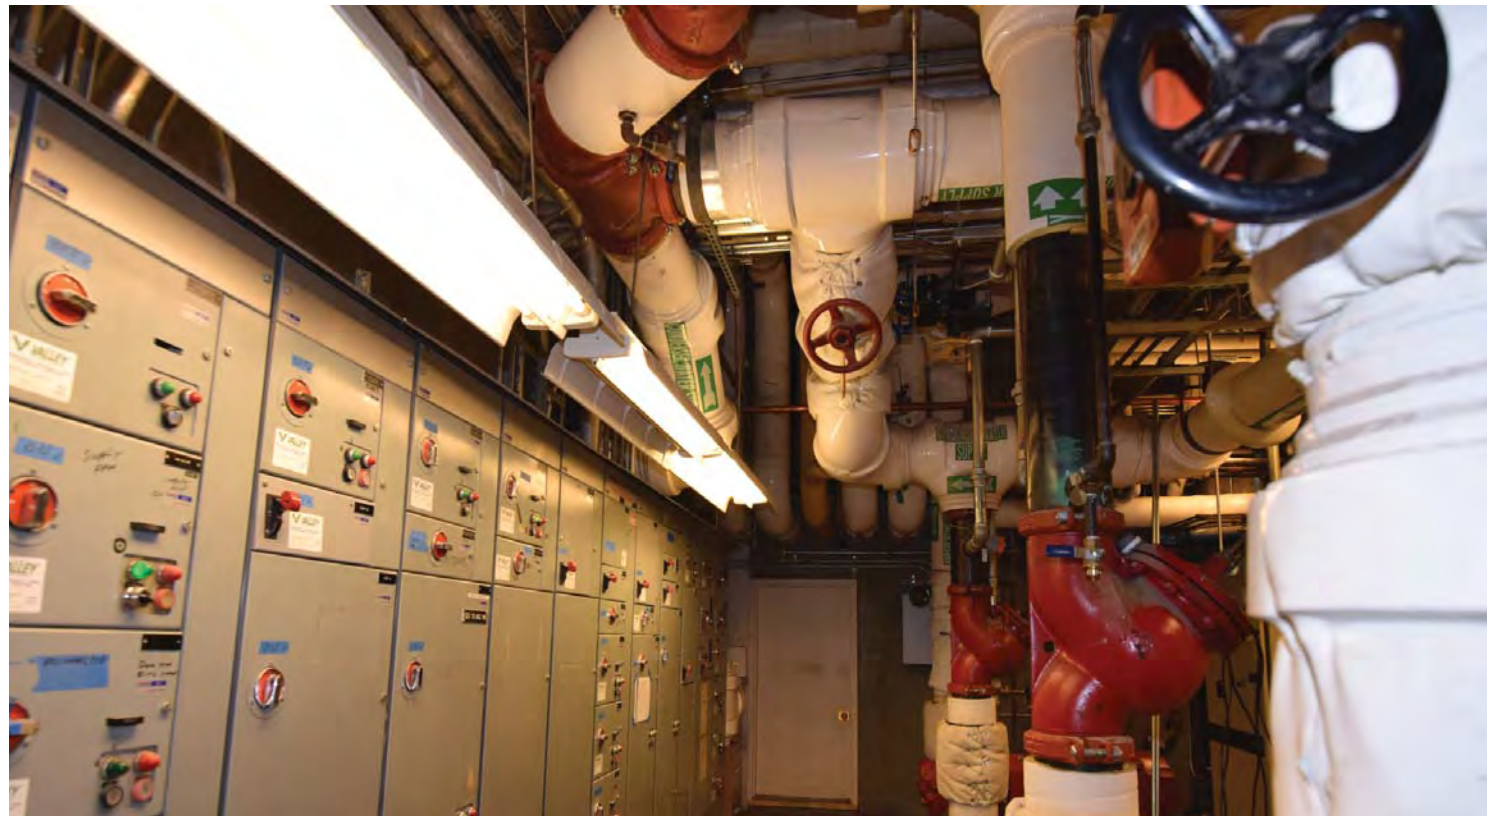
One of the existing motor control centers is located beneath an existing waterline as well. A water leak could potentially occur and cause the motor control center to malfunction.

One of the existing motor control centers

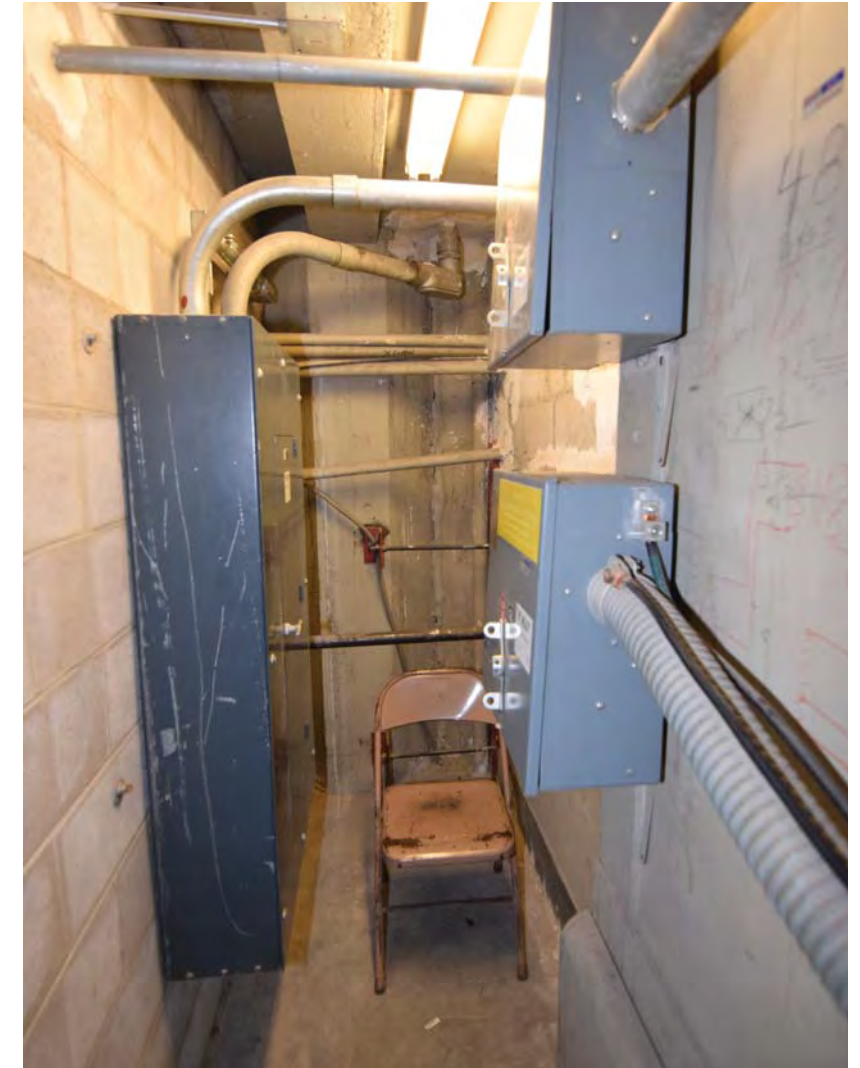
The lack of arc flash labels is a safety hazard for electricians. These labels inform an electrician of the proper safety equipment to wear when working on a piece of equipment. It is possible that an uninformed electrician may not wear the appropriate level of protection, and if an incident occurred, he may be seriously **injured** or **killed**.

Electrical closet on upper level

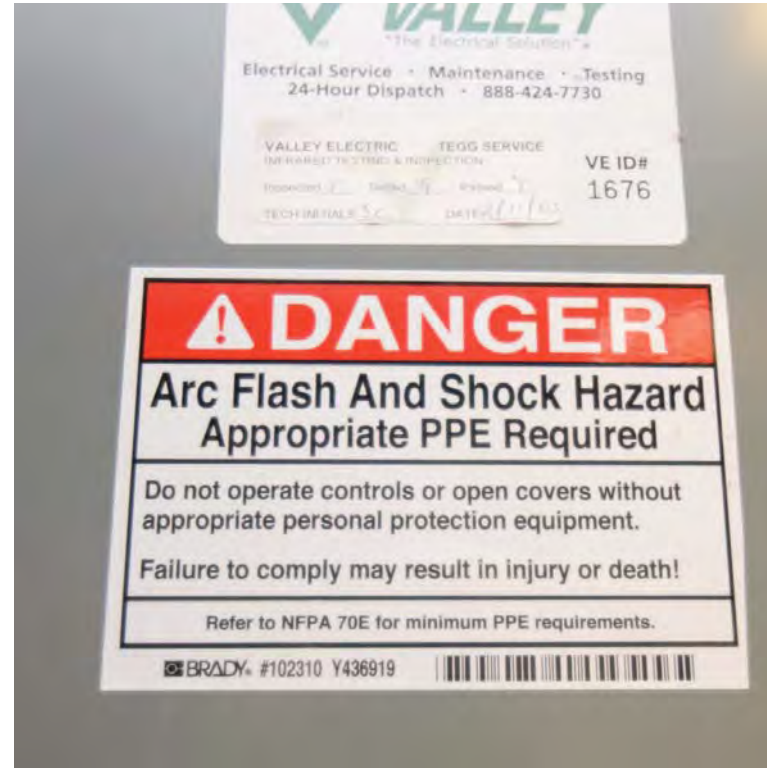
1. *Arc Flash ratings inform electricians of specific types of required safety equipment to wear in the event a fault occurs in a piece of equipment while the electrician is present. Faults can directly electrocute a person, or cause explosions, or generate fires. It is possible for an electrician to be shocked, burned, or receive damage from an explosion by a fault if he/she is not wearing the correct level of safety equipment.*

*Arc flash label***1.1.7 LIGHTING**

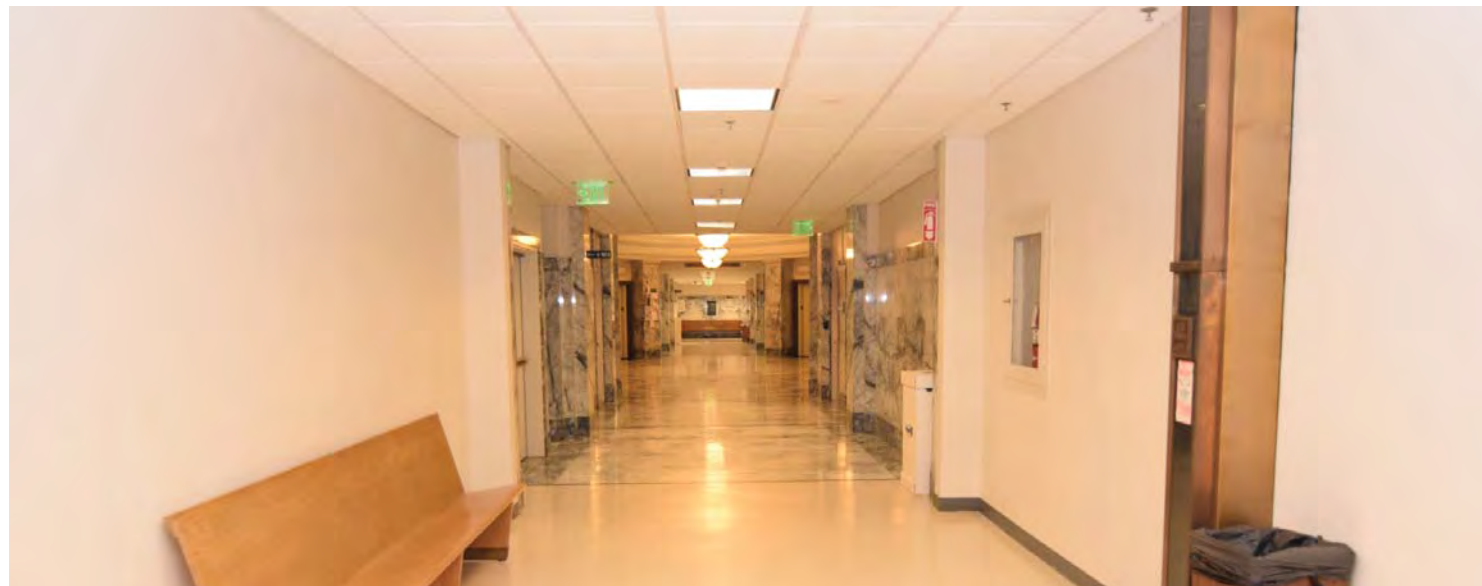
Existing lighting is primarily fluorescent. Automated controls are provided for corridor spaces (via Square D power panels with controlled breakers), where the Building Management System is programmed to turn them on and off based on a schedule. Controls in other spaces appear to be manual, with on/off switches only, and no occupancy sensors or daylight sensors to help automatically turn off or lower lighting levels when they are not needed.

*Fluorescent lighting in typical corridor*

T8 type fluorescent lamps are common, but there are locations that have T12 type lamps. It is understood that the County has been trying to phase T12 type light fixtures out as renovation projects allow, as T12 type lamps are significantly less energy efficient than T8 type lamps.

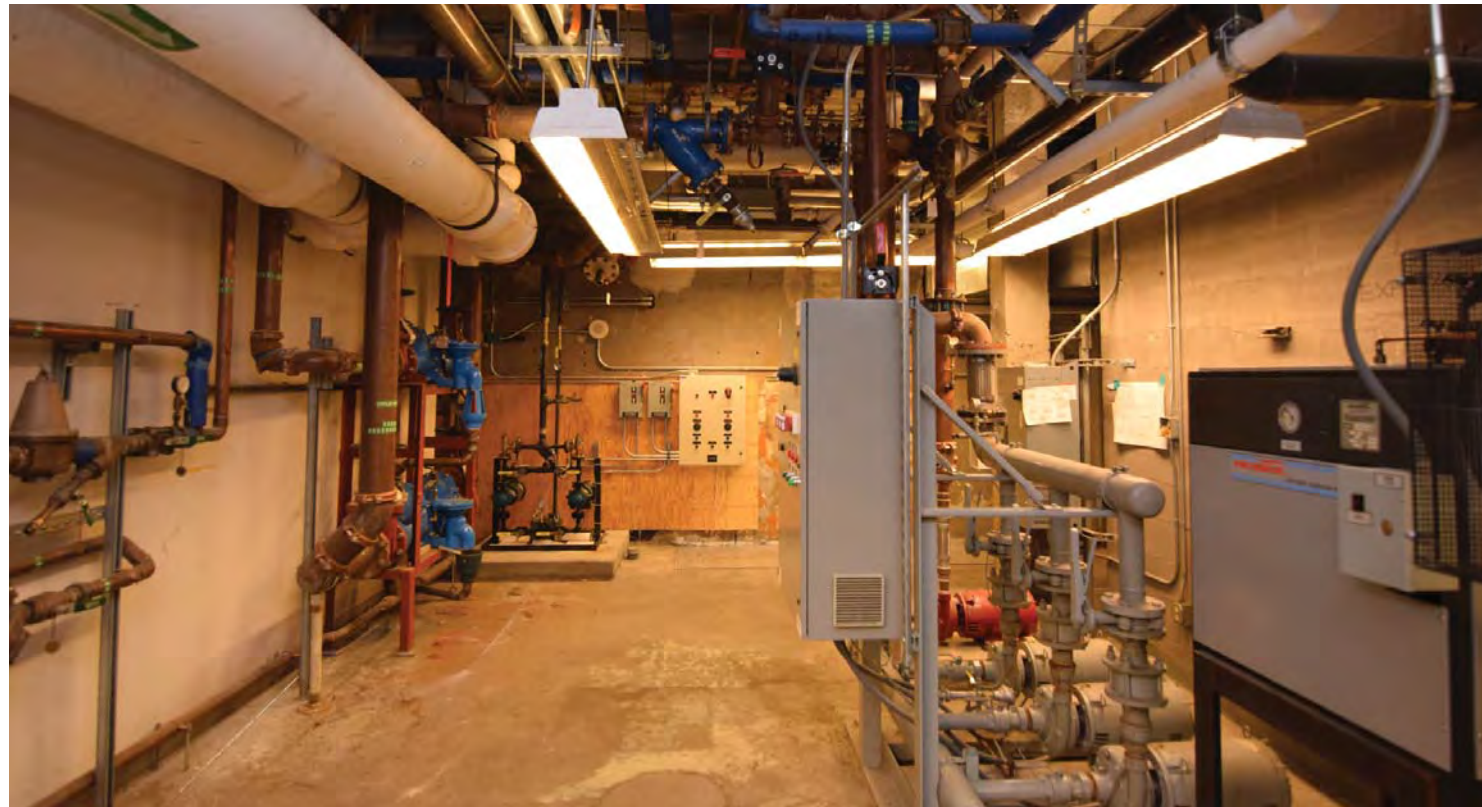
Domestic Cold Water Booster Pumps

The booster pumps and associated fixtures and fittings appear to be in fair operating condition but are not delivering water appropriately throughout the building.

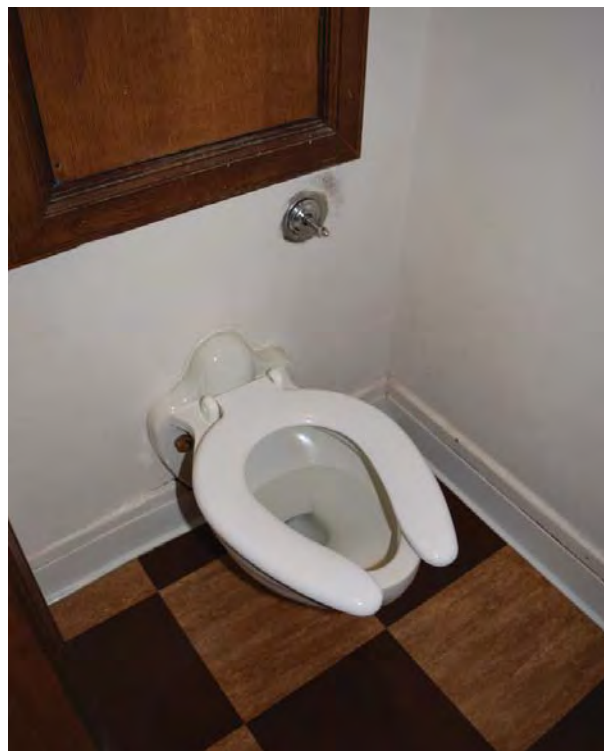
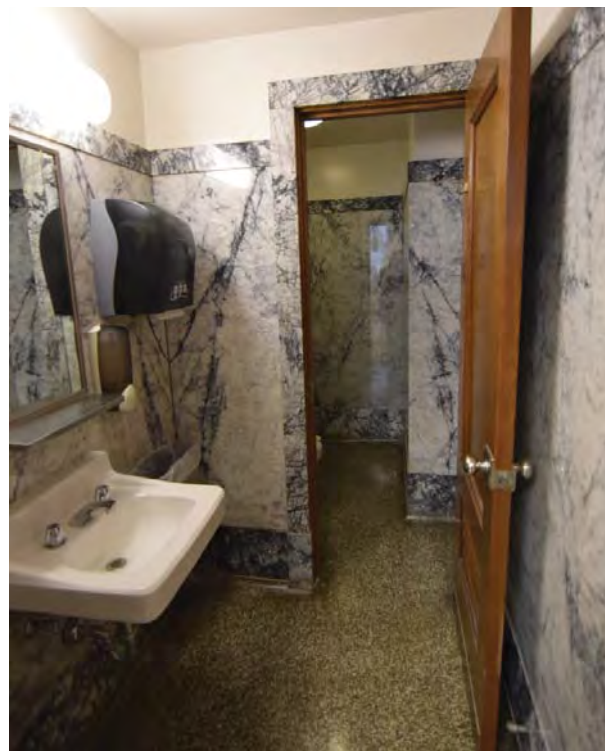
Typical Plumbing Fixture Examples

The current fixtures themselves are in fairly good operating condition. There is concern with hot water delivery times that falls on the domestic water piping configuration and not the fixtures themselves.

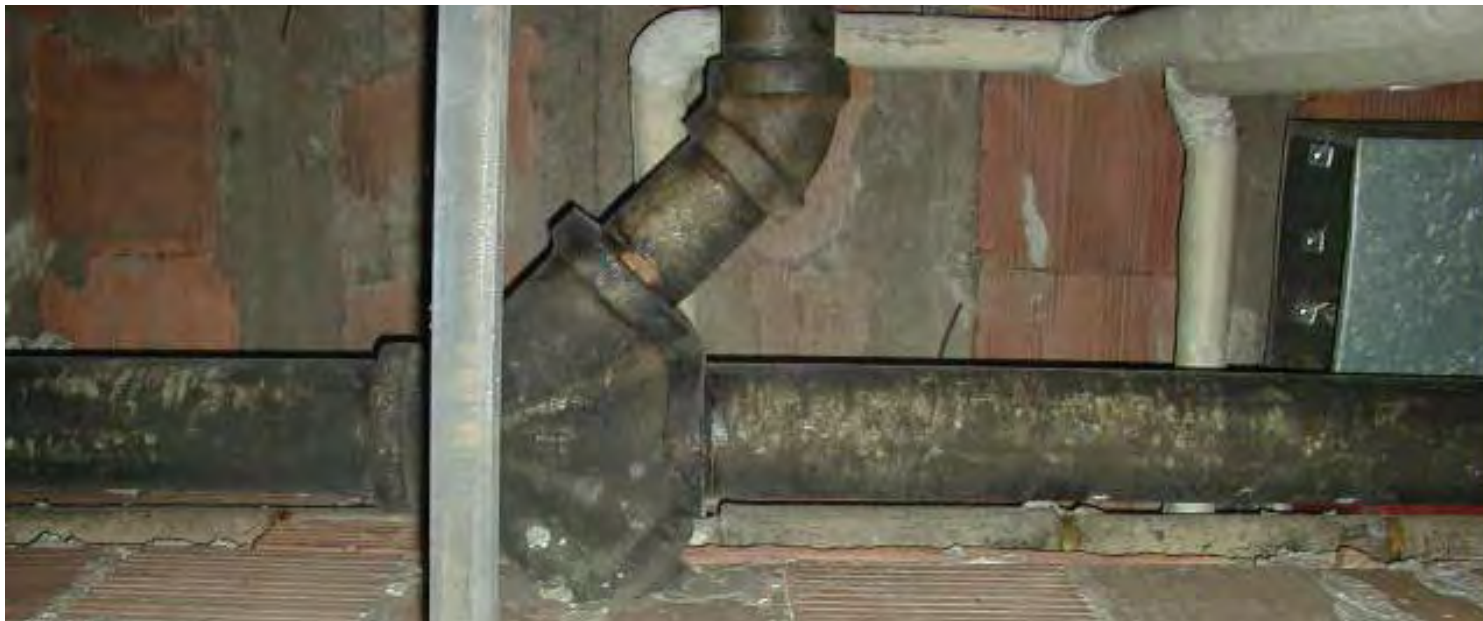
Cast-iron sanitary waste piping is distributed throughout the entire facility. Multiple drainage mains travel up through utility shafts, and branch piping is distributed horizontally to fixtures on each floor. Grooved couplings are utilized.

Cast-iron sanitary waste piping. CPL photo, February 13, 2001.
