**KING COUNTY COURTHOUSE REVITALIZATION
BUILDING SYSTEMS REPORT**

Building Systems Report

Ordinance 18239 Section 41 Proviso P5 Response
Project No. 1124472

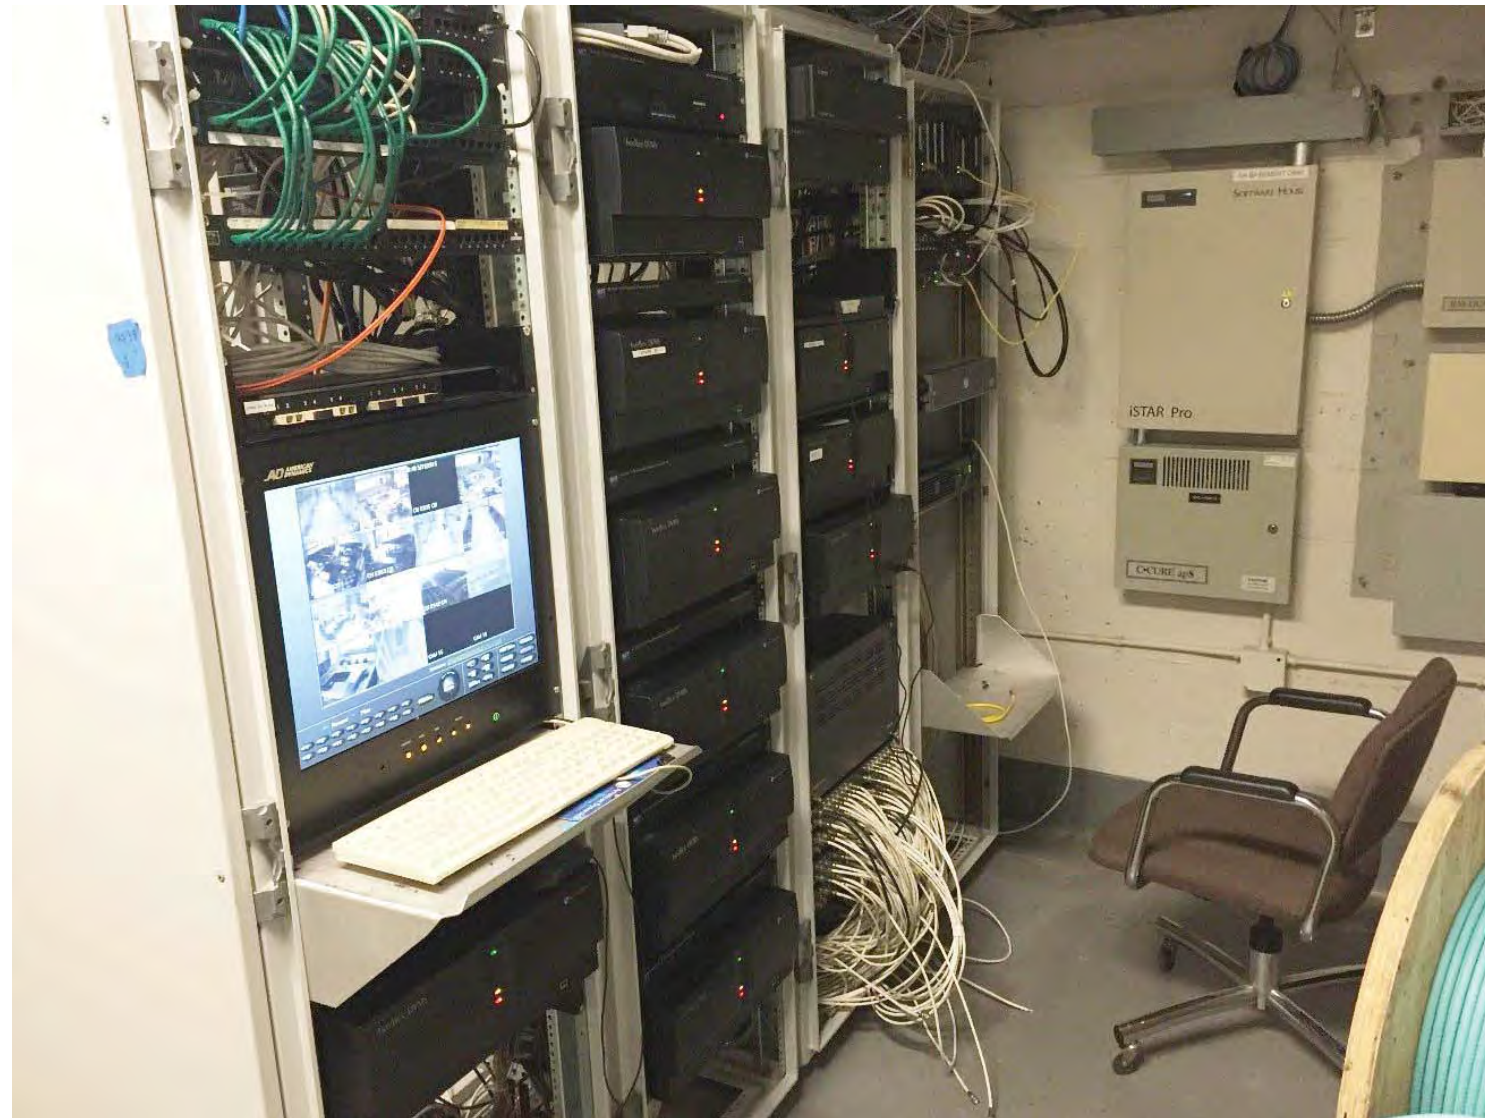
FIGURE 4 Room CB40 - Feeds from security cameras are routed through Security Room CB40 in the basement before being fed up to Security Office E195

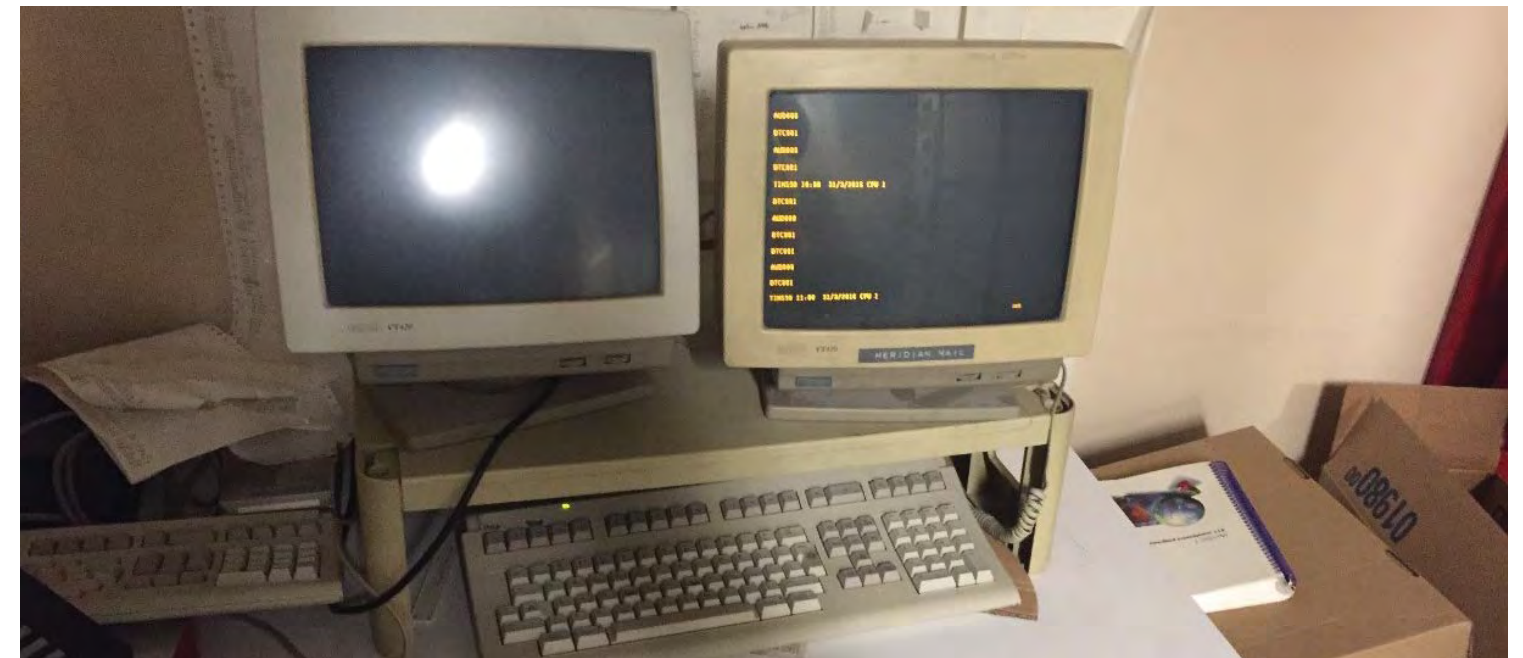
FIGURE 6 Obsolete voice-mail server terminal, consuming power and generating heat

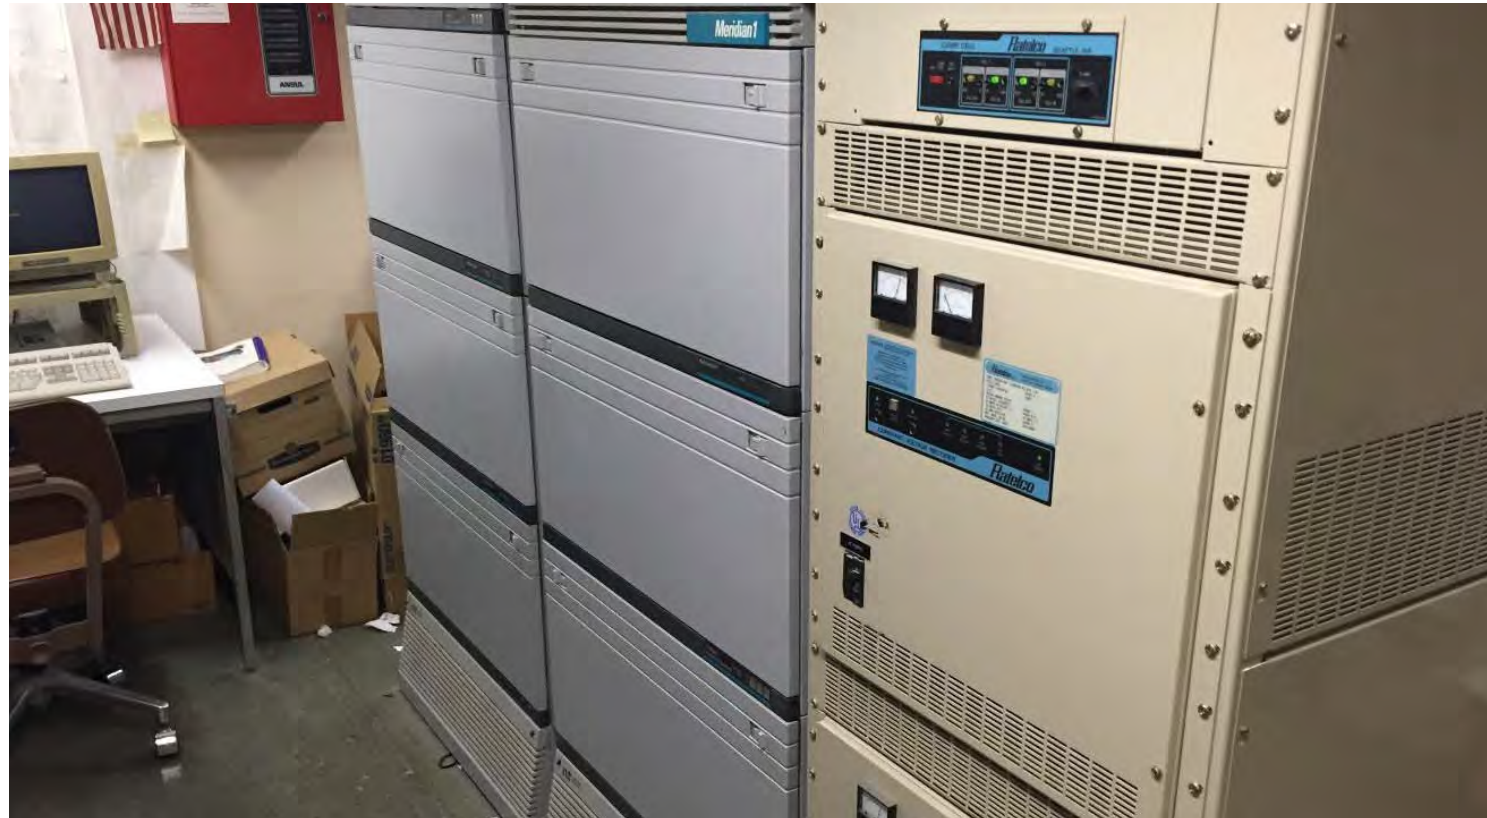
In spite of their obsolescence, abandoned systems and equipment appear to be in operating condition. One exception are battery banks for outdated Uninterruptable Power Supplies which require regular testing and maintenance for reliable operation. Reference FIGURES 6 and 7.

FIGURE 7 Out of use Uninterruptible Power Supply (UPS) system and associated battery stack

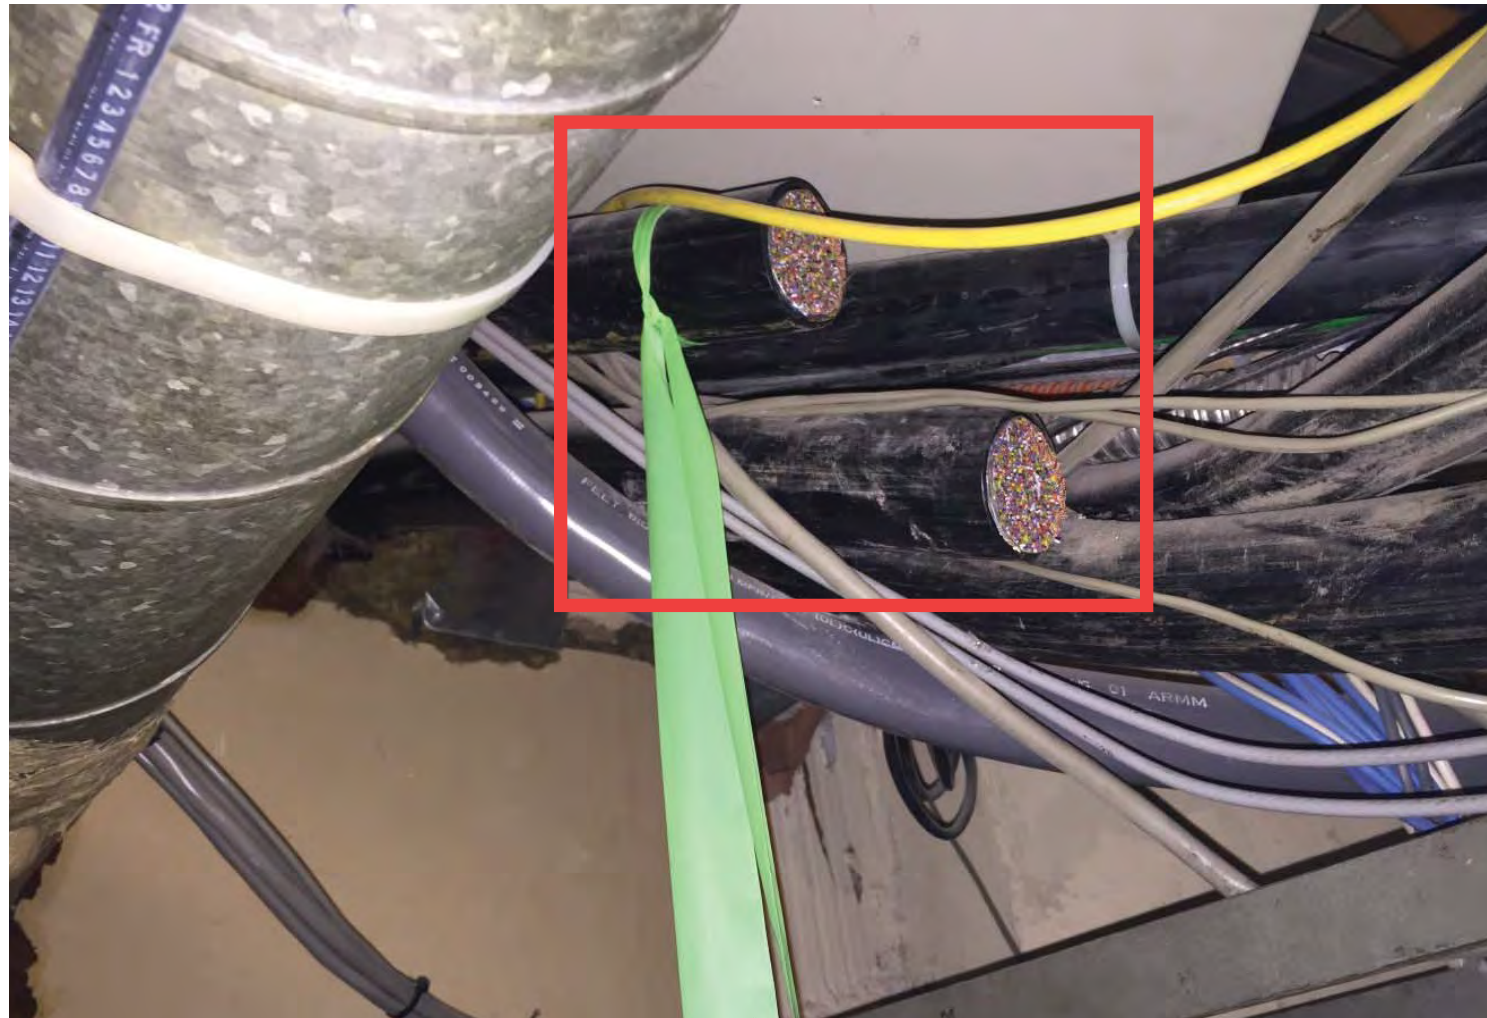
There are thousands of feet of abandoned cabling in place in varying conditions, from fully functional to degrading, to fully severed. Reference FIGURES 8 and 9.

FIGURE 8 Communication cables have been severed and abandoned in place

Abandoned cabling provides an unnecessary propagation path for fires and can, if routed through plenum spaces, unnecessarily restrict airflow. Additionally, pathways for communication cabling are a finite resource. Removing obsolete and unused cabling will reclaim pathway space for future expansion.

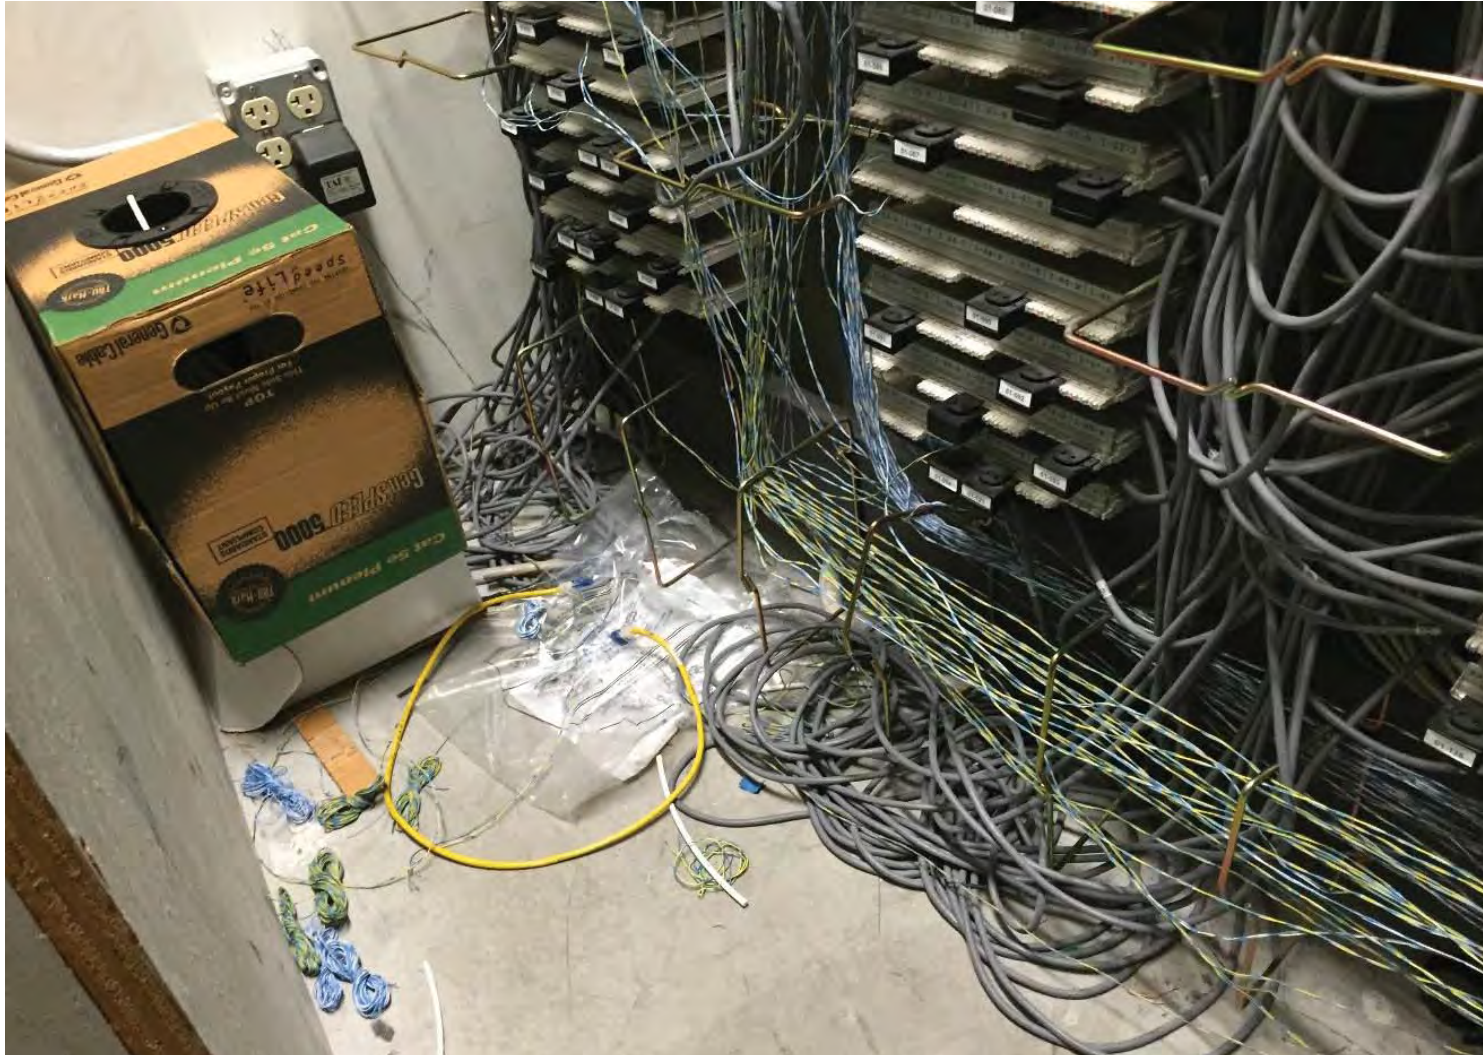
FIGURE 12 Proprietary low-density cable patching system. Debris from construction and maintenance has been allowed to accumulate in communication spaces

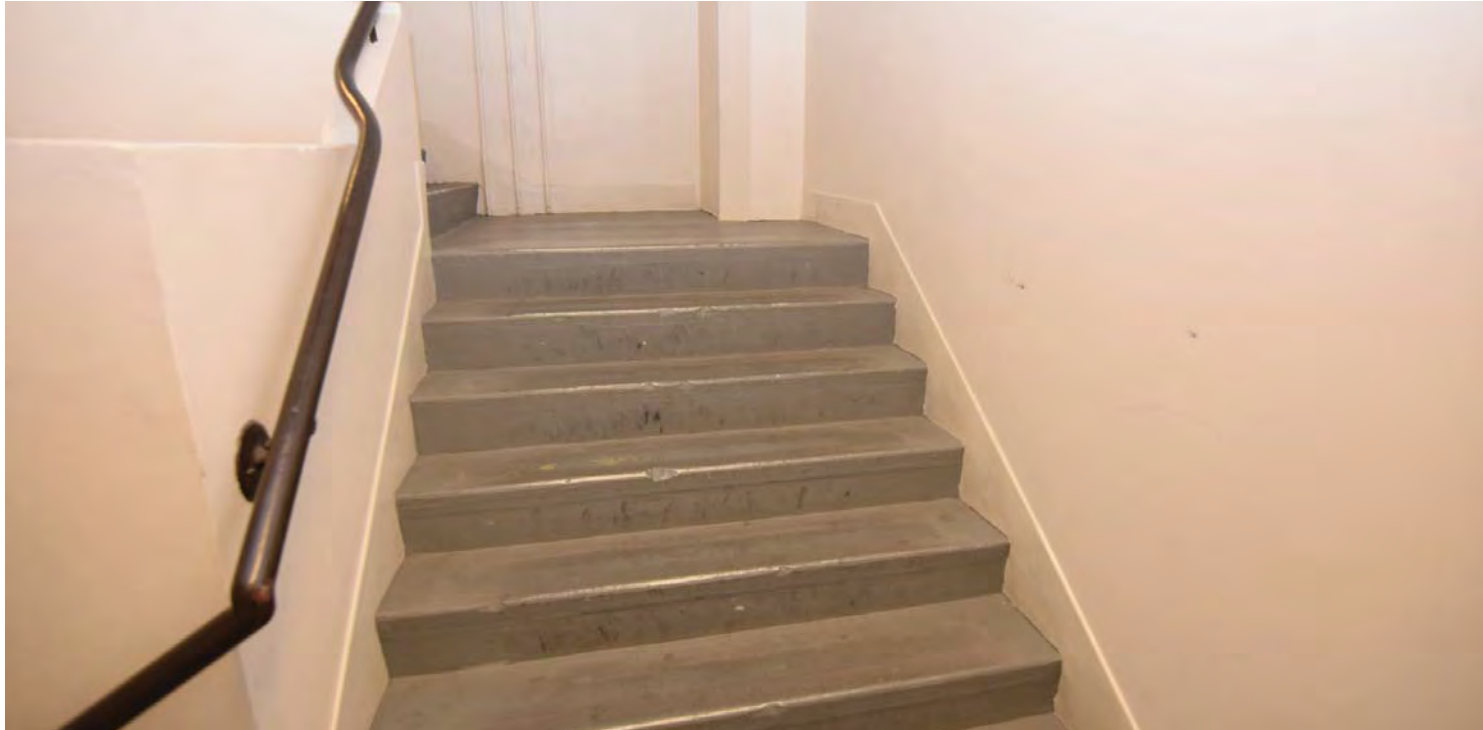
Photo of Stair 4 at level 10. A handrail would need to be added to the stair if the building is substantially altered. CDG photo, May 7, 2016.

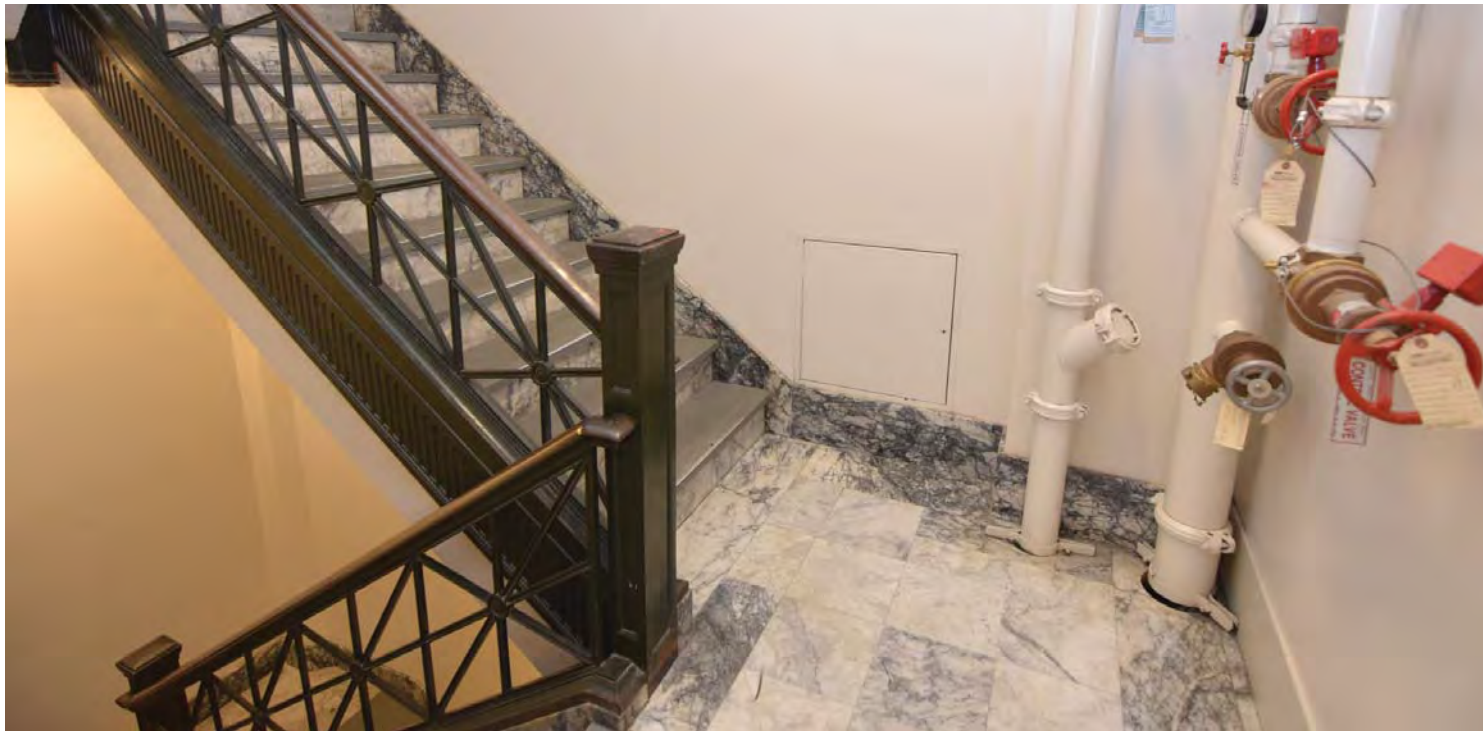
Photo of Stair 4 at level 5. The existing handrail is non-code compliant and may need to be upgraded if the building is substantially altered. CDG photo, May 7, 2016.

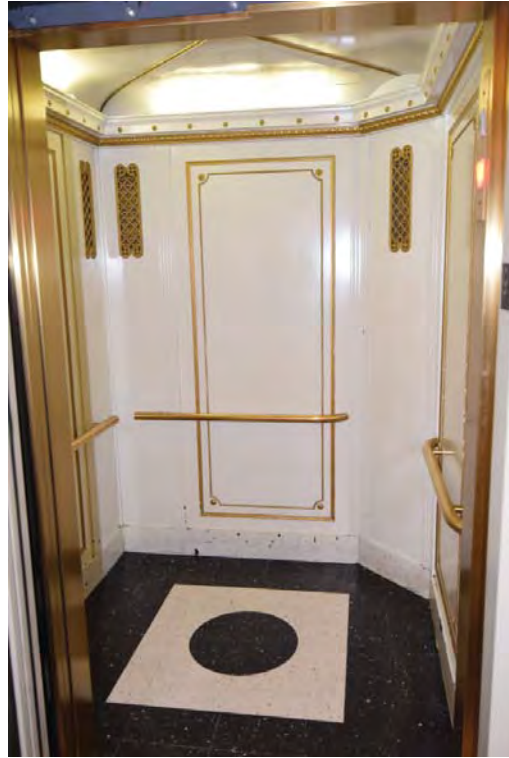
View of historic elevator cab. Originally installed in 1914-1916, this cab has been modernized. CDG photo, April 16, 2016.

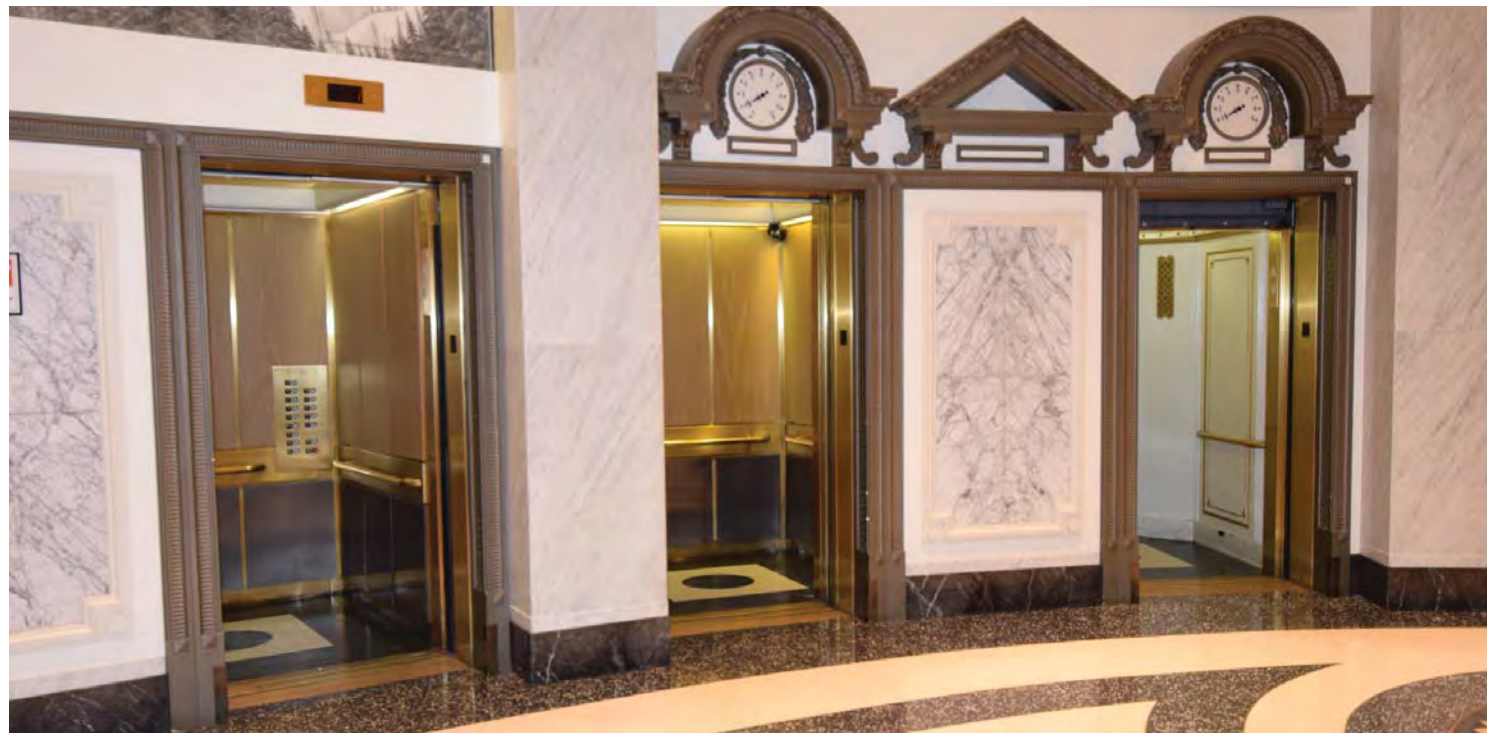
View of elevators on fire service recalled to level 1 during inspection. CDG photo, April 16, 2016.

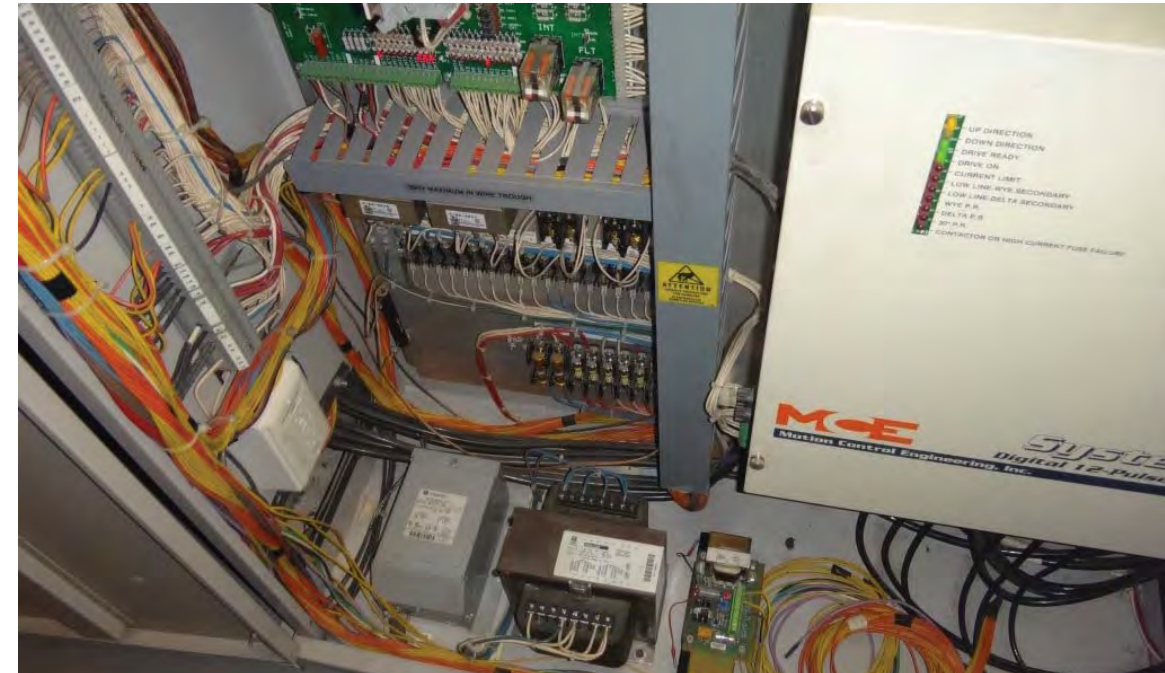
Figure 1 - Motion Control Engineering (MCE) IMC controllers with energy efficient 12 pulse SCR drives installed on Cars 1-10.

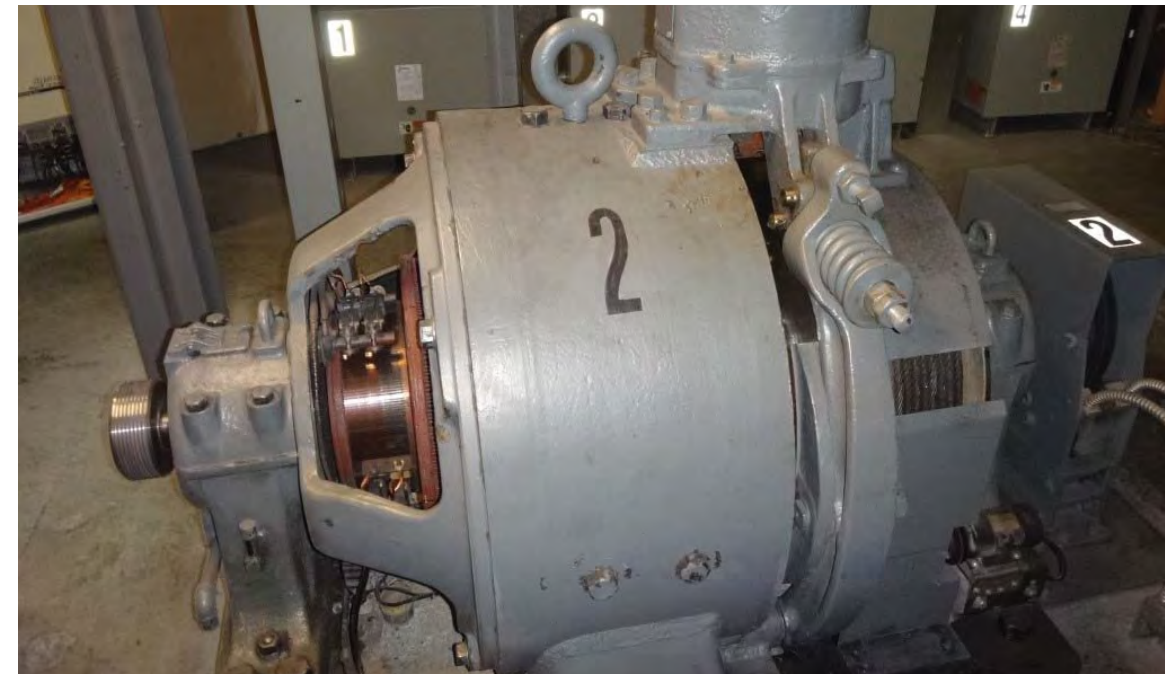
Figure 2 – Original Westinghouse Gearless machines for Cars 1-10 appear to have been installed during the 1960 modernization of the Court.

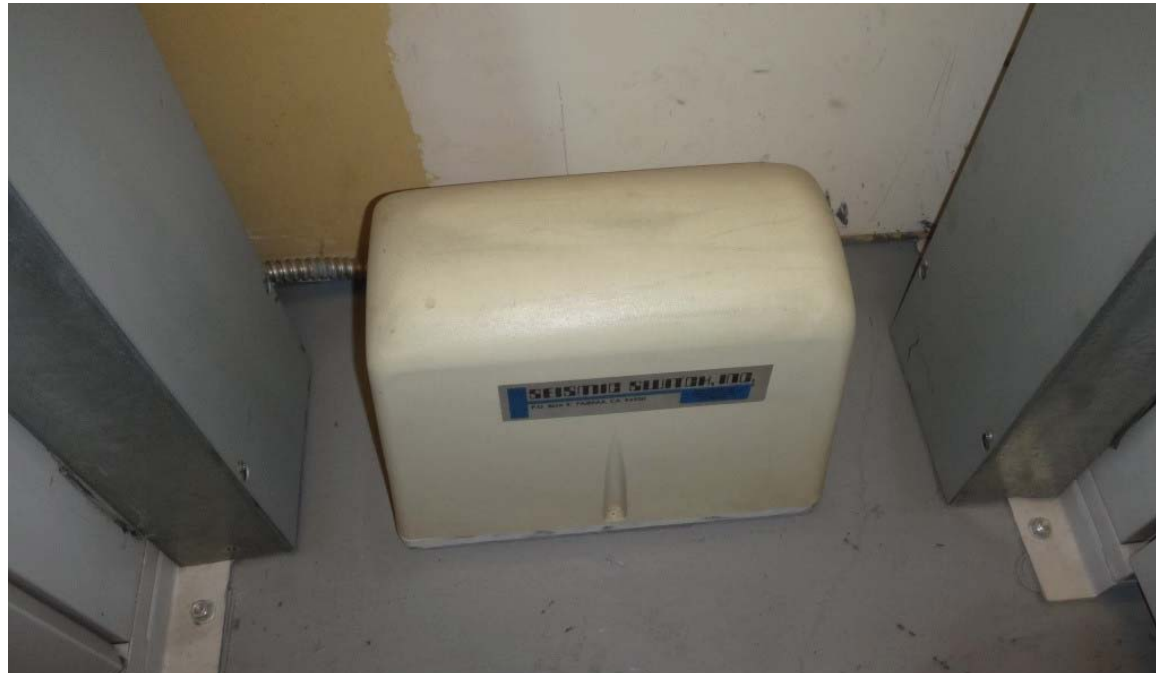
Figure 3 – Seismic switch installed during the modernization in 2004/05.

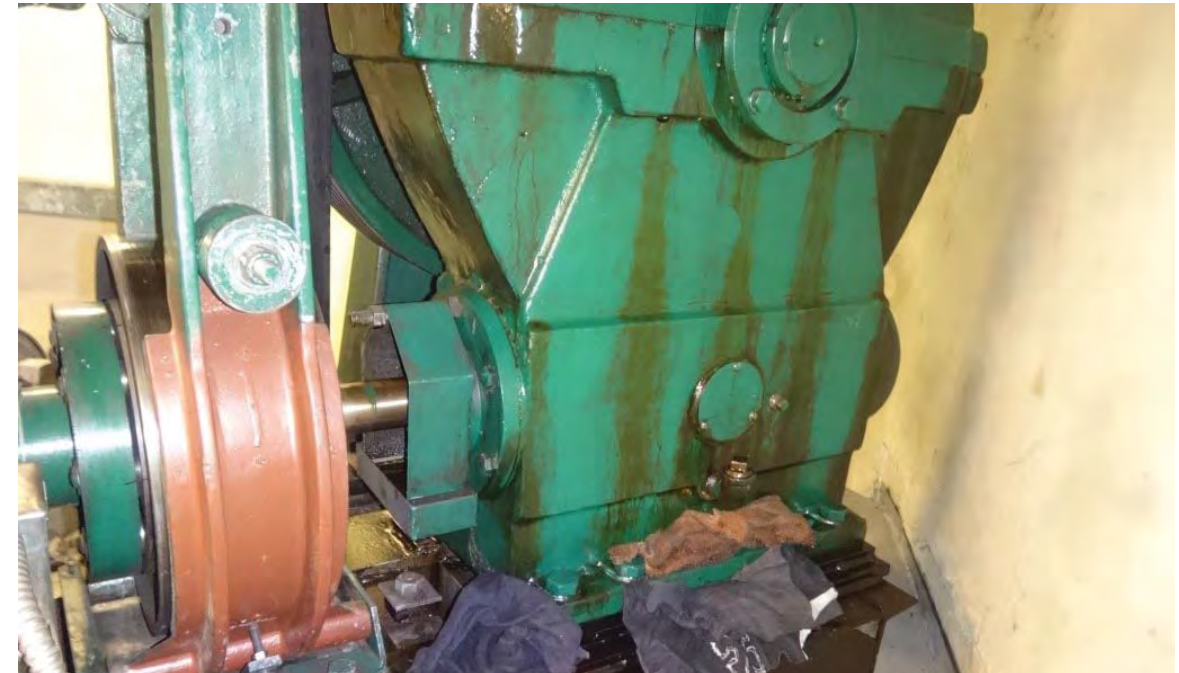
Figure 5 – Geared elevator machine for Cars 11 and 14 is leaking oil.

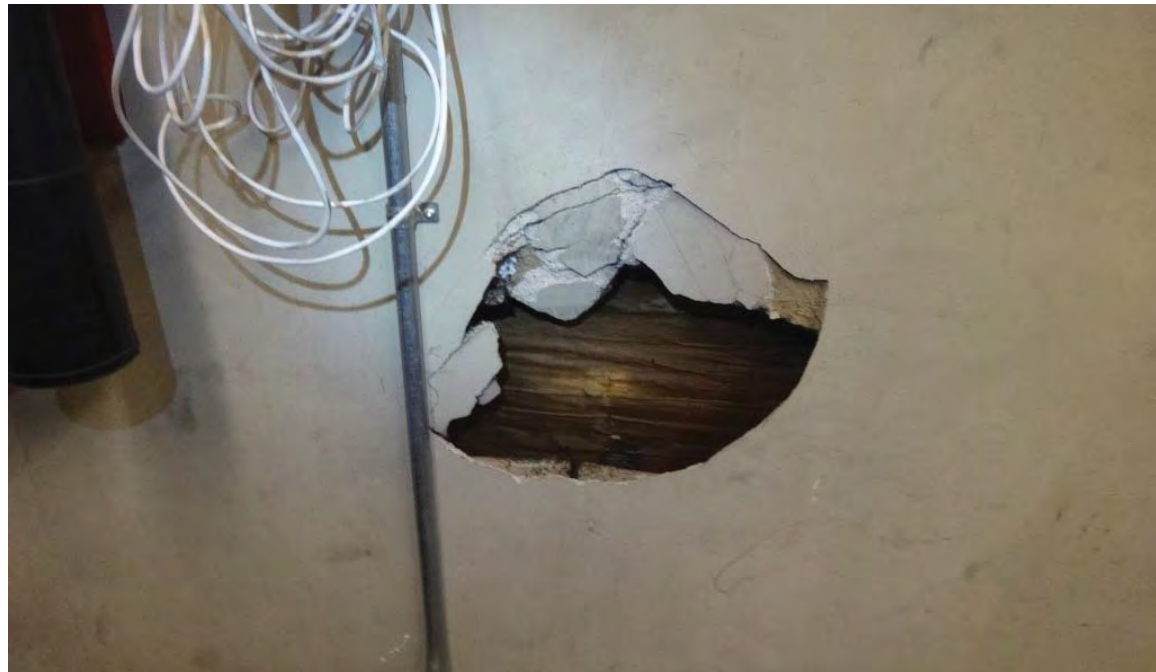
Figure 4 – Hole in the wall of the elevator machine room.

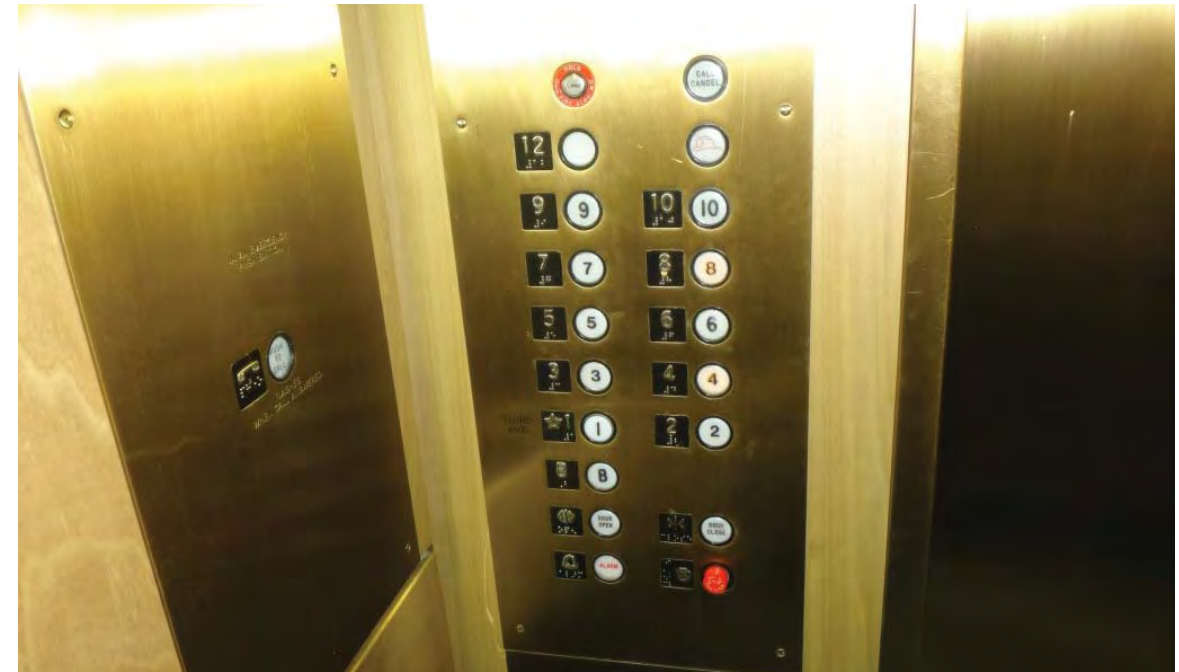
Figure 6 – Bronze fixtures installed in 2004/5 during modernization Meet code except for push/pull stop switch.

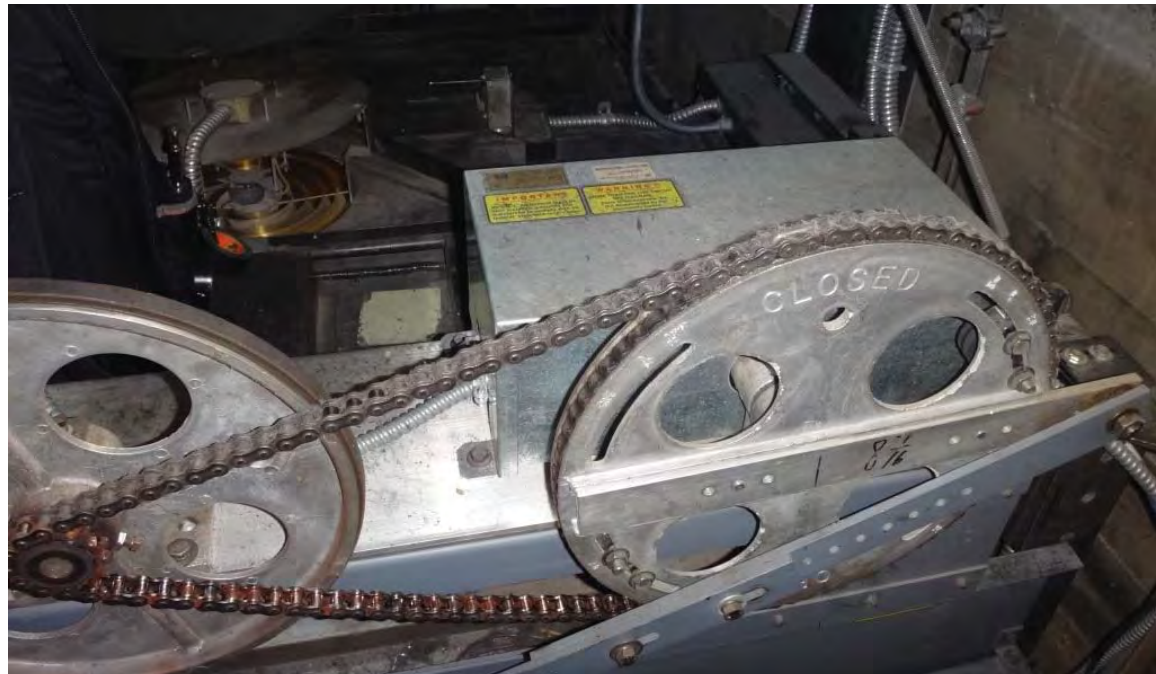
Figure 8 – GAL MOVFR closed loop door operators installed during modernization in 2004/5.

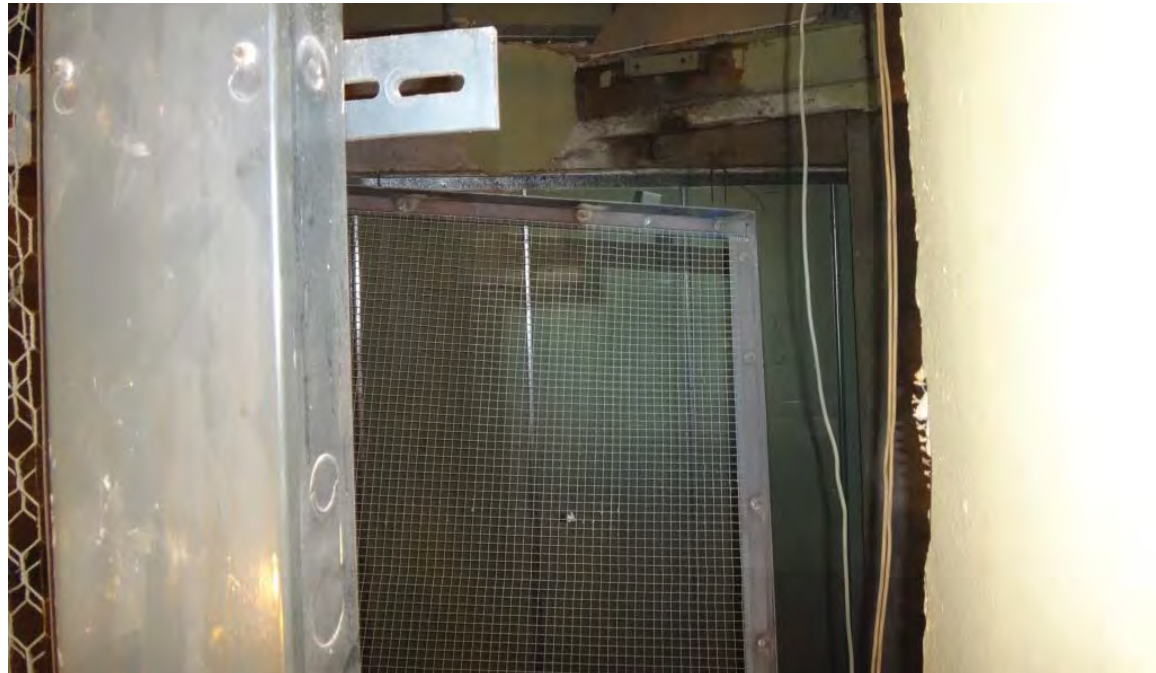
Figure 11 – Part of hoistway screening between Cars 9 and 10 is coming down and should be re-anchored.

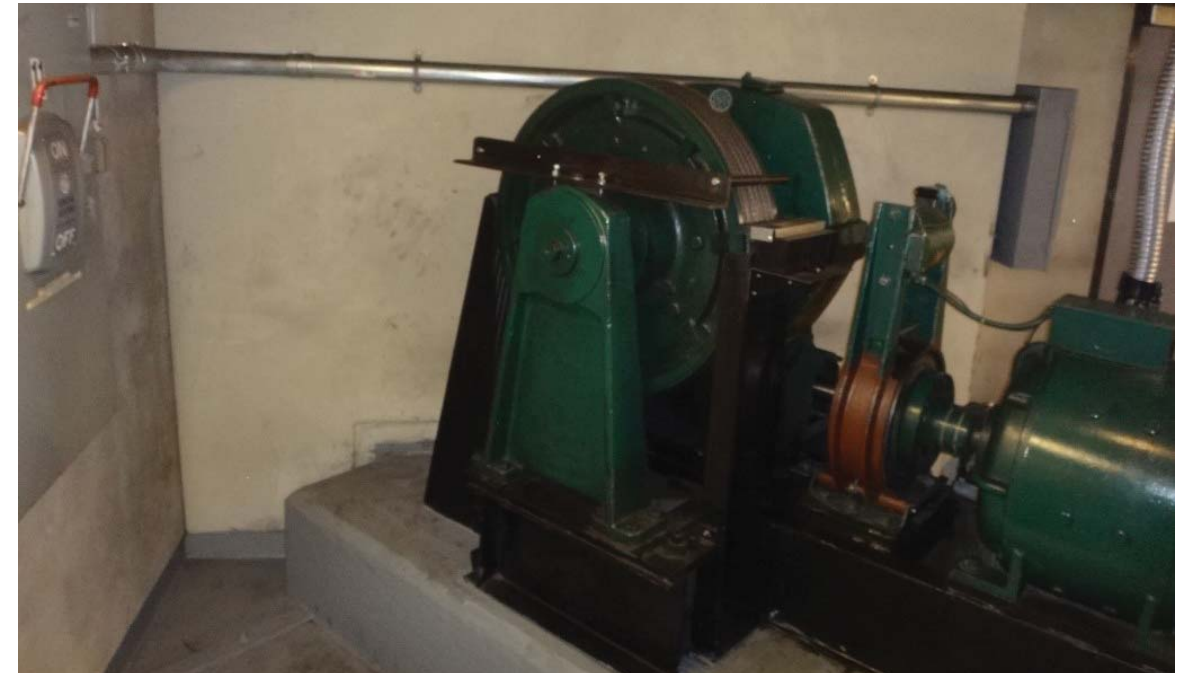
Figure 13 – Geared hoist machine for Car 11. Manufactured by Dover.

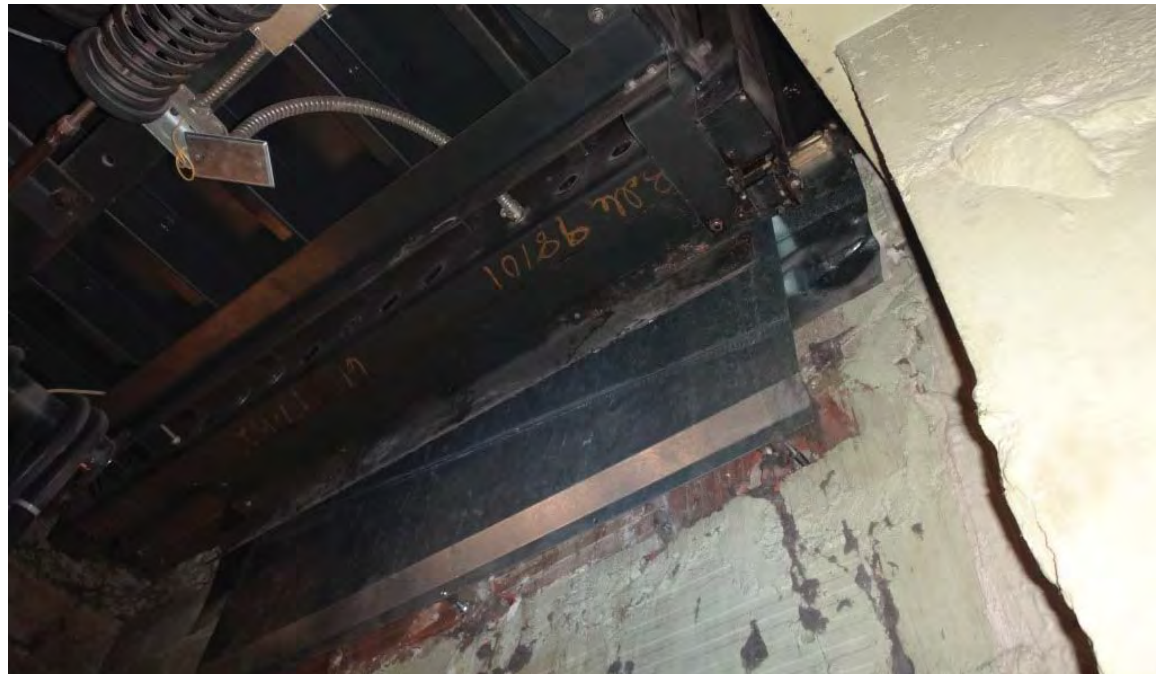
Figure 12 – Car aprons are missing from most of Cars 1 to 10.

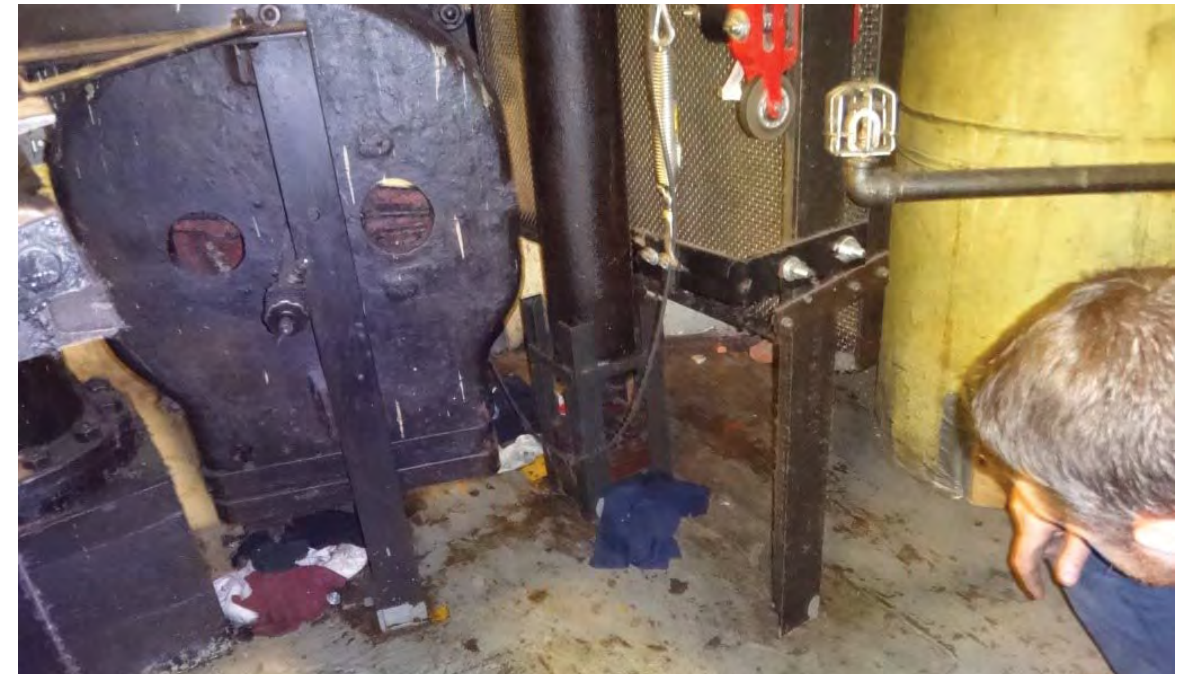
Figure 14 – Typical pit with rags and dirty floor.

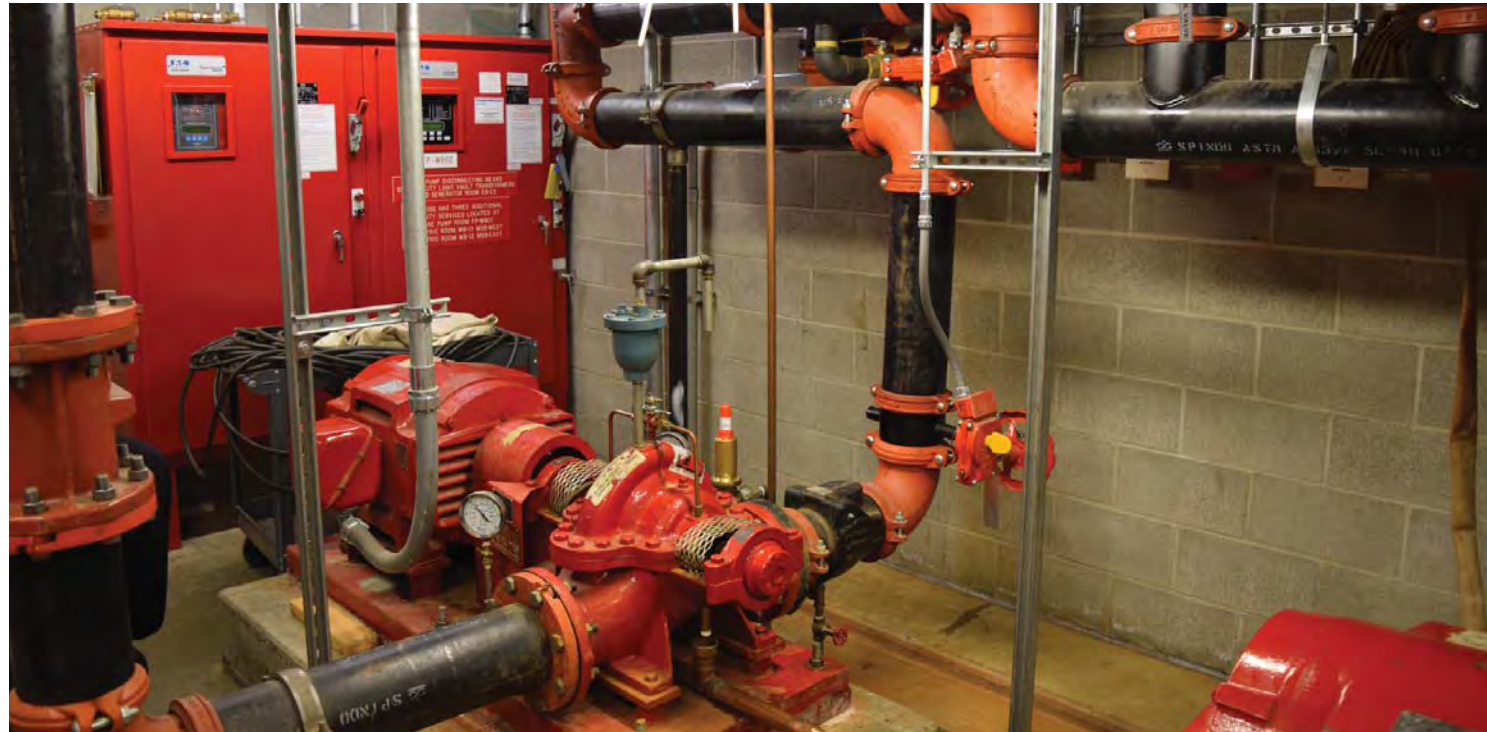
Photo of fire sprinkler pumps, fire sprinkler control panel, and fire protection water piping at basement Room WB9B. CDG photo, May 24, 2016.

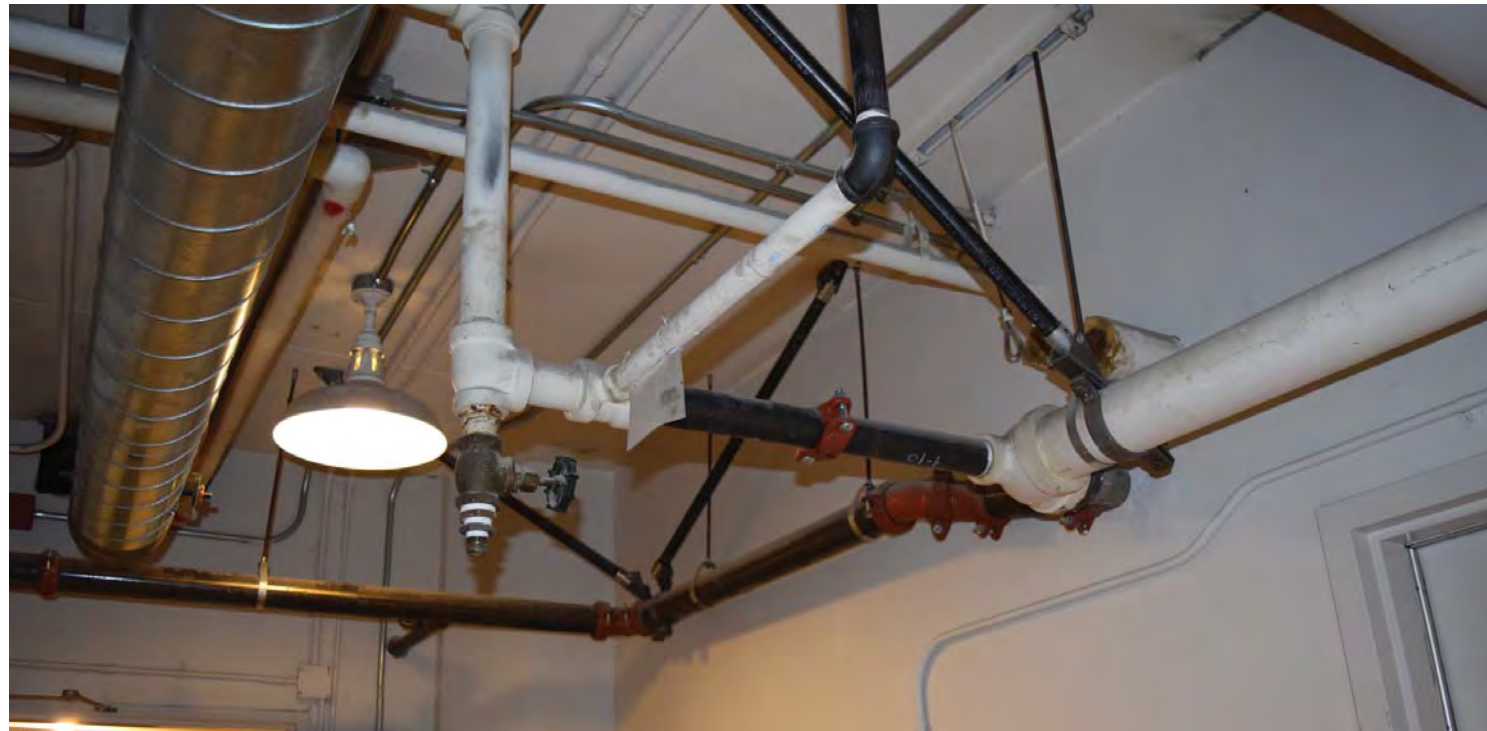
View of seismic bracing for fire protection water piping at ceiling of basement Room EB9. CDG photo, May 24, 2016.
