**KING COUNTY COURTHOUSE REVITALIZATION
BUILDING SYSTEMS REPORT**

Building Systems Report

Ordinance 18239 Section 41 Proviso P5 Response
Project No. 1124472

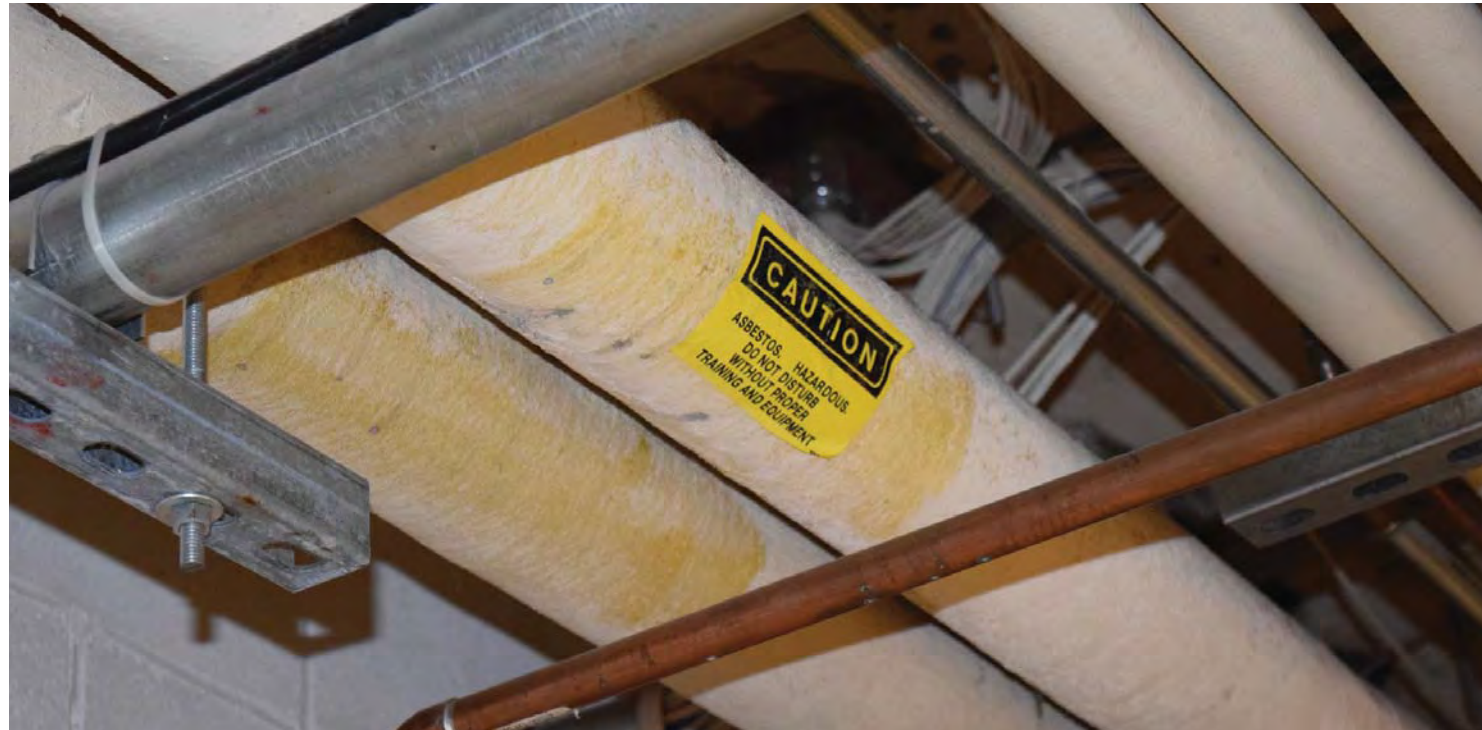
View of label identifying asbestos pipe insulation. CDG photo, May 24, 2016.

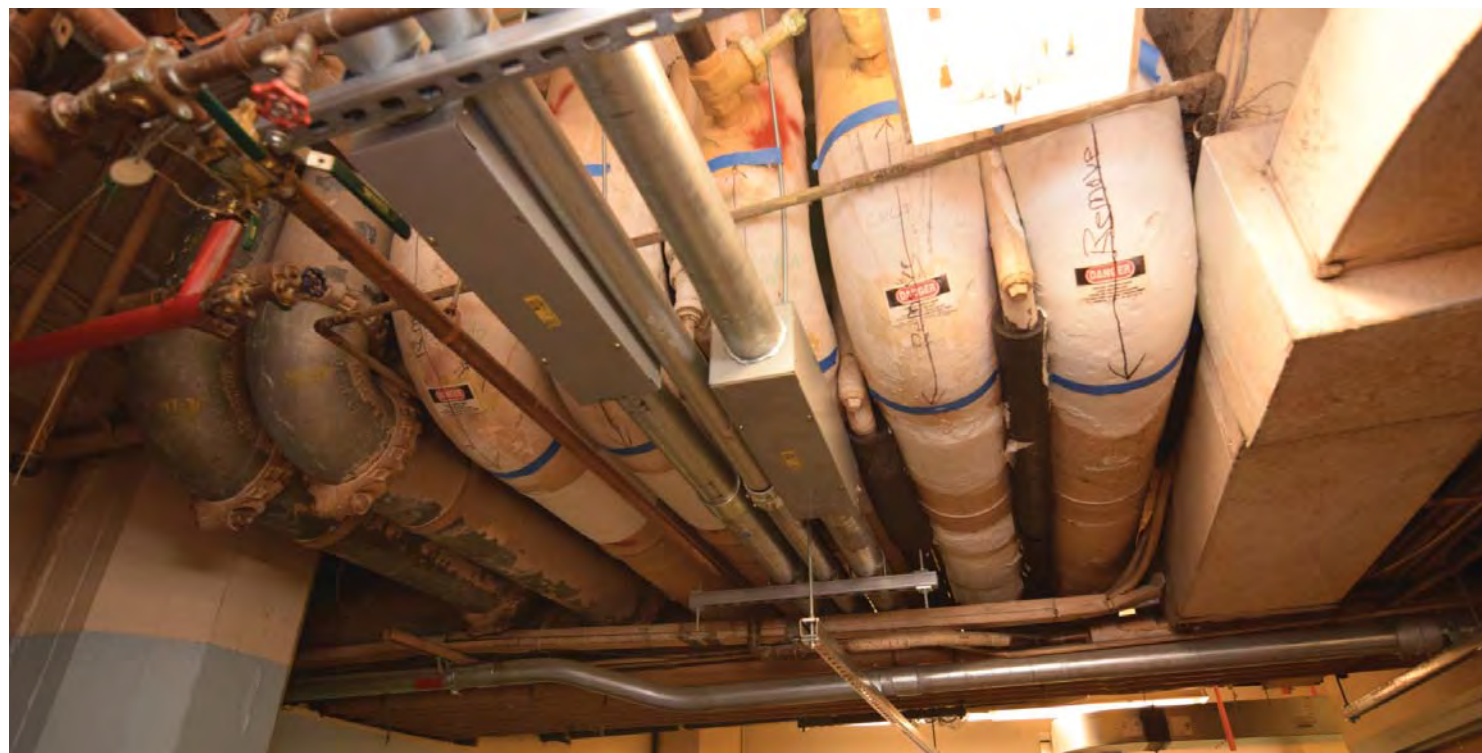
View of labels identifying asbestos pipe insulation. CDG photo, March 18, 2016.

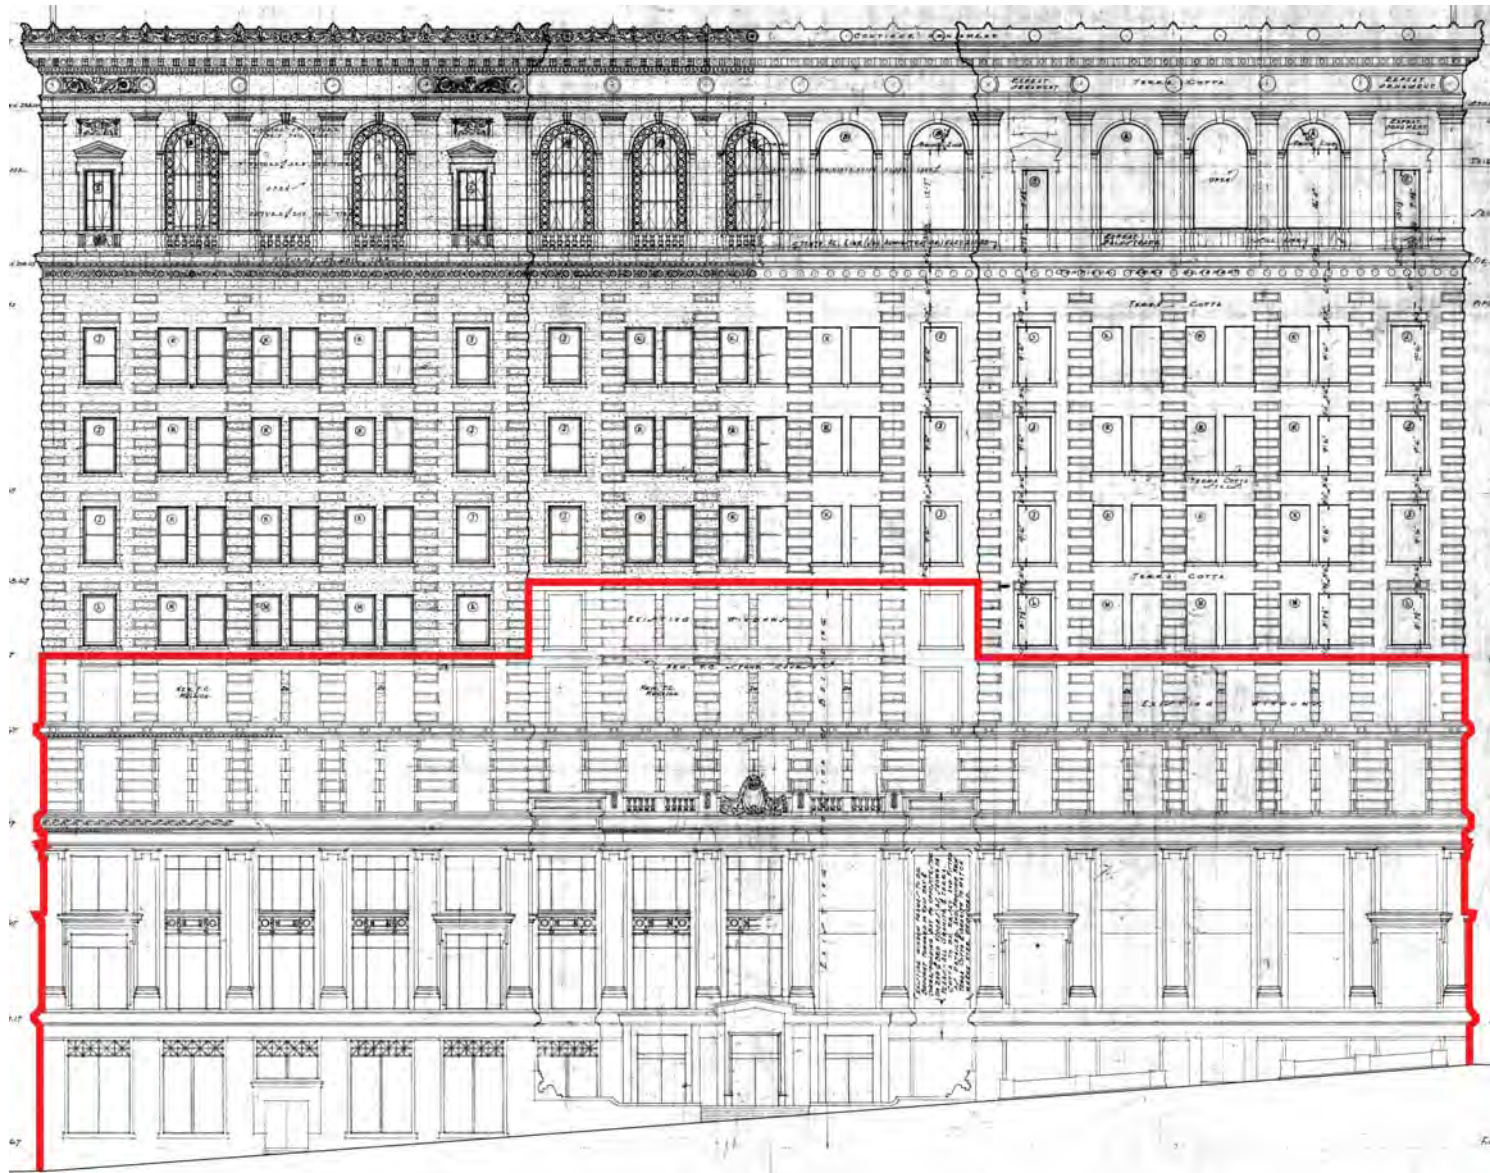
Architectural drawing of expanded County-City Building 1929-1931. Courtesy of King County Facilities Management Division. The red line indicates the original 1914-1916 five-story building.

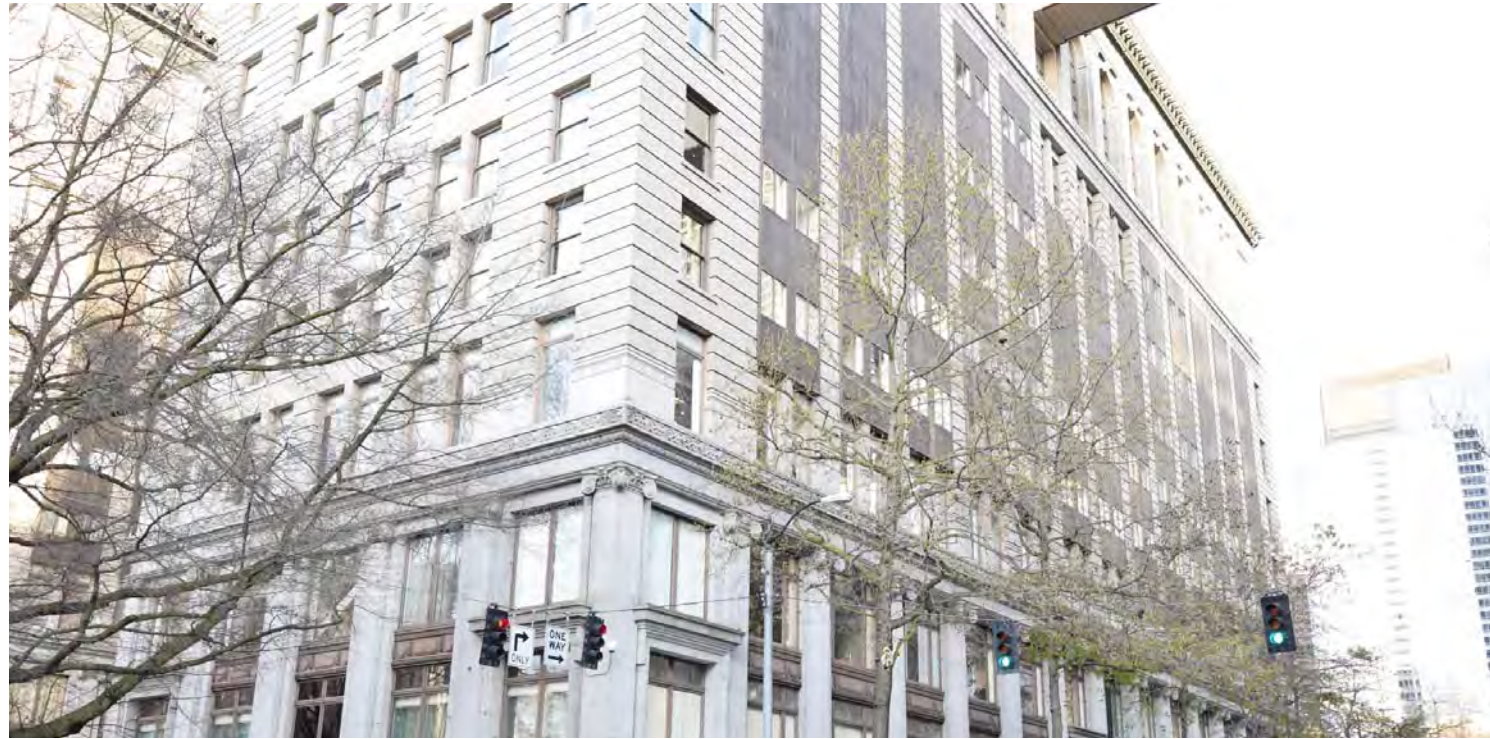
King County Courthouse exterior, view of the aluminum window wall systems at the Fourth Avenue facade. CDG photo, March 18, 2016.

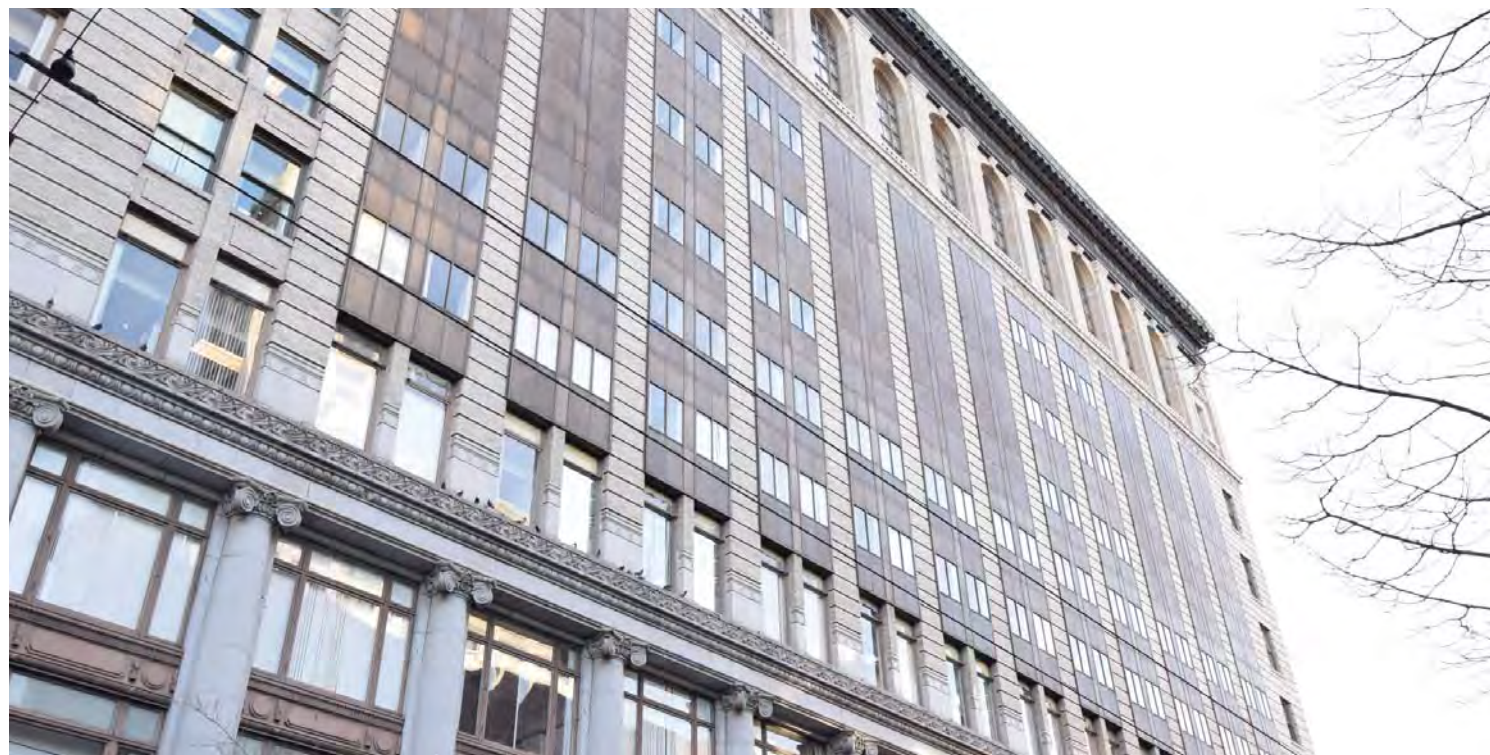
King County Courthouse exterior, view of the aluminum window wall systems at the Third Avenue facade. CDG photo, March 18, 2016.

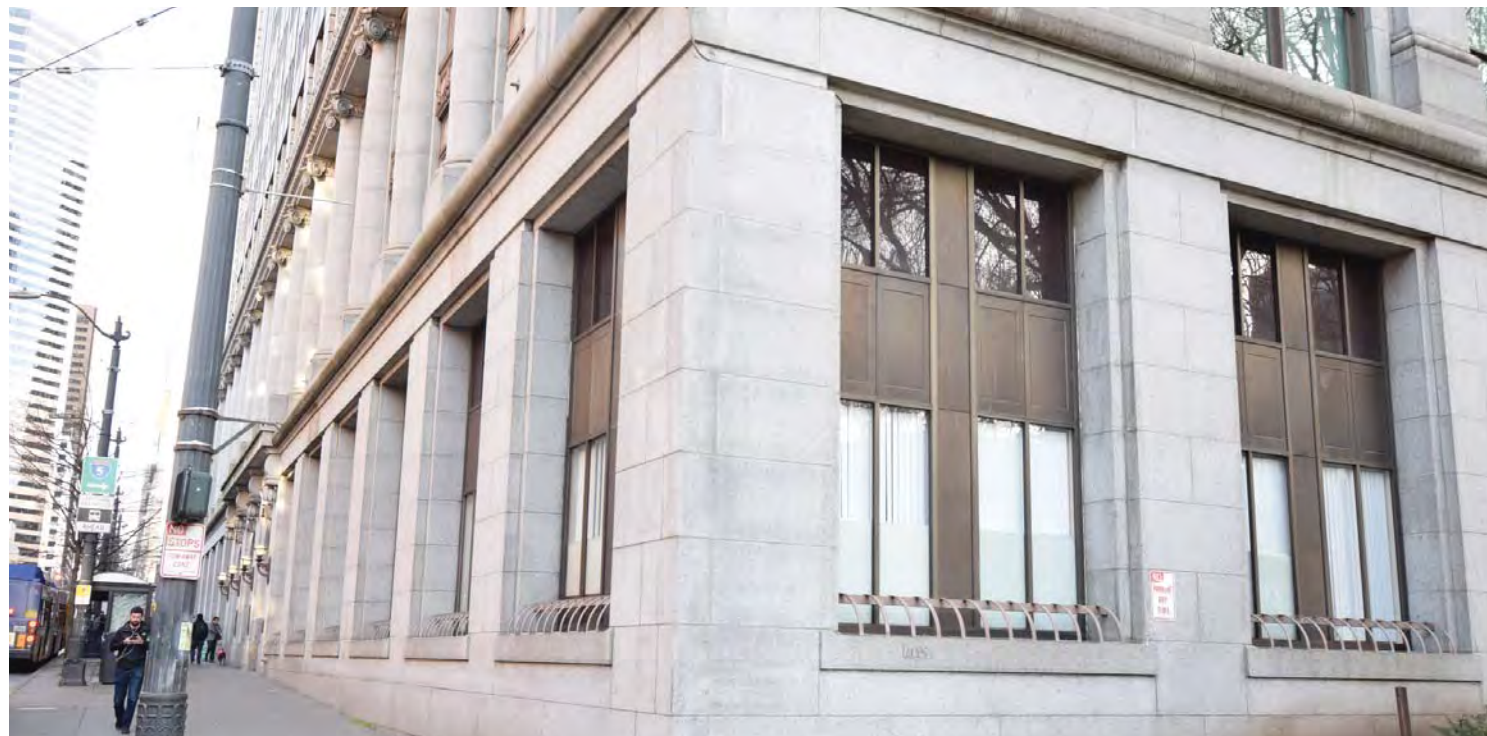
King County Courthouse exterior, view of the aluminum window wall systems at the southwest corner of the first floor. CDG photo, March 18, 2016.

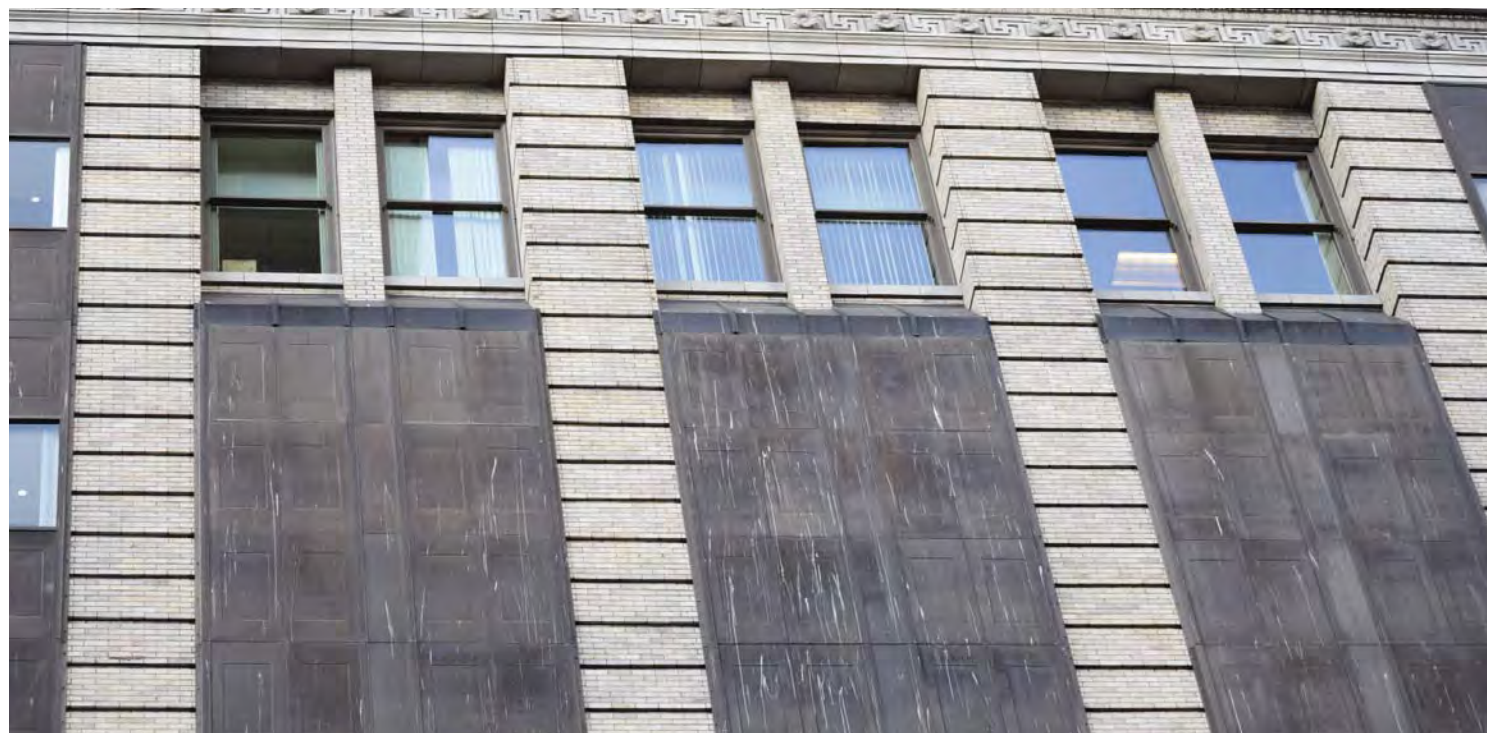
King County Courthouse exterior, detail view of the aluminum window wall systems at the Fourth Avenue facade. CDG photo, March 18, 2016.

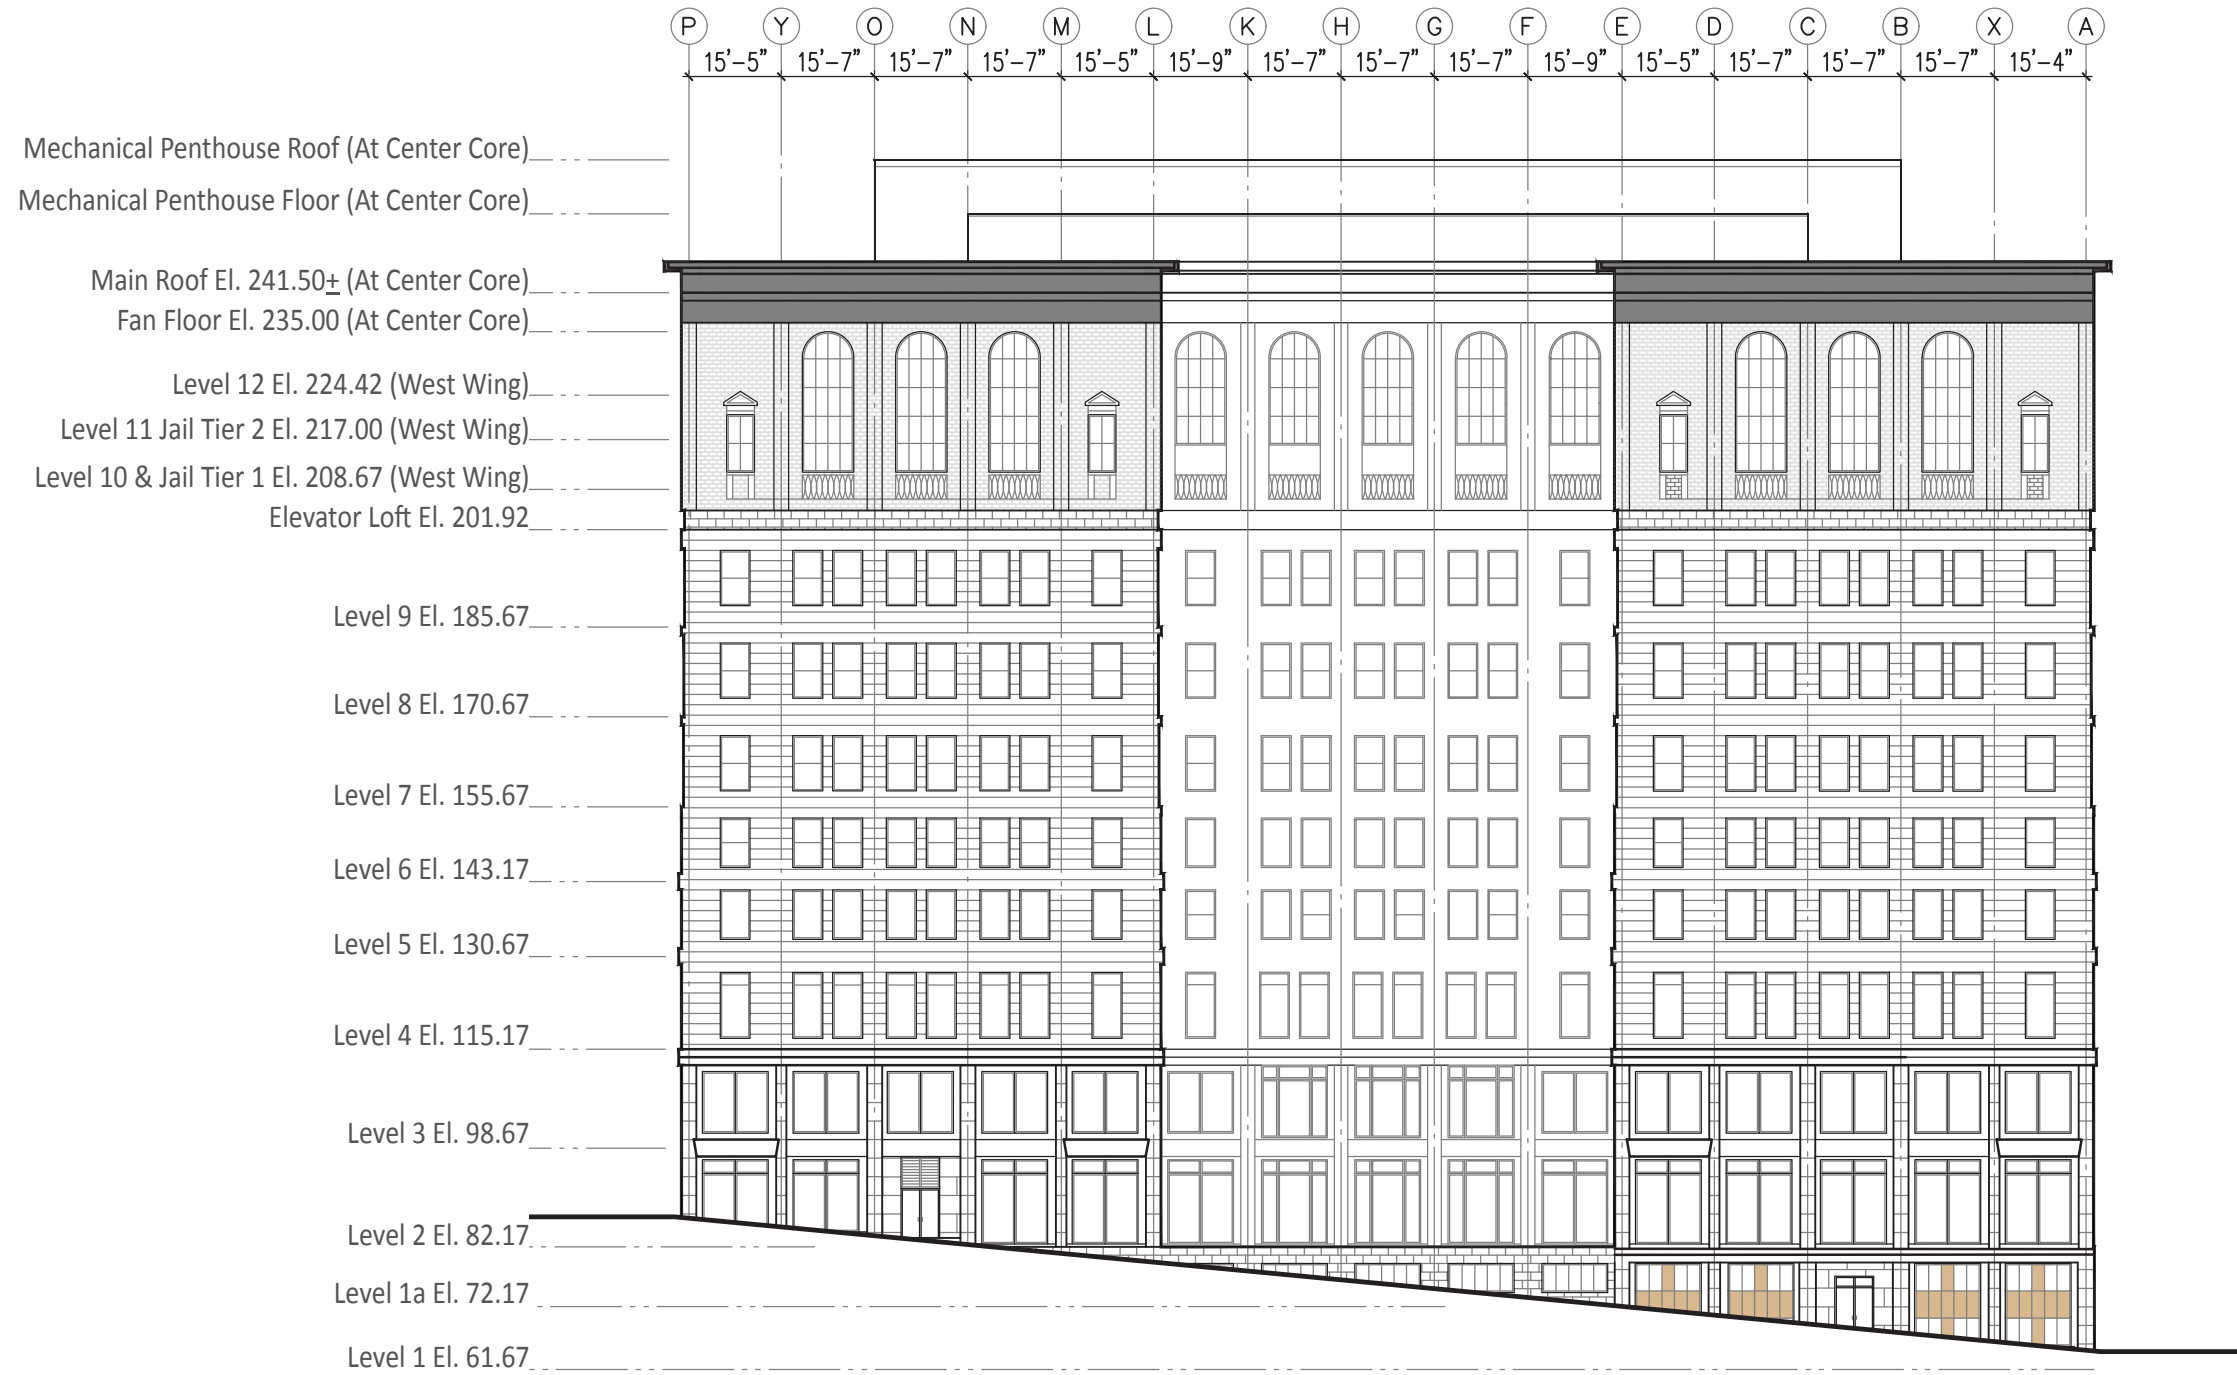
1 NORTH ELEVATION
SCALE: 1/32" = 1'-0"

The elevation and section diagrams on the following pages illustrate the existing exterior conditions of the King County Courthouse. The diagrams show the locations of the aluminum window wall systems and also the location of historic designated courtrooms.

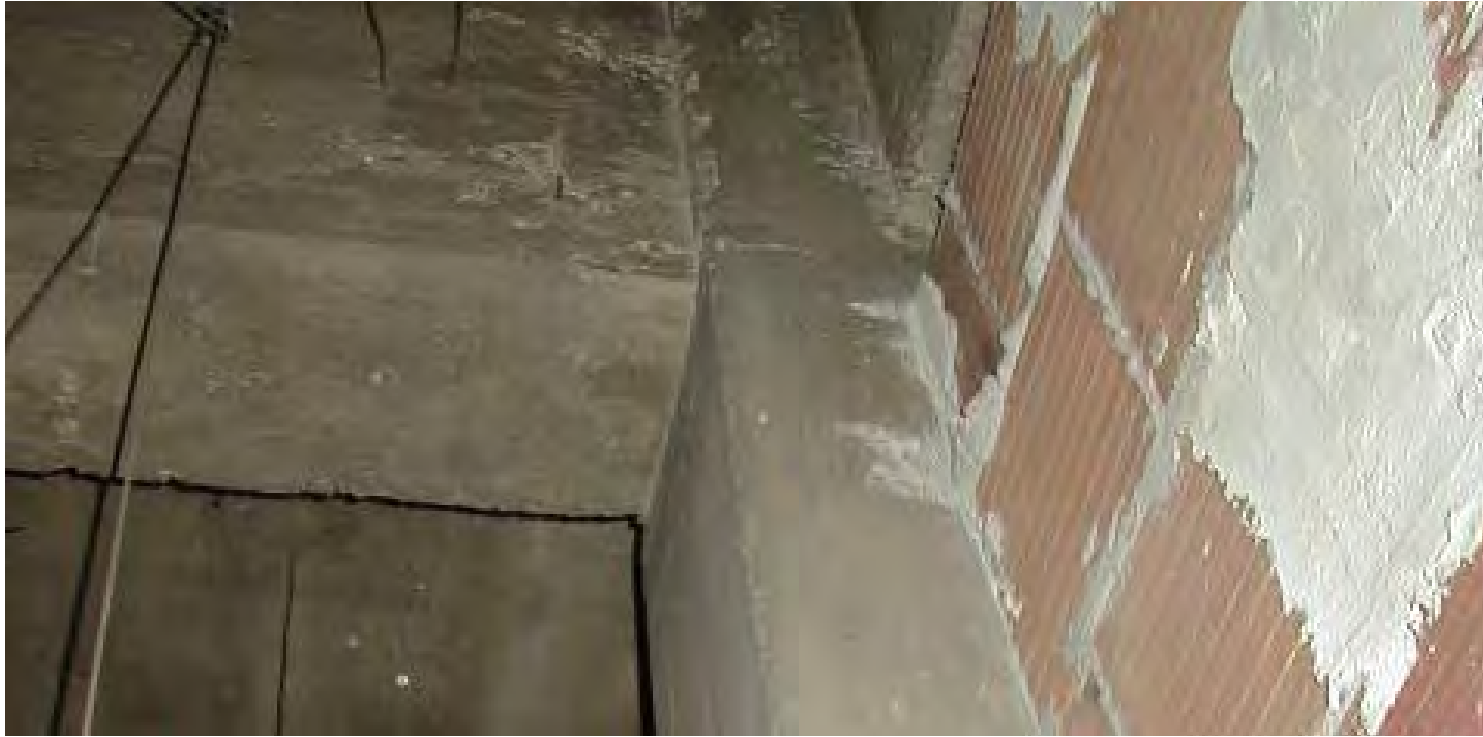
King County Courthouse, view of hollow clay tile infill between reinforced concrete columns at exterior walls. CPL photo, February, 1, 2001.

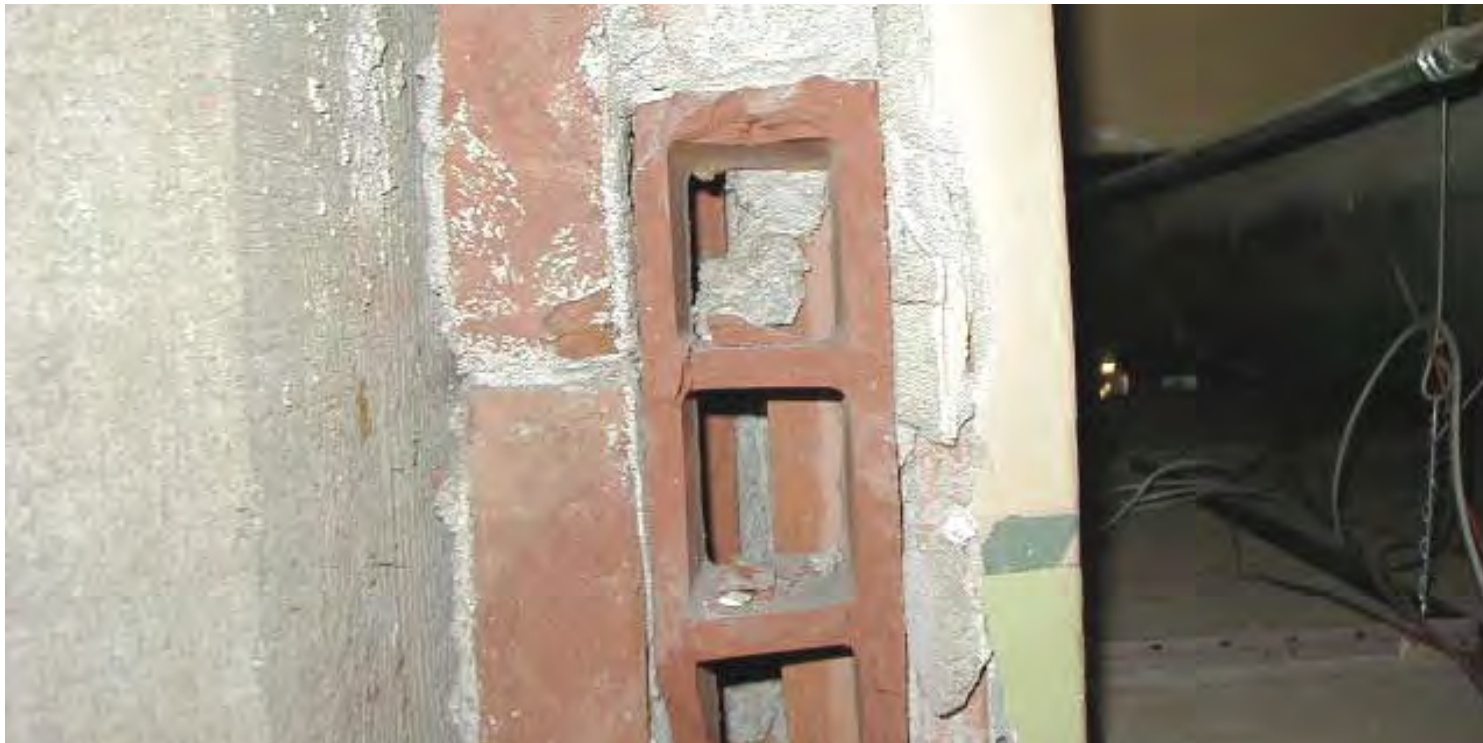
King County Courthouse, detail view of voids inside hollow clay tile infill at exterior walls. CPL photo, February 1, 2001.

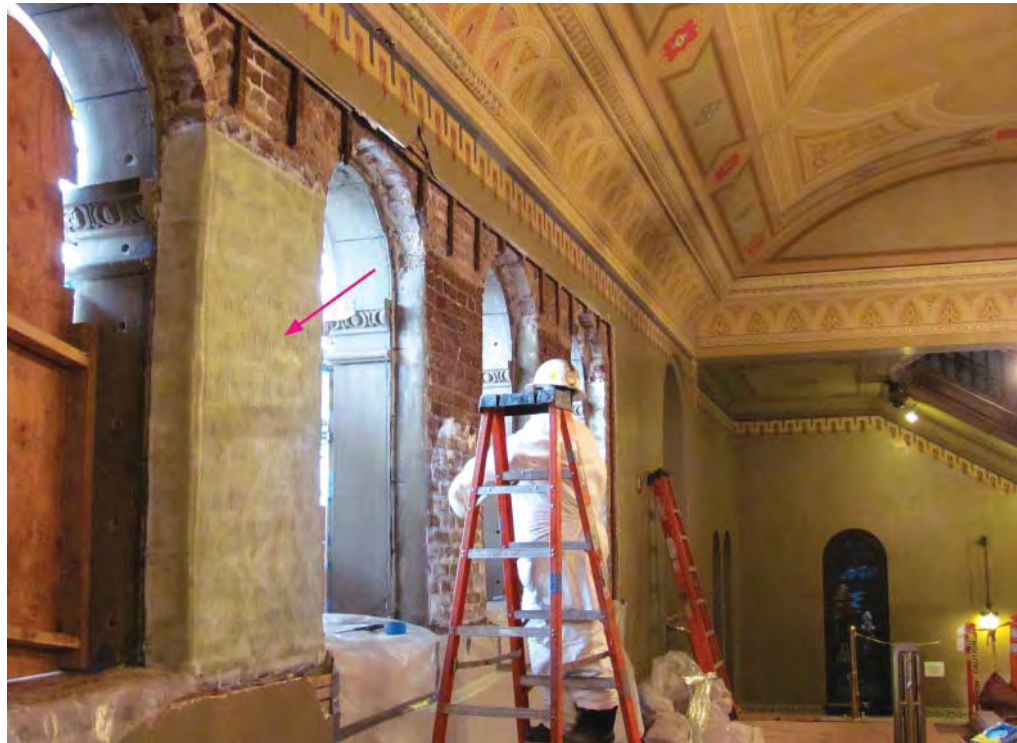
Example of fiberglass mesh strongbacking reinforcement for masonry walls. Photo from National Park Service Preservation Brief #41. Courtesy Wiss, Janney, Elstner and Associates.

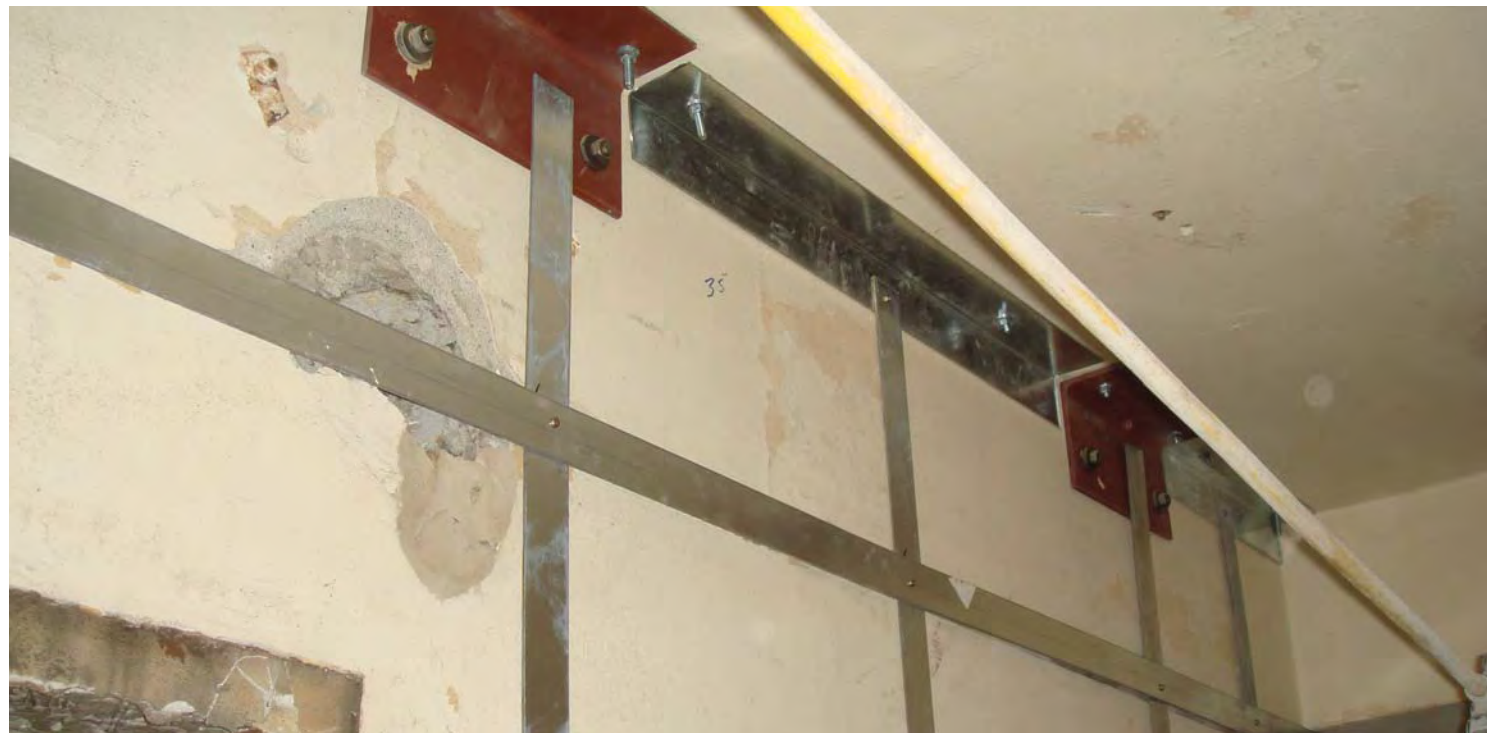
Example of steel strap strongbacking for hollow-clay tile masonry interior wall. CDG photo, April 22, 2015.

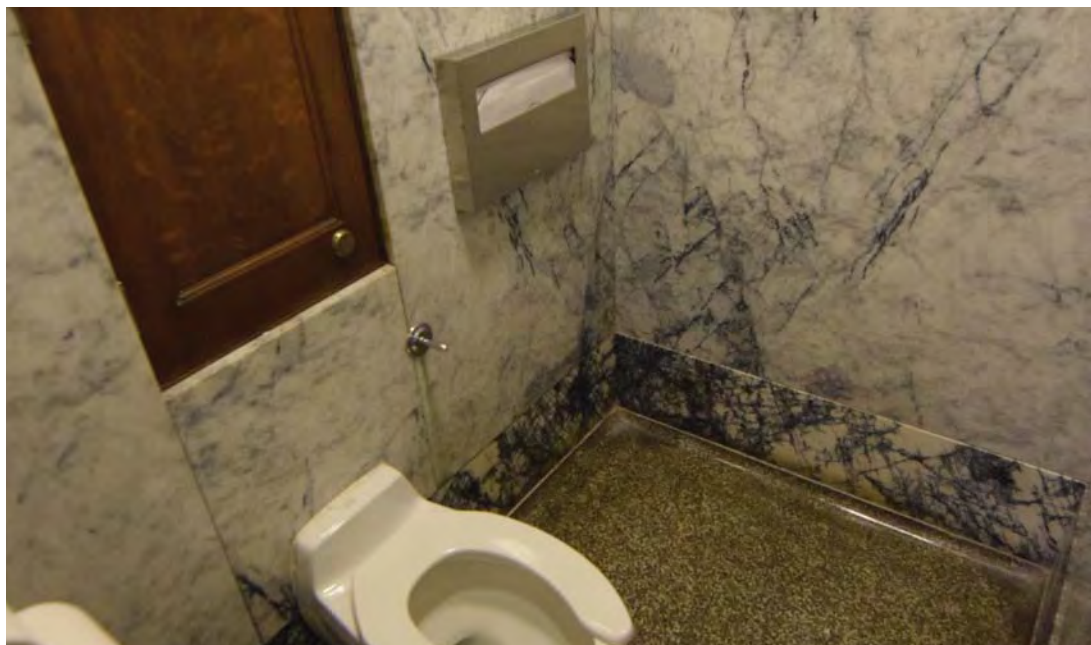
King County Courthouse interior view of marble wainscoting at jury deliberation room restroom E761A. CDG photo, June 2, 2016.

In order to replace plumbing fixtures such as water closets, it will be necessary to open up the restroom walls in order to replace piping, change out the carriers for the water closets, upgrade flush valves. This work has the potential to affect existing historic materials at the restrooms. There are a variety of existing materials at the water closet locations, ranging from historic marble wainscoting and plaster walls in some of the judge's chamber and jury deliberation room restrooms to 1960s-era tile in the public restrooms. Additionally, some of this work may also affect historic flooring materials such as tile or terrazzo.

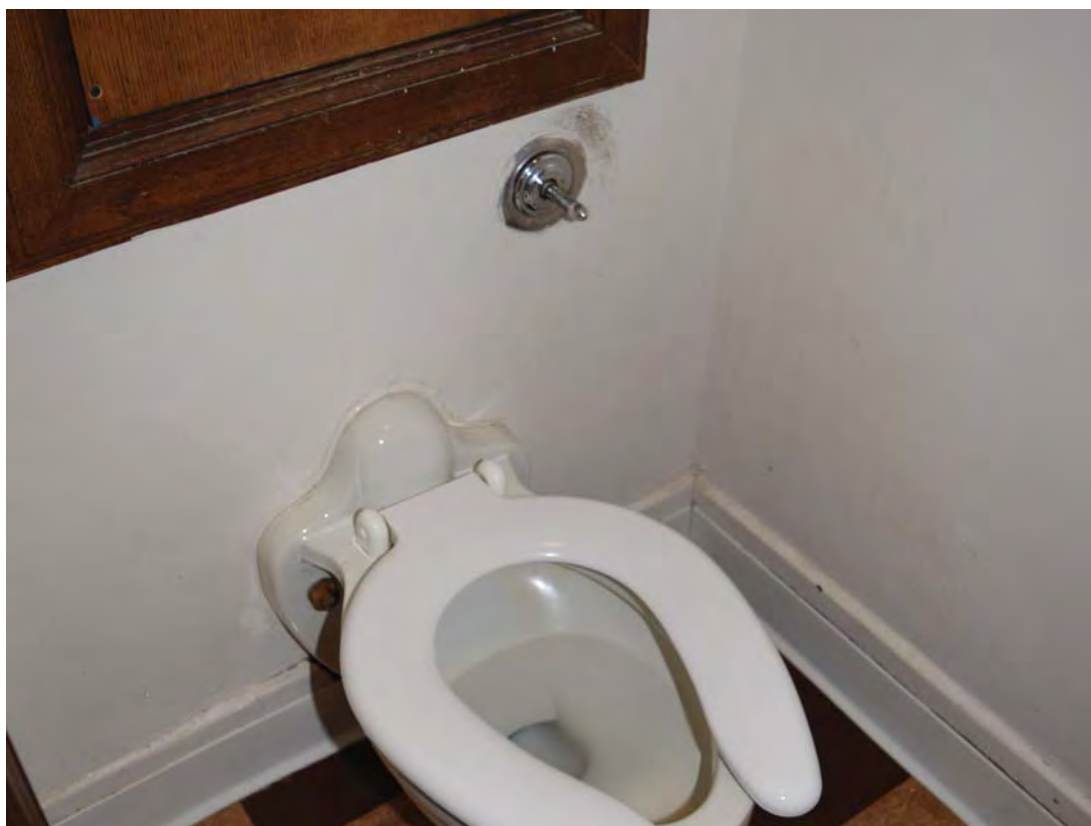
King County Courthouse interior view of plaster wall finish at jury deliberation room restroom W727B. CDG photo, May 20, 2016.

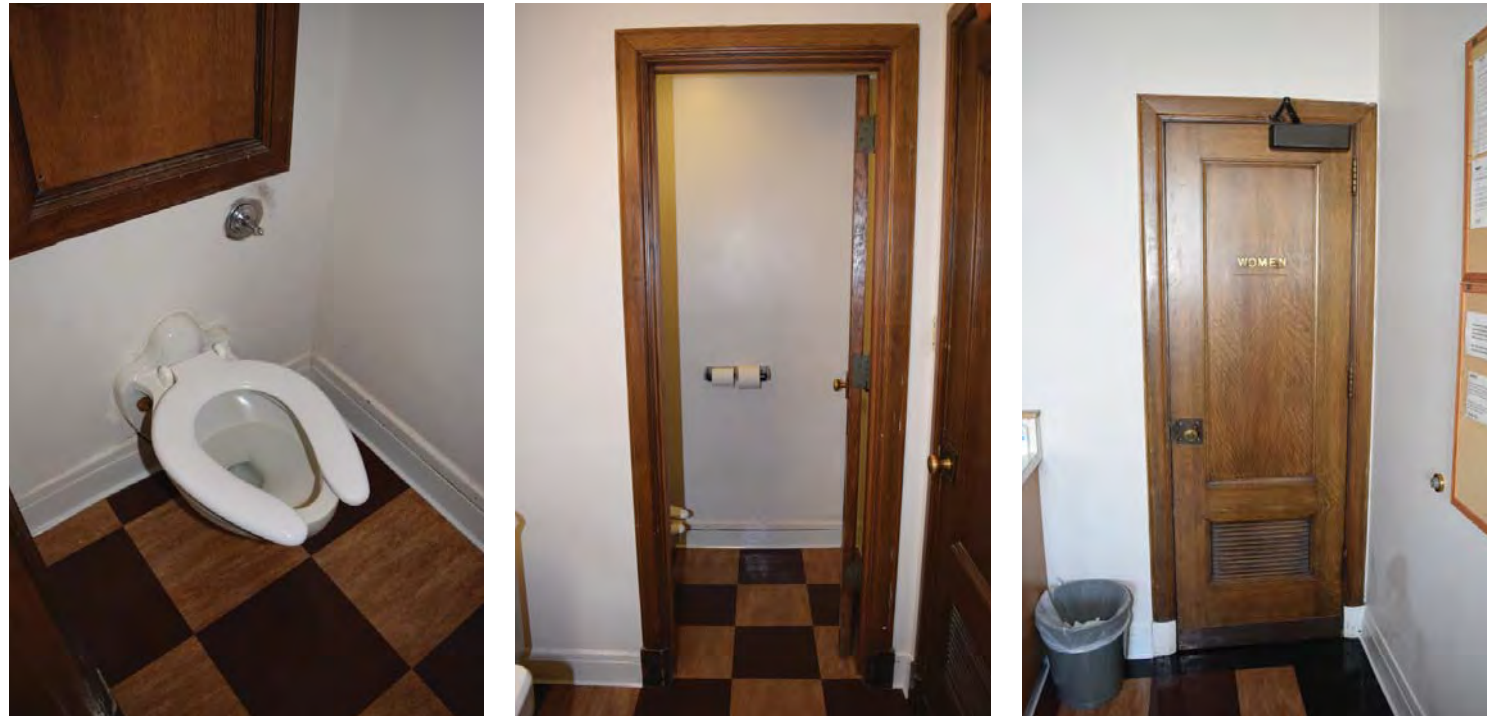
King County Courthouse typical non-ADA compliant jury deliberation room restroom and door. CDG photos, May 20, 2016.

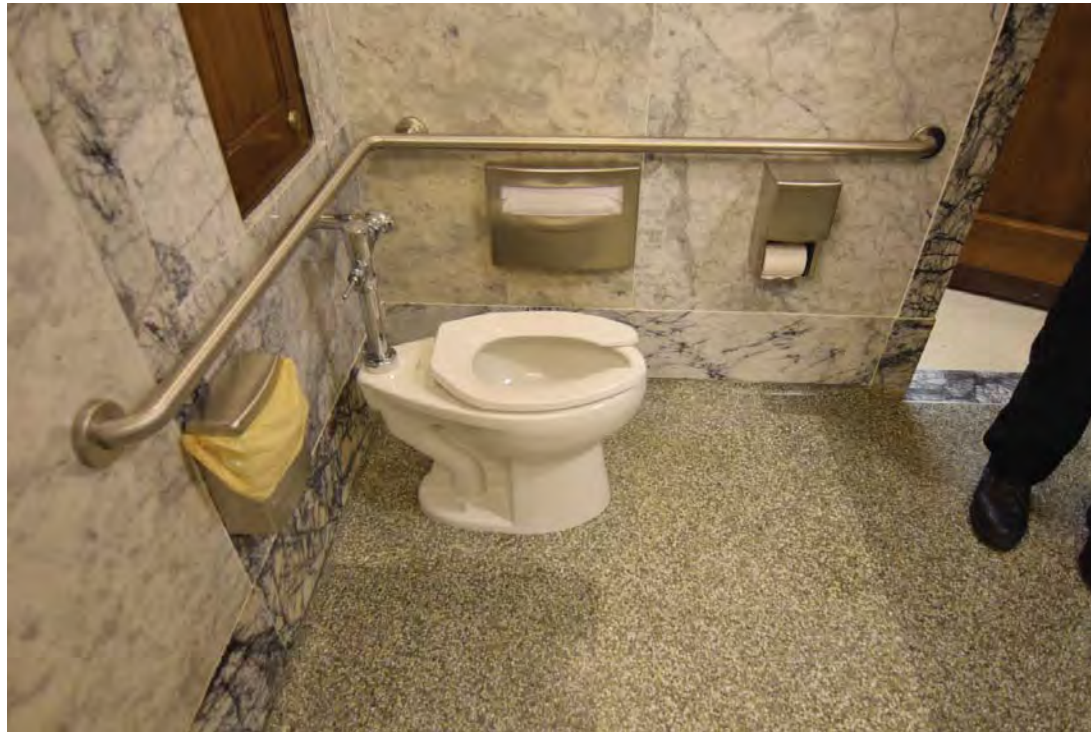
King County Courthouse jury deliberation room restroom E761B showing the ADA upgrade performed by King County Facilities Management Division. CDG photo, June 2, 2016.

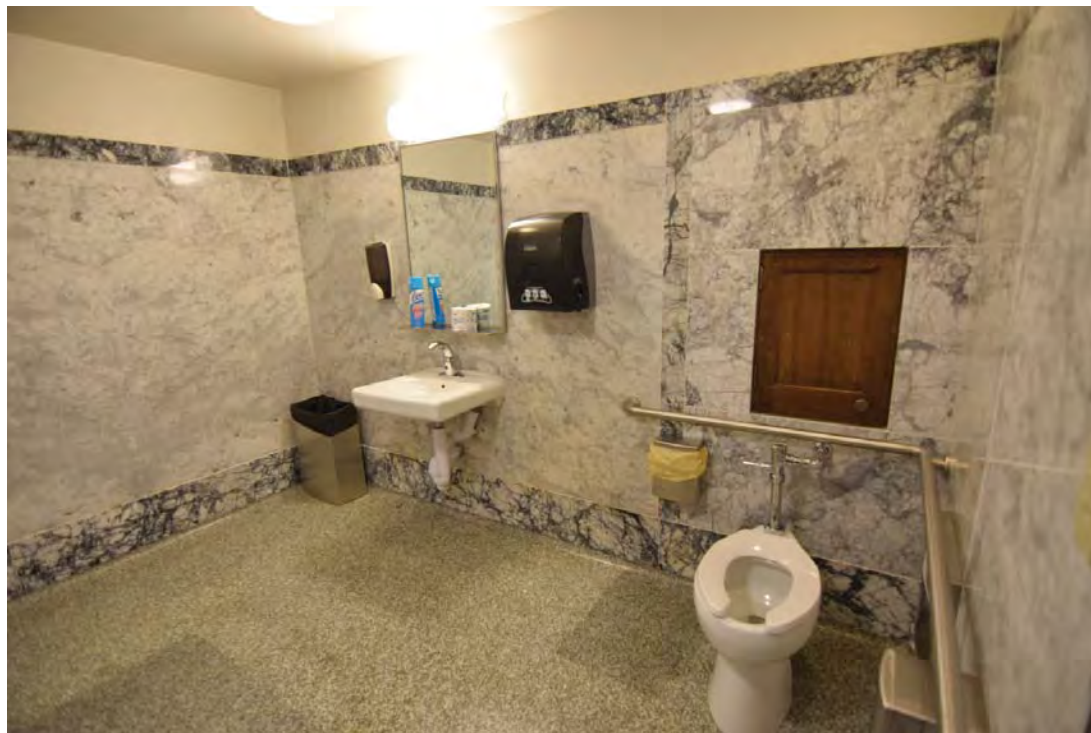
King County Courthouse jury deliberation room restroom E761B showing the ADA upgrade performed by King County Facilities Management Division. CDG photo, June 2, 2016.
