**KING COUNTY COURTHOUSE REVITALIZATION
BUILDING SYSTEMS REPORT**

Ordinance 18239 Section 41 Proviso P5 Response
Project No. 1124472

**Department of Executive Services
Facilities Management Division**

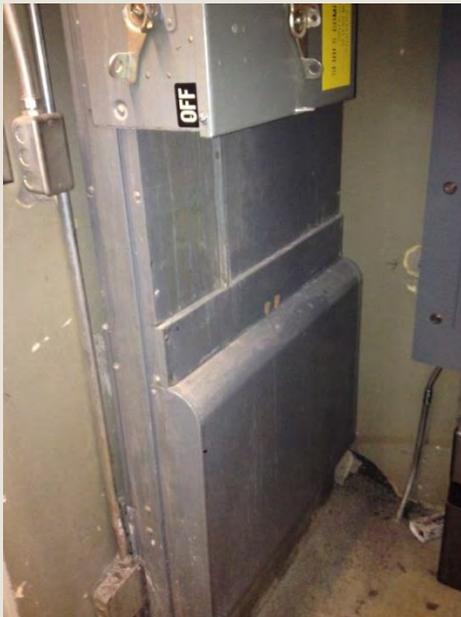
Figure 1 4000 amp buss electrical buss duct (East Riser)

The electrical power in the building is delivered to the upper floors via two buss ducts, one for the west side of the building, and one for the east side. The buss ducts were installed in the 1967 system upgrade project and have a recommended life cycle of twenty years⁹. This system requires replacement as soon as possible, particularly if the decision is made to remain in the Courthouse for the foreseeable future. A failure of a section of this system would shut down the building for occupancy until repairs could be affected.

“As electrical equipment ages, the insulation inside of it becomes brittle. Any motion or contact with the equipment can cause brittle insulation to break, which allows for electrical arcing (sparking) to occur, which ultimately can lead to explosions and/or fires. (Glumac)¹⁰”

Another problem with the age of this system is the unpredictable nature of the system, and the lack of replacement parts. Electrical contractors, specialty buss duct inspection firms, and engineers are all concerned that any work on this system may cause a system failure which would be impossible to correct or repair for lack of parts. There is currently no redundancy to deliver power to the upper floors of the building.

The recommended scope of work for this project would be to construct new electrical rooms adjacent to the restroom on the east and west sides of the building, install new buss duct risers and buss plugs, and install feeders conduits and wire into the old electrical rooms. This would allow the work to advance without interruption of the existing electrical service. Cutovers from old to new would then be done at night and on weekends to minimize disruption due to power outages.

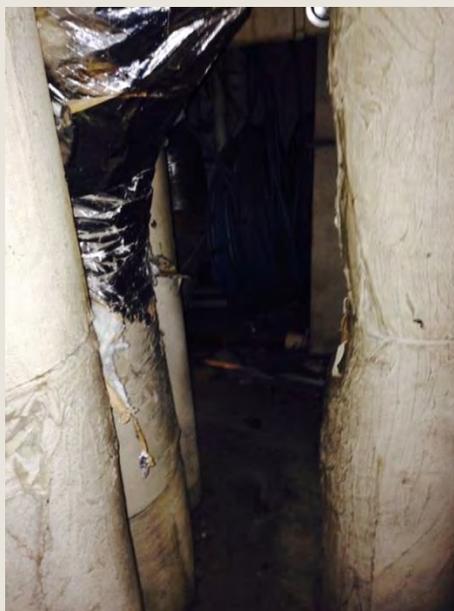
interference from ductwork and piping risers (figure 2 and 3 below). Also, there is no Arc Flash warning system in place. Due to this worker risk, no work should occur in this space until clearances are corrected, out of service date equipment is replaced, and adequate labeling and warning systems are in place. A Selective Coordination Study should be performed to insure that coordination exists at all levels from the Service Switchboard down to branch circuit before an Arc Flash study is performed. This study should be performed by a registered electrical engineering firm whose specialty includes the performance of Arc Flash reports.

Figure 3 Access to floor 1A east electrical room (part two) by crawling through an 8” wide space between heating riser pipes. Extracting an injured worker from behind here would be next to impossible.

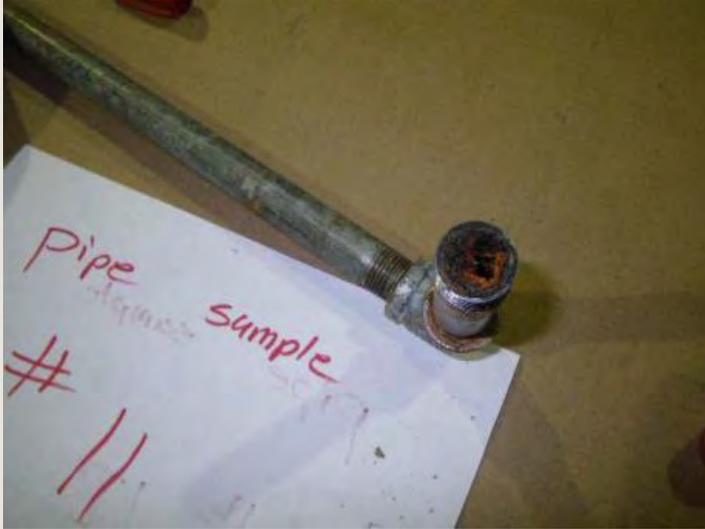
The Domestic Water system remains a problem and still utilizes some piping dating from the 1929 addition. Approximately 5% of the domestic system water piping is original galvanized piping dating back to 1930. This piping is badly rusted and should be replaced immediately

Figure 4 Pipe Sample from Courthouse domestic water system

This project would replace the entire system with new piping, water saving fixtures and pumps.

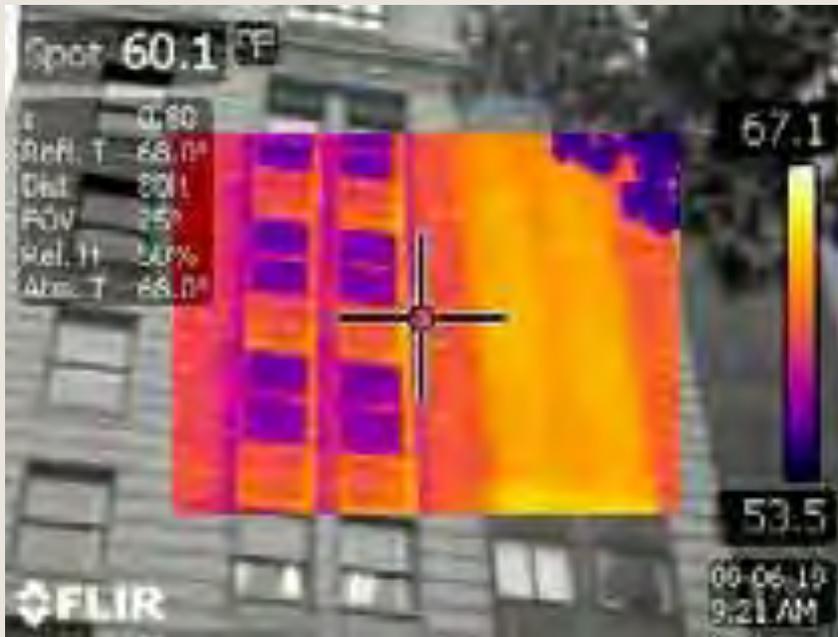
Limited, poor quality Insulation in the panel system (less than 1" of poor quality Styrofoam), causes the panels to radiate substantial amounts of energy out of the building creating substantial heat gain in the summer and heat loss during the winter. Poor air sealing of the aluminum window system creates air pressure losses thru the exterior skin, which unbalances the HVAC system, and causes significant fan and heating/cooling plant energy losses.

Figure 8 Infrared photo shows heat loss (yellow) through panel section on right compared to high efficiency windows on the left. Outdoor Temp is 53 degrees in this picture.
