TECHNICAL MEMORANDUM

West Point Flooding Investigation

Preliminary Findings Report

Prepared for
King County

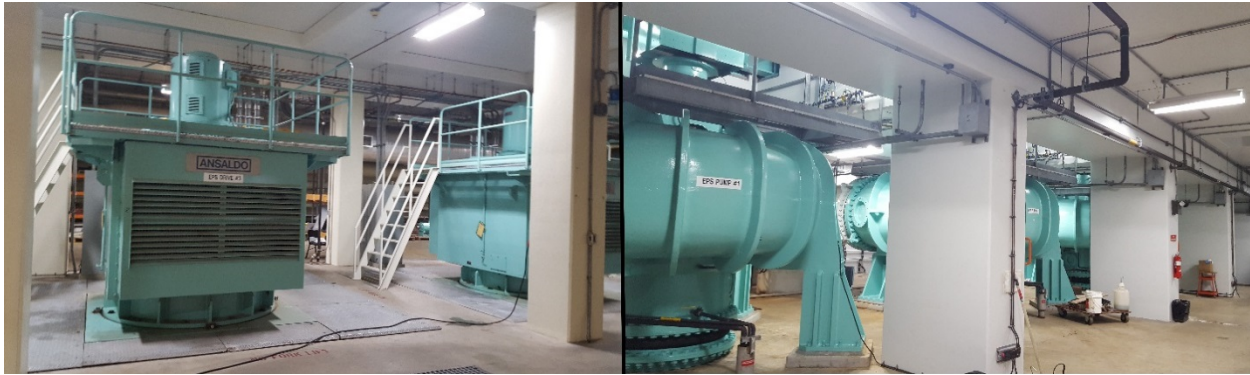
Figure 05. Effluent Pump Station

At the time of the electrical failure, Pumps 2, 3 and 4 were running with Pump 1 on standby. Immediately after losing power to the A-side electrical gear, the main drives of EPS Pumps 1 and 2 (and the hydraulic system that operates the discharge valves for all four pumps) lost power (Figure 05). Pump 1 was not running, but upon loss of power, Pump 2 immediately shut down. Due to the hydraulic system losing power, all of the discharge valves then drove to the closed position. Pumps 3 and 4 continued to run for approximately 30 seconds, initially showing high differential pressure alarms. Shortly thereafter, the pumps shut down due to high vibration. Operations attempted to start Pump 3 and Pump 4 twice, first at 2:21AM and again at 2:31AM. A final attempt to start Pump 3 occurred at 3:00AM. All of these attempts resulted in similar shutdowns due to high vibration (Appendix H).

Shown is the EPS. Left is the motor and drive which is upstairs from (right) the pump, discharge control valves, and hydraulic skid system.
