**KING COUNTY COURTHOUSE REVITALIZATION  
BUILDING SYSTEMS REPORT**

# King County Courthouse Revitalization

## Building Systems Report

Ordinance 18239 Section 41 Proviso P5 Response  
Project No. 1124472

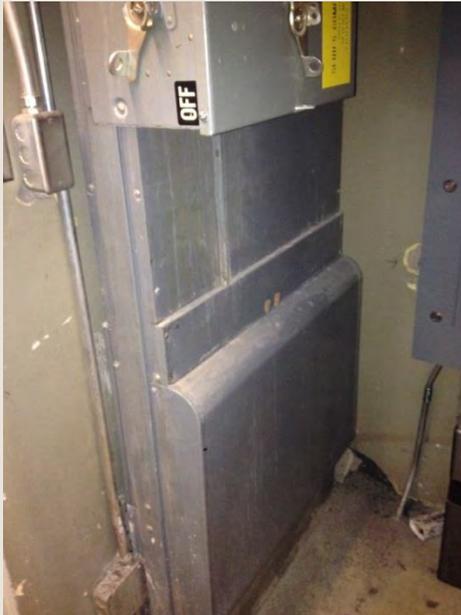
The electrical power in the building is delivered to the upper floors via two buss ducts, one for the west side of the building, and one for the east side. The buss ducts were installed in the 1967 system upgrade project and have a recommended life cycle of twenty years<sup>9</sup>. This system requires replacement as soon as possible, particularly if the decision is made to remain in the Courthouse for the foreseeable future. A failure of a section of this system would shut down the building for occupancy until repairs could be affected.

**Figure 1 4000 amp buss electrical buss duct (East Riser)**

“As electrical equipment ages, the insulation inside of it becomes brittle. Any motion or contact with the equipment can cause brittle insulation to break, which allows for electrical arcing (sparking) to occur, which ultimately can lead to explosions and/or fires. (Glumac)<sup>10</sup>”

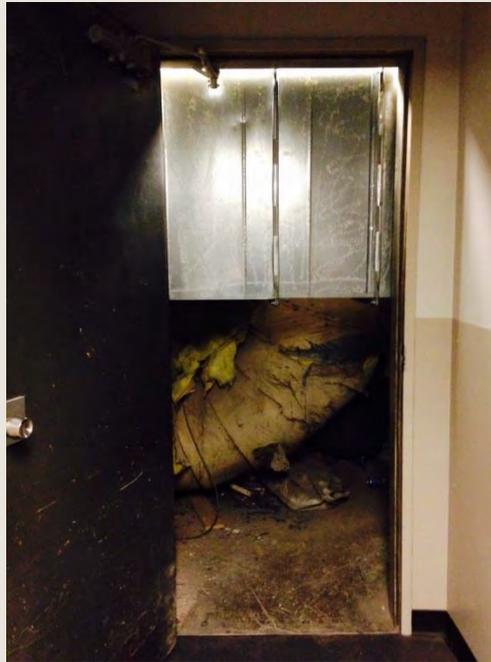
interference from ductwork and piping risers (figure 2 and 3 below). Also, there is no Arc Flash warning system in place. Due to this worker risk, no work should occur in this space until clearances are corrected, out of service date equipment is replaced, and adequate labeling and warning systems are in place. A Selective Coordination Study should be performed to insure that coordination exists at all levels from the Service Switchboard down to branch circuit before an Arc Flash study is performed. This study should be performed by a registered electrical engineering firm whose specialty includes the performance of Arc Flash reports.

**Figure 2 Access to floor 1A east electrical room by crawling under ductwork, a serious safety hazard and code violation**

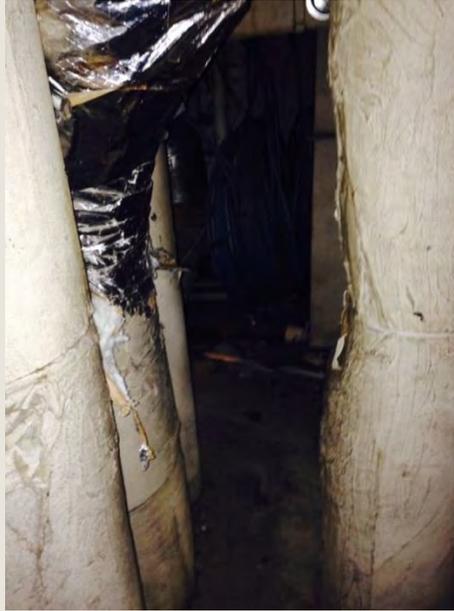
**Figure 3 Access to floor 1A east electrical room (part two) by crawling through an 8” wide space between heating riser pipes. Extracting an injured worker from behind here would be next to impossible.**

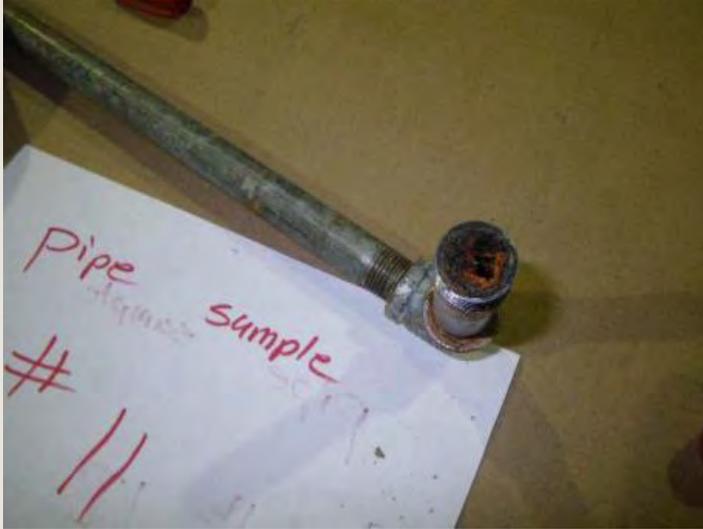
The Domestic Water system remains a problem and still utilizes some piping dating from the 1929 addition. Approximately 5% of the domestic system water piping is original galvanized piping dating back to 1930. This piping is badly rusted and should be replaced immediately

**Figure 4 Pipe Sample from Courthouse domestic water system**

In the 2012 report prepared by FSi Engineers, it was estimated that the Domestic Water system wastes over 179,000 gallons of water per year based on the current plumbing fixtures. The report also noted severe corrosion in piping and stagnant water in dead piping runs has increased the risk of contamination and disease. Water and sewer use rates for this site are

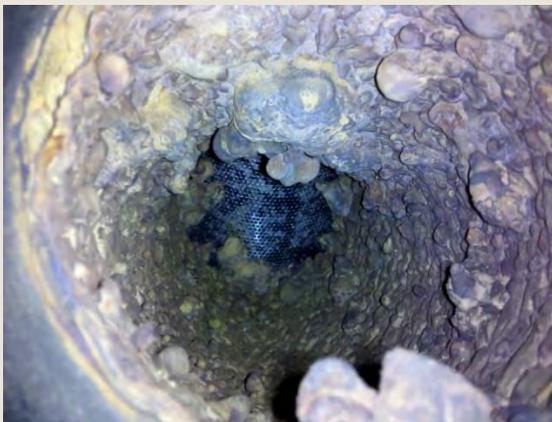
The west facing 3" water service main pipe on 3<sup>rd</sup> Avenue delivering potable water from the City owned pipe in the street are seriously clogged with mineralization and is probably effectively a 1" pipe due to mineralization. The South water connection is a 6" steel pipe installed in 1968 that was replaced from the building to the water meter in 2014 with an 8" line. The City owned line from the meter to the water main in the street remains at 6" and it likely badly clogged with mineralization. This pipe from the meter to the street main should be replaced. This situation should also be reviewed by a Fire Protection engineer to ensure that the system has adequate capacity to support the fire suppression system.

Camera investigations inside the south water supply pipe showed a 6" pipe reduced to a 3" diameter by mineralization. The 3<sup>rd</sup> Avenue supply pipe, installed in the 1920 era is probably much worse. This section of piping should also be replaced to provide redundant water supply to the Courthouse, particularly in support of the fire sprinkler system.

**Figure 5 Camera picture of inside south water main to building similar to the west water main**

There is also concern that the water supply to the building may not be adequate particularly for the fire protection system, which relies on water mains for its source of water. Current code requires a large tank to store fire water for this very reason. The revitalization project would restore the 3<sup>rd</sup> Avenue water connections and add 30,000 gallon tank to provide fire sprinkler water supply.

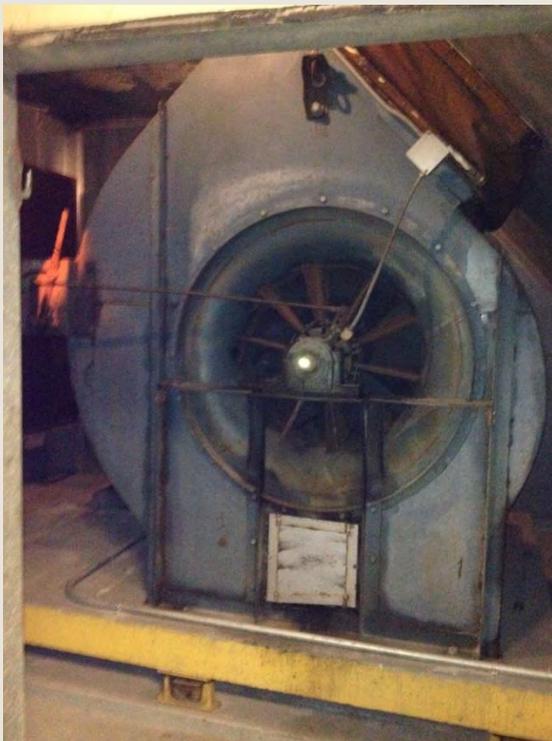
**Figure 6 1965 era Dual Duct Single Fans**

The recommended project for this area is total replacement of all Fan Floor equipment, plenums, controls, and associated works.

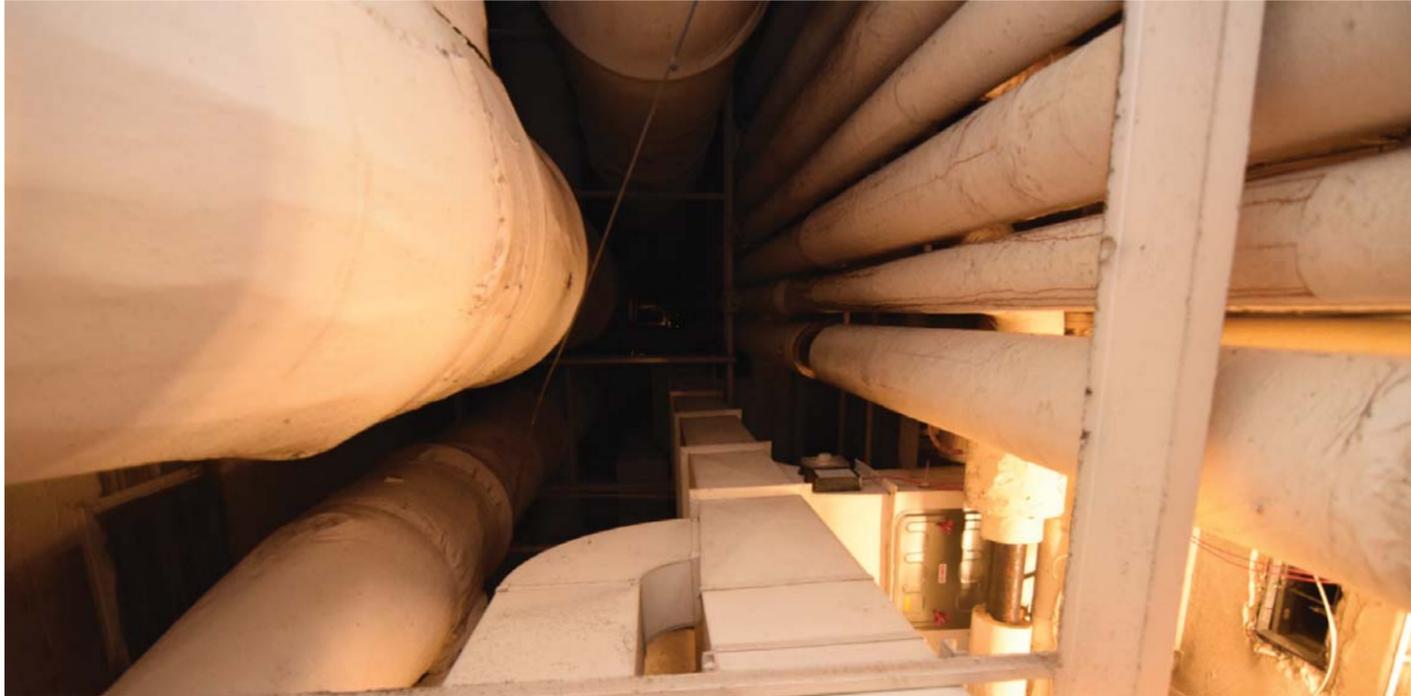
*View of ducts and piping inside vertical mechanical, electrical, and plumbing shaft. CDG photo, March 31, 2016.*

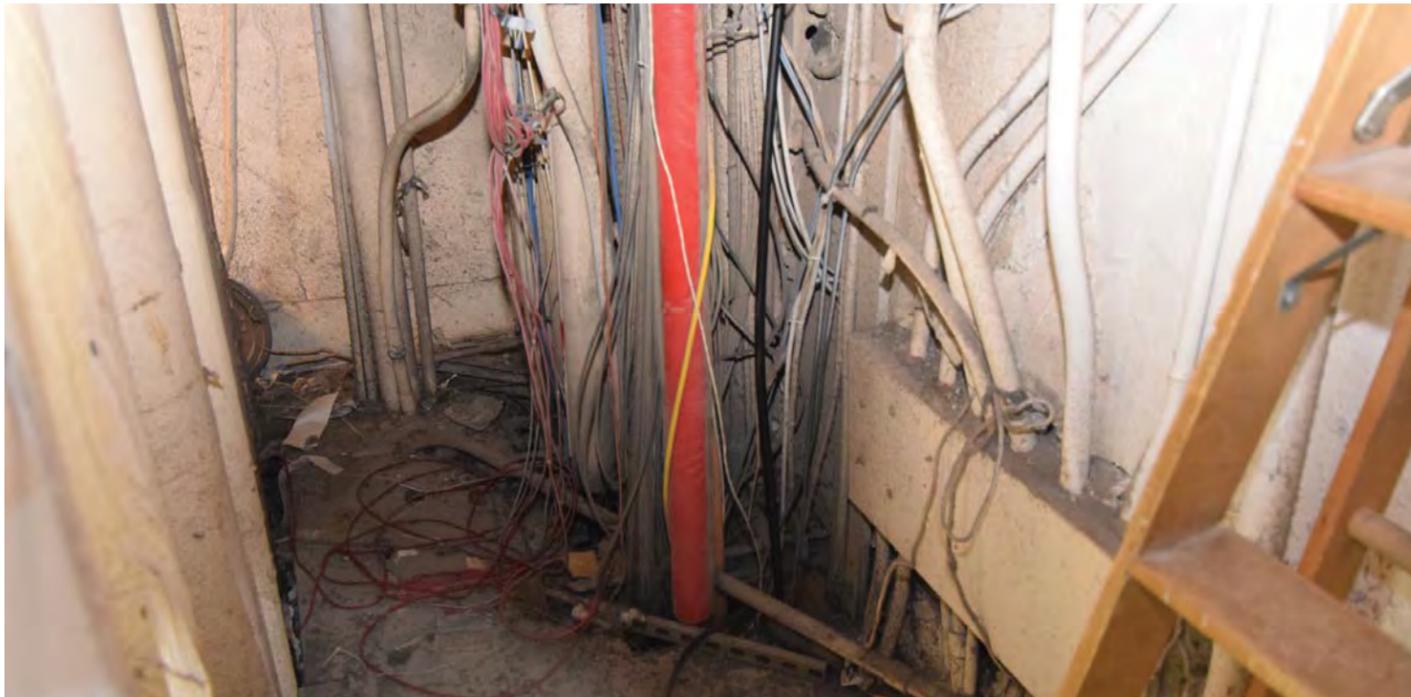
*View of space inside vertical mechanical, electrical, and plumbing shaft. CDG photo, May 31, 2016.*

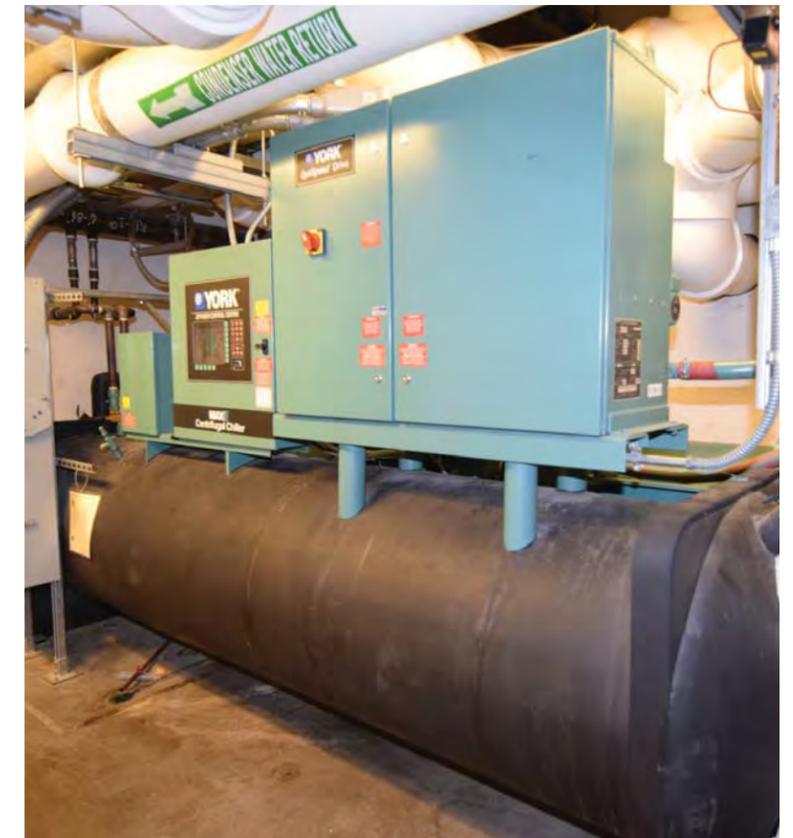
Chiller

All chillers are in good operating condition and are working properly during all times of the year. However, many of the variable frequency drive (VFD) controls for the compressor motors within the chillers are not functioning properly, which has a negative impact on the chiller efficiencies.

It is recommended that the current chillers not be replaced and remain to service the building. Since the current equipment is operating properly and has substantial equipment life remaining, the cost of implementing new chillers, as well as required operational downtime, cannot be justified.

It is recommended that the variable frequency drive controls for the compressor motors be replaced, as this is a comparatively low-cost and simple solution that will yield significant energy efficiency benefits.

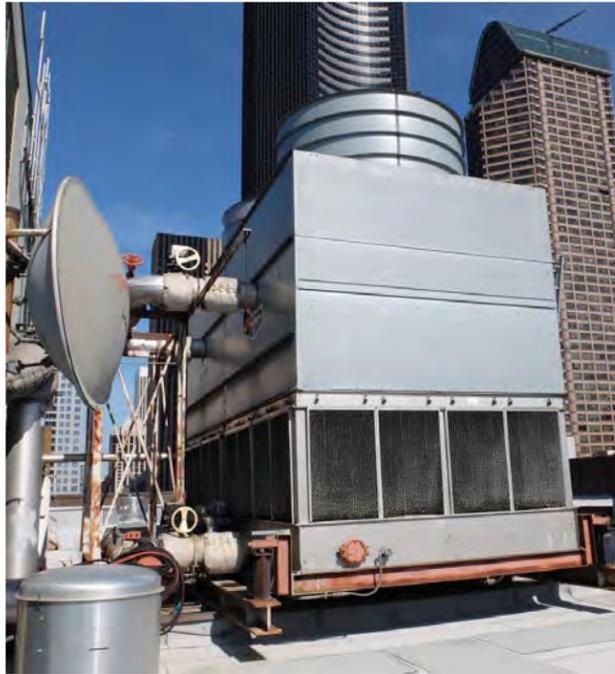
*Cooling Tower*

Both cooling towers are past serviceable equipment life and are in poor operating condition. Each tower shows significant signs of the typical wear and tear for cooling towers over 40 years old. There is significant corrosion of pipes and cooling tower components, which could cause complete system failure if left untreated. There is also substantial scaling, or calcium and magnesium deposits, on the heat transfer media. Scaling dramatically reduces the efficacy of the heat transfer and results in higher energy and operating costs.

Both cooling towers are past the recommended equipment life, are operating inefficiently, and are subject to partial or complete failure at any time.

It is recommended that both cooling towers be replaced with new towers that are selected for identical heat rejection capacity with identical configuration (induced draft, counter-flow) as the current cooling towers. The current cooling towers are past the recommended equipment life, inefficient, and suffering from corrosion, scaling, and microbial growth. Replacing these towers will increase the energy efficiency of the chilled water system as well as lower the operating cost for this system. In addition, replacement of these towers will significantly reduce the risk of a complete shut-down of the building cooling system due to cooling tower failure.

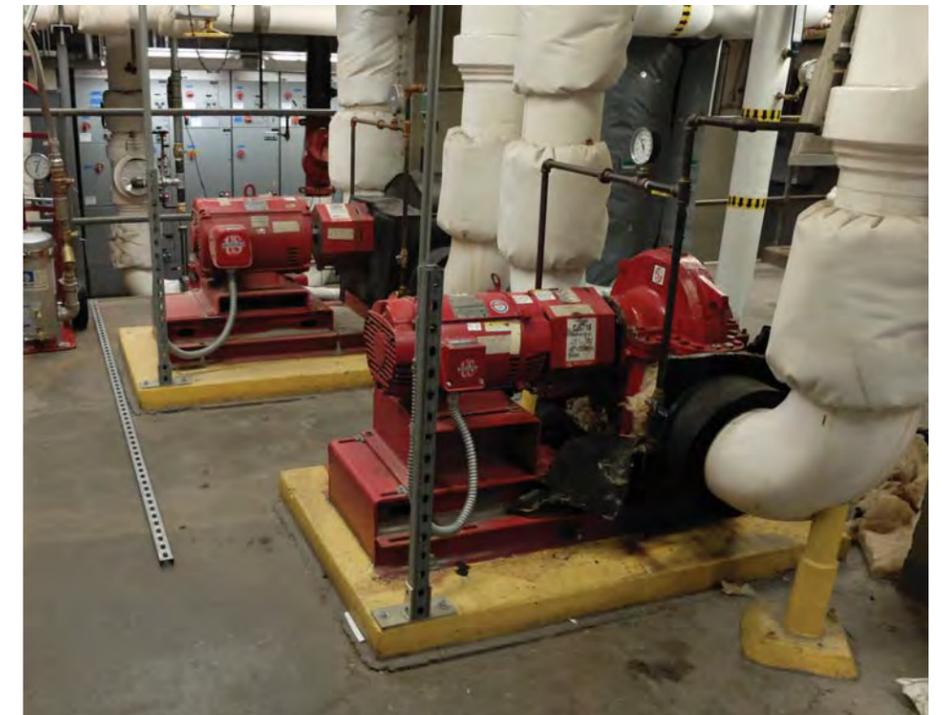
*Water Pumps*

Each of the pumps appear to have been serviced most recently in 2013. There are indications on various pumps that motor bearings were sealed in October of 2013 and some motors appear to have been completely rebuilt in February of 2013. However, through conversations with the operating engineers, it is apparent that many of the pumps are wearing out and all will need to be replaced. The motor bearings have been sealed, meaning that these bearing cannot be frequently lubricated. In addition, variable frequency drive and pump controls in general are not operating properly.

Each of the pumps are past the recommended equipment life, are operating inefficiently, and are subject to failure at any time.

It is recommended that all chilled water and condenser water pumps be replaced with new pumps that are selected for identical flow volume and available head pressure as the pump that is being replaced. Replacing these pumps will increase the energy efficiency of the chilled water system as well as lower the operating cost for this system. In addition, replacement of these pumps will significantly reduce the risk of a complete shut-down of the building cooling system due to chilled water pump or condenser water pump failure.

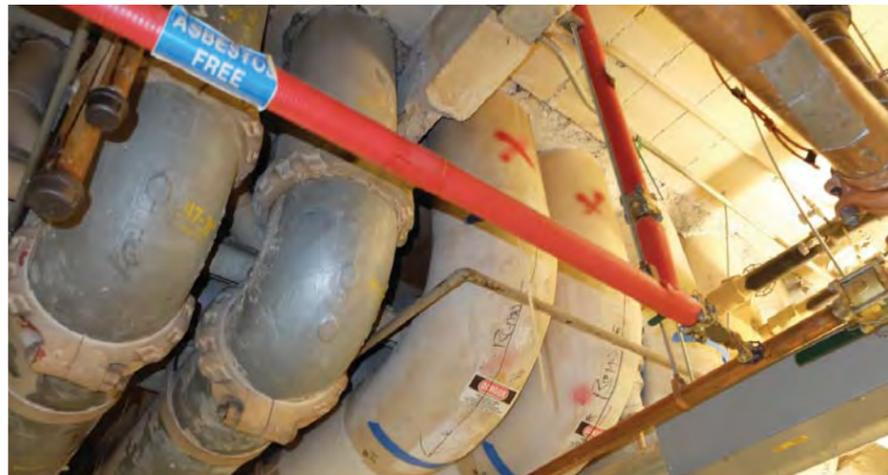
*Water Piping Example*

Much of the chilled water distribution piping is in fair condition and at a low risk for pipe bursts or leaks. There are portions of the chilled water piping that is uninsulated, which is both energy inefficient and a code violation.

Any uninsulated chilled or condenser water piping is a code violation and will need to be insulated to bring these systems up to current energy code.

It is recommended that all chilled water and condenser water piping be tested for signs of severe corrosion or thin walls. If there are sections of piping that appear to be at significant risk for failure, these sections should be replaced. All piping (existing and new) will need to be properly insulated.

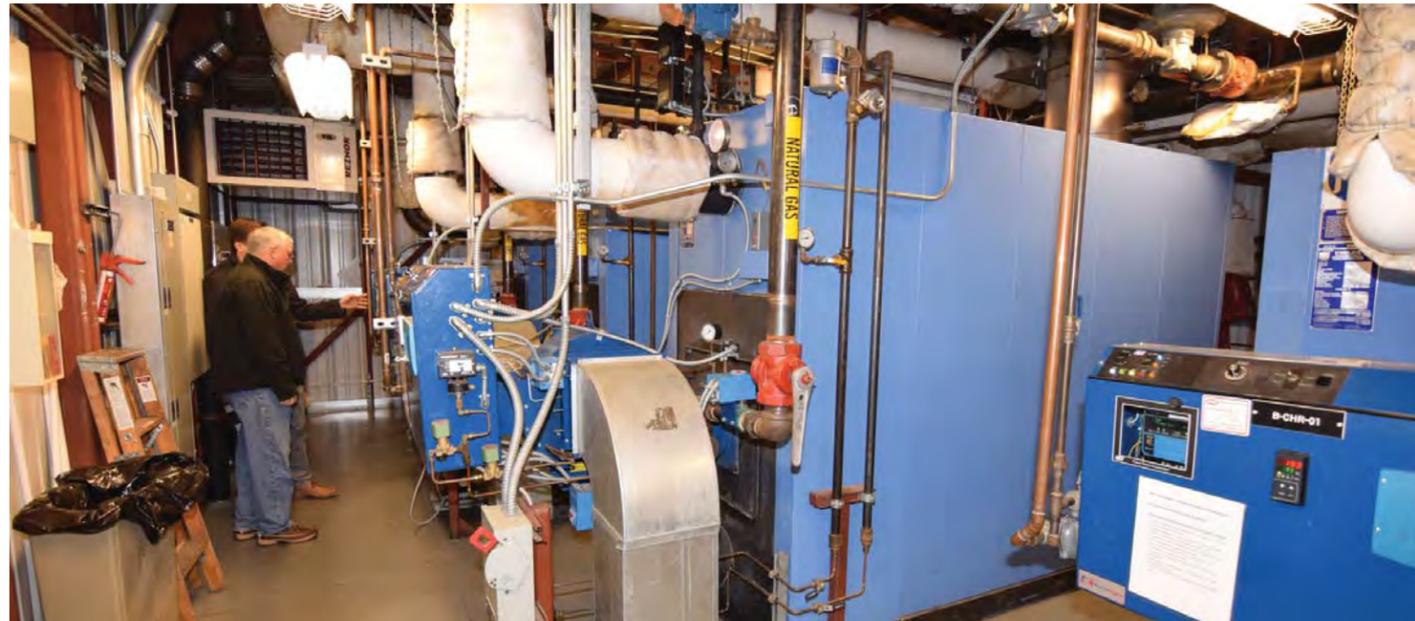
Boilers

The boilers and associated piping, controls, and pumps were installed in 2010 and are in very good operating condition.

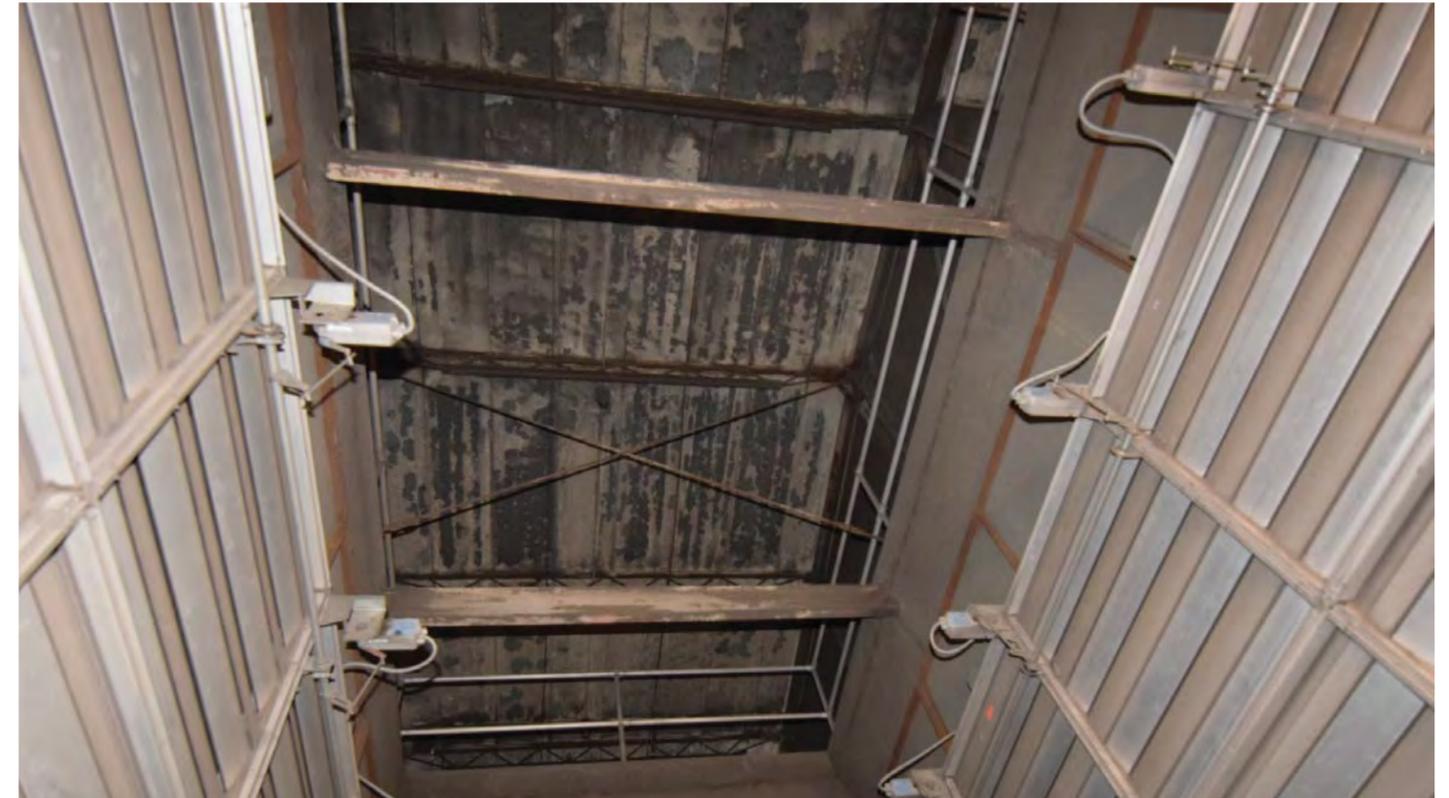
Outside Air Intakes

In all operation modes, at least the code-required minimum outside air levels are being supplied to each interior and perimeter space. However, the outside air dampers for the interior zone air handling units are barely open, meaning that ventilation to these units, and thus to the dual duct terminal units, cannot be appropriately increased. This increase of outside air delivery in periods where the outside air temperature is appropriate to provide free cooling is called airside economizer mode and is required by the Washington State and Seattle Energy Codes. This is not being met by the current outside air damper design for the interior zones.

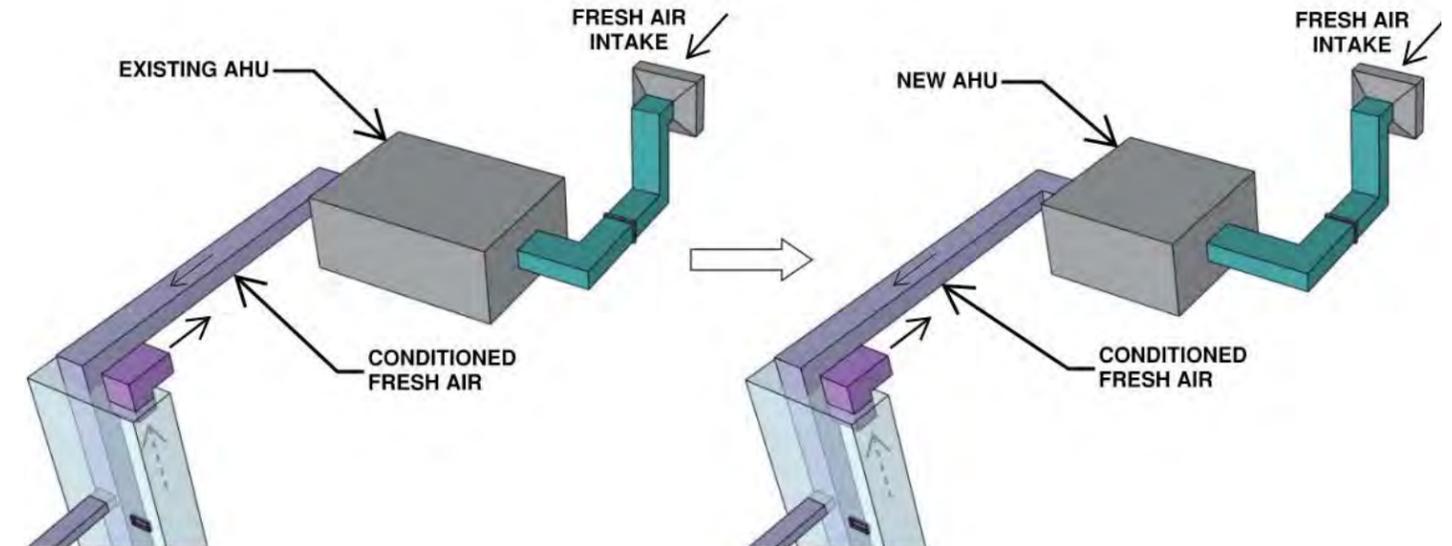
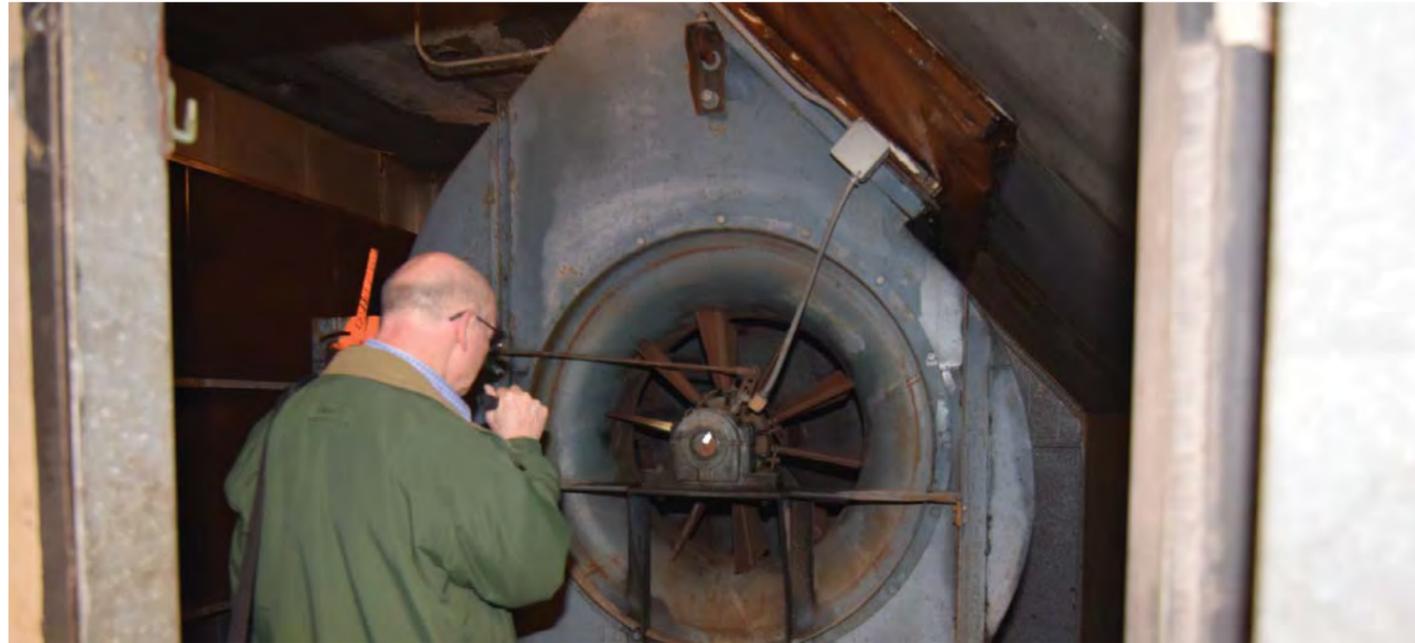
Air Handling Unit

These units are in poor condition due to age. The supply fan drives are worn and the fan, and the fan casings have cracked and been welded back into place. The motor bearings have likely never been replaced and are at risk of failure. Failure of these components could result in significant portions of the building not being conditioned or ventilated.

The sheet metal casing for the air handling units is no longer sealed properly and is extremely leaky. This accounts for a significant increase in the energy and cost required to supply the required airflow to each floor and zone.

These units are past the recommended equipment life and could be subject to complete failure at any time. There is no service life left in these air handling units.

It is recommended that these air handling units be completely replaced with new units selected for the same heating capacity, cooling capacity, and airflow volume. Similar to the current units, each new air handling unit will be a 100% dedicated outside air unit with a supply fan, heating and cooling coils, and filters. The existing ductwork and fittings shall be reused as described in the following sections of this report.

There is ample space on the Fan Floor for the replacement of these air handling units, and the distribution ductwork is in acceptable condition. Replacing just the air handling unit and not the entire ductwork system is a cost-effective and energy efficient solution to upgrading this system.

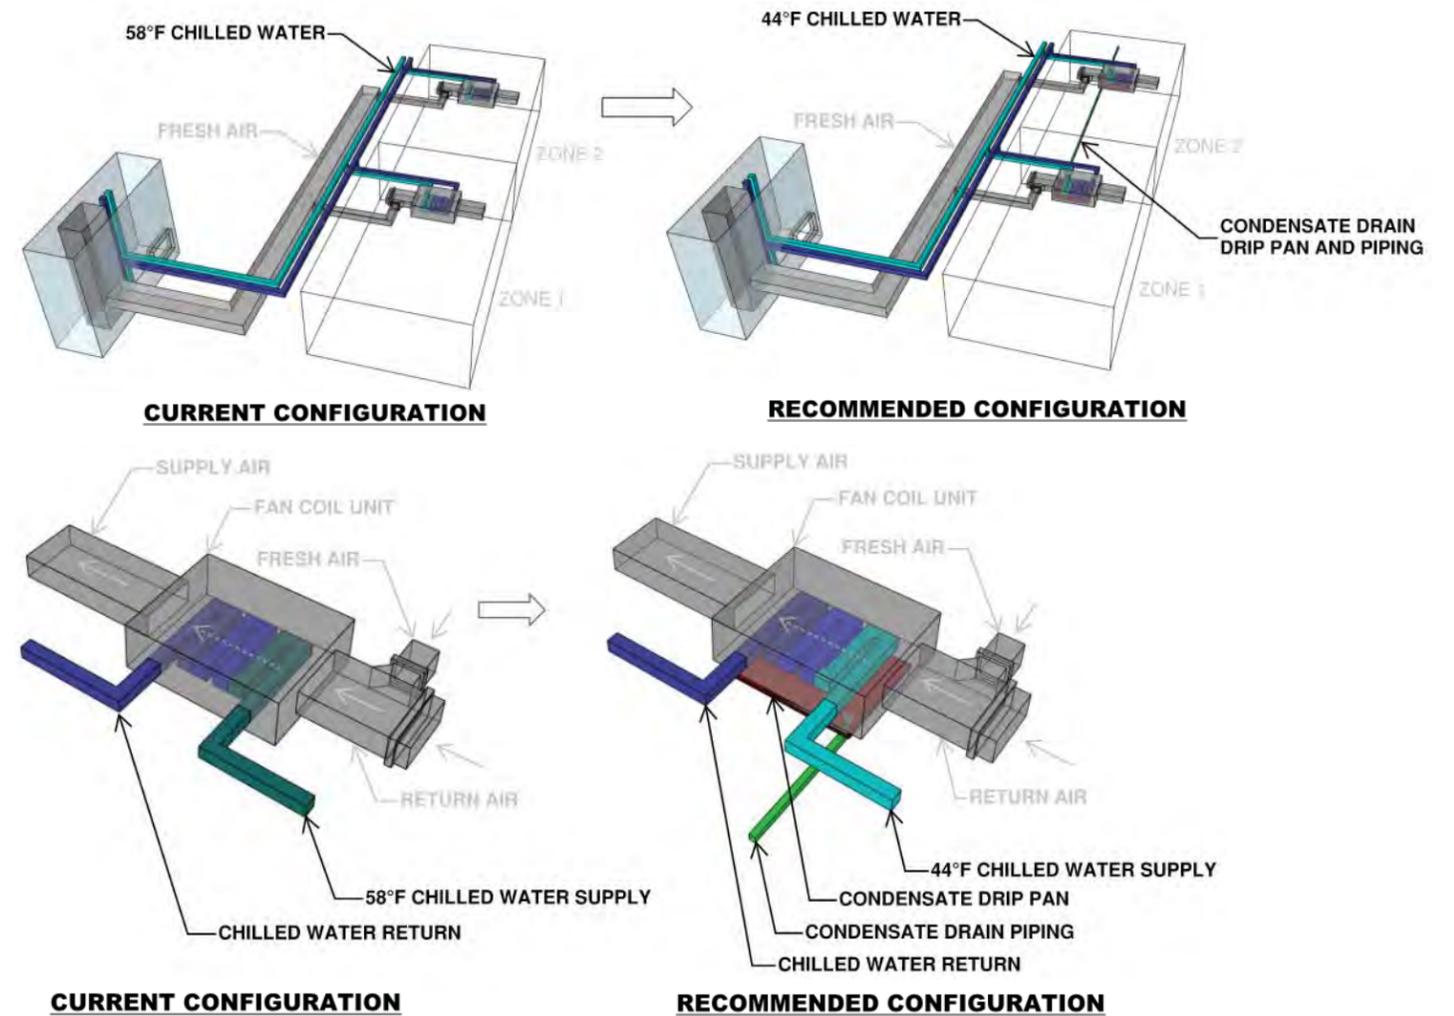
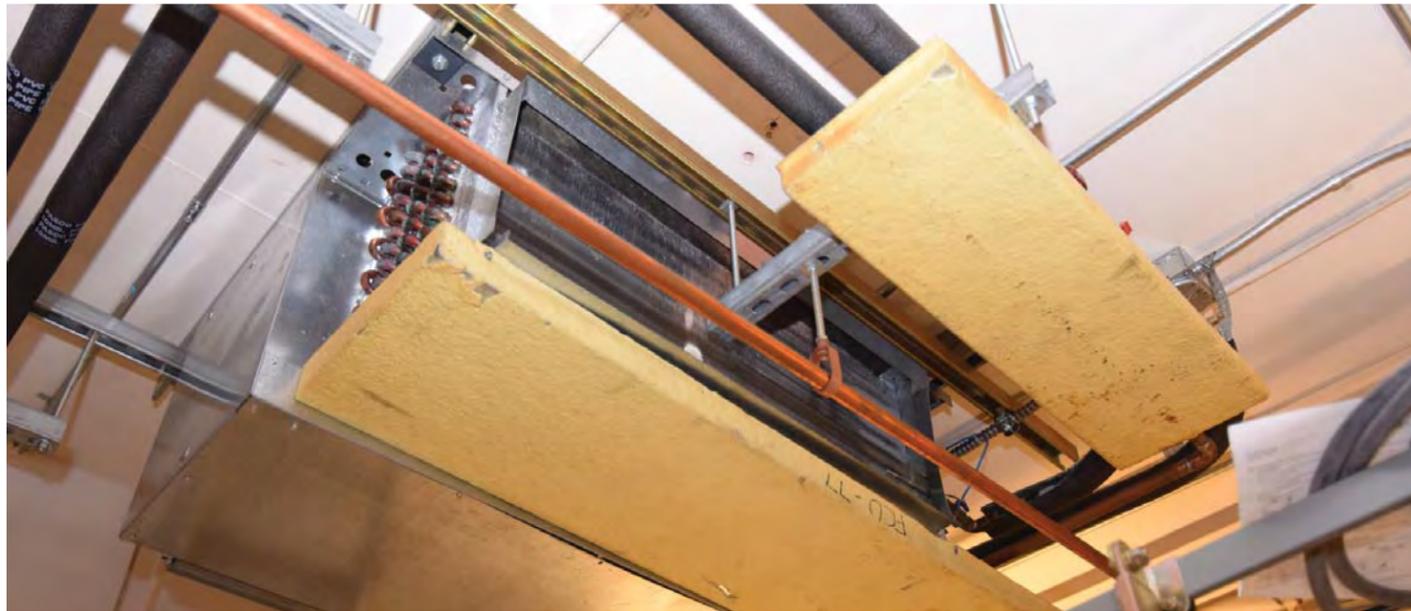
Fan Coil Terminal Units

Fan coil terminal units (FCUs) are used to cool and heat the perimeter spaces in the building. Each fan coil unit is supplied with ventilation air via the perimeter zone air handling unit described above, and utilizes chilled and hot water to cool and heat each space. Condensate drip pans and associated condensate drain piping have not been installed on many of the fan coil units.

Because there is no condensate drainage for many of the fan coil units, chilled water is supplied to the fan coil units at 58°F, thereby eliminating condensation on the cooling coils and preventing excess moisture from damaging the ceiling and nearby property. However, the cooling coils cannot properly dehumidify the space in this configuration, which can cause significant occupant discomfort as well as potential property damage in historic or otherwise sensitive spaces. These types of units are designed to utilize chilled water around 44°F and operate most efficiently with entering chilled water in that temperature range.

Fan coil units throughout the property were replaced within the past decade, and are currently in excellent operating condition. However, they are not able to be operated properly due to the condensate drainage issue outlined above. In the spaces surveyed, there is ample plenum space above the ceiling to run condensate drainage.

Fan coil units replaced or installed in 2004 have approximately 20-25 years of usable equipment life remaining. However, these units are no longer supported by the manufacturer, so any upgrades that occur to these units will involve rebuilding each box in-house as opposed to using replacing parts ordered from the manufacturer.

In order for the fan coil units to function properly and for occupant comfort to be satisfied, low temperature chilled water (44°F) should be supplied to the coils, and condensate drainage from these coils needs to be addressed. The fan coil units will operate much more efficiently, occupant discomfort will be minimized in these spaces, and historical elements in these spaces will not be subject to excess moisture.

The fan coil units themselves have been recently replaced and are in good operating condition. The units themselves will not need to be replaced, which results in saving significant money and time. Additionally, there is adequate space to run sloped condensate drain piping in the ceiling plenums, which will reduce the amount of coordination required with other equipment and disciplines.

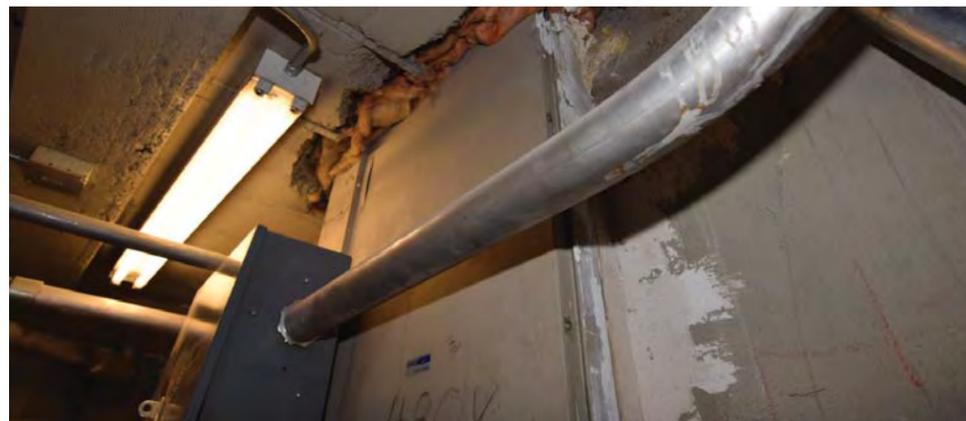
Bus duct photo

Similar to Figure 1, the Courthouse has 480V and 208V panels on each level, and normal power is provided to upper levels of the building through a large power trunk called a bus duct. Each side of the Courthouse (the west and the east) has its own dedicated bus duct and associated panels that tap off of it.

A foreseen challenge in replacing the bus ducts is that the new bus ducts will require a significant amount of new space throughout upper floors. Similar to the existing bus ducts, the new ones will require an accessible electrical closet on each floor they run through, and current code clearances (2014 National Electrical Code 110.26) will be required in these new spaces, which the existing closets do not provide. Glumac estimates each of these closets may need to be approximately 6'x10' in size, as conceptually illustrated in [Figure 2](#). Mechanical cooling will also be required in these closets. While the space requirement is significant, providing a larger space for electrical equipment will help to resolve the safety issues identified in [Section 1.1.5](#).

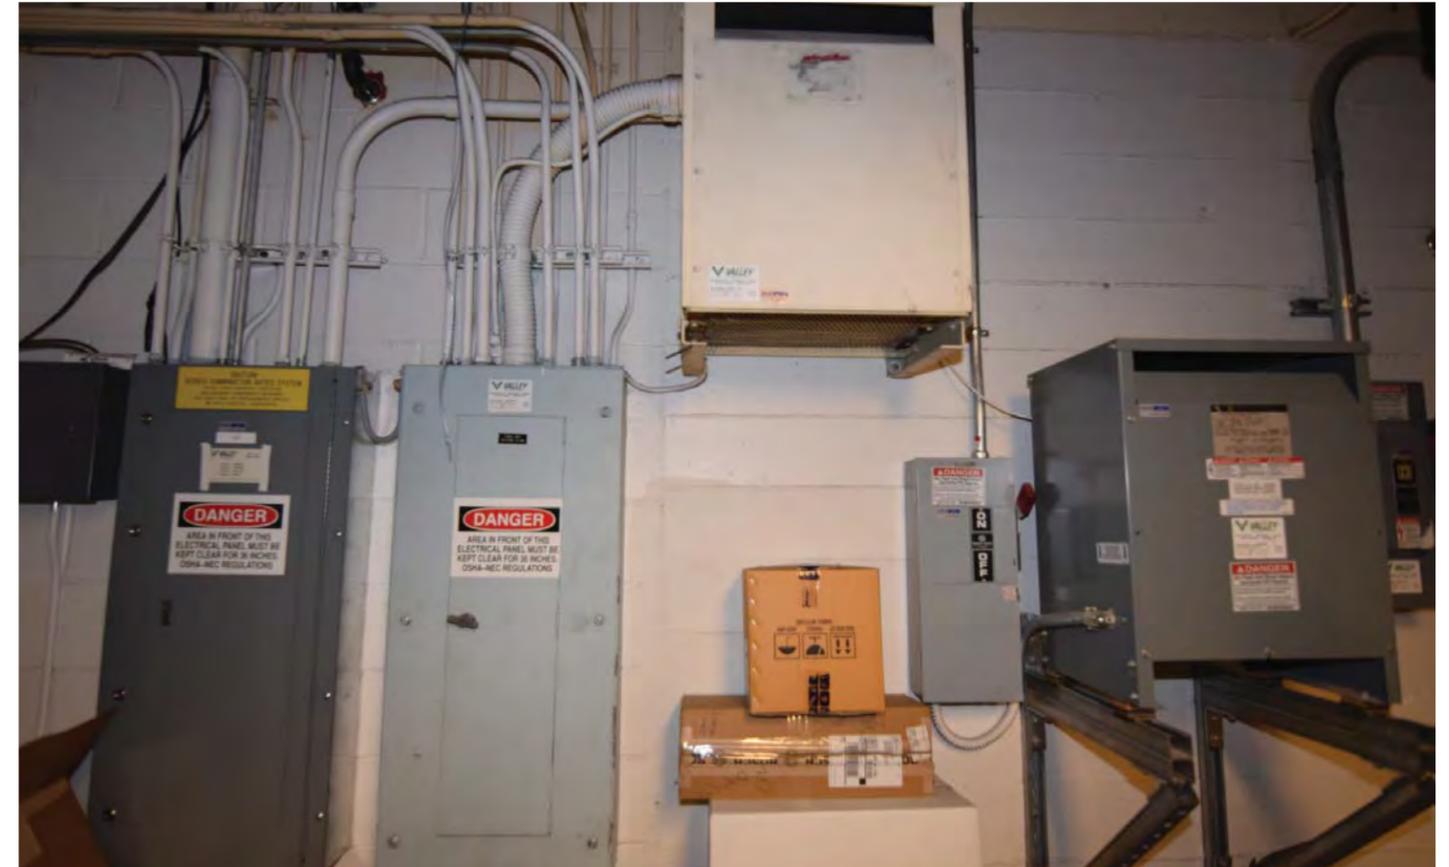
208V circuit breakers

Similar to the bus duct discussed in [Section 1.1.2](#), the 208V panels and associated transformers are dangerously old, with the potential of creating explosions and/or fires. **Injury** and **death** are possible results.

It should be noted that if a panel or its associated transformer goes down, it will require immediate replacement in order to restore functionality to the areas they serve.

208V power panels and transformers may be replaced one at a time, and during off hours where applicable. If certain spaces have a 24/7 up-time requirement, the functions of these spaces may need to be relocated during the duration of the construction areas related to those spaces.

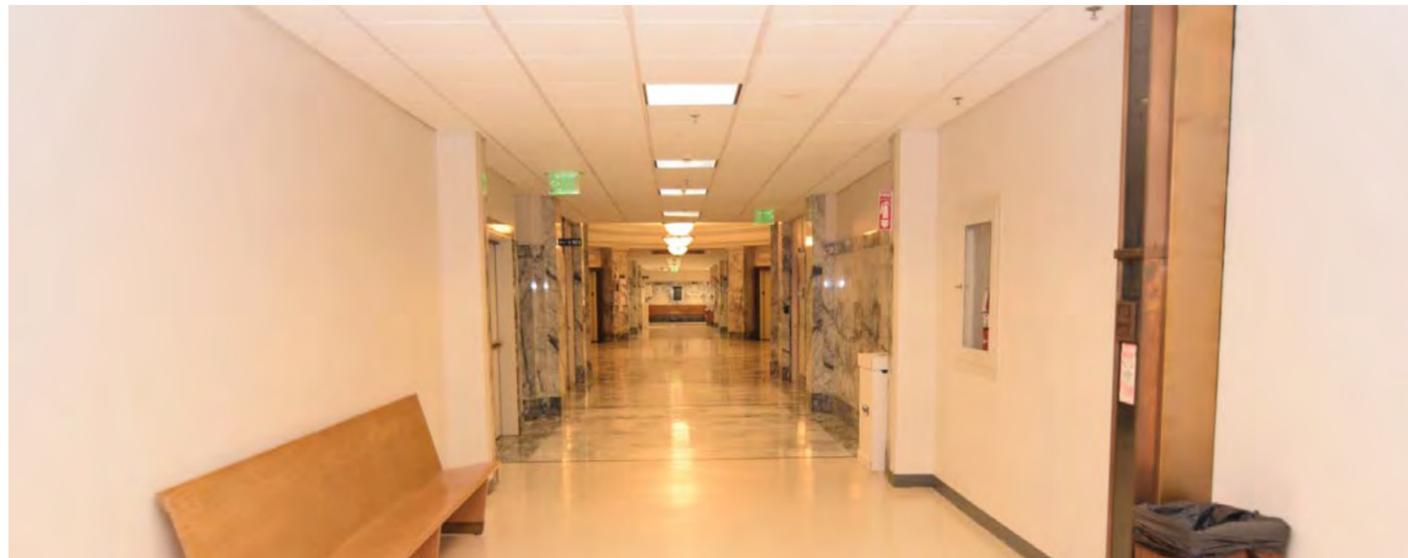
*Fluorescent lighting in typical corridor*

T8 type fluorescent lamps are common, but there are locations that have T12 type lamps. It is understood that the County has been trying to phase T12 type light fixtures out as renovation projects allow, as T12 type lamps are significantly less energy efficient than T8 type lamps.

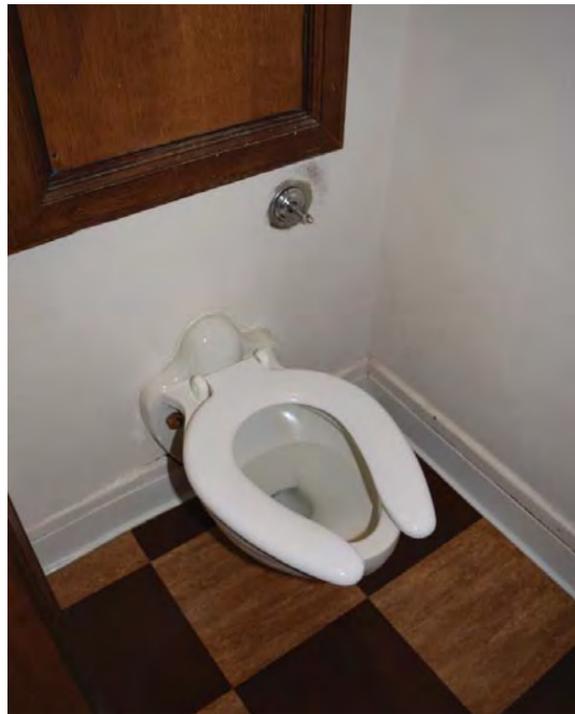
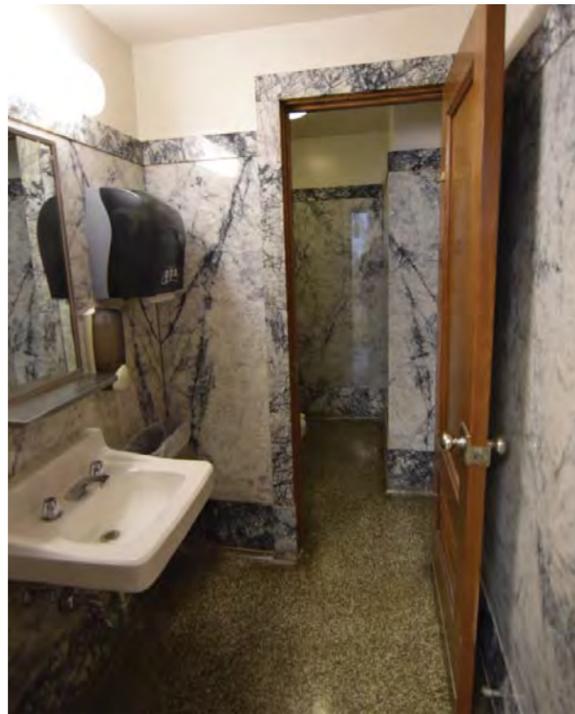
*Typical Plumbing Fixture Examples*

The current fixtures themselves are in fairly good operating condition. There is concern with hot water delivery times that falls on the domestic water piping configuration and not the fixtures themselves.

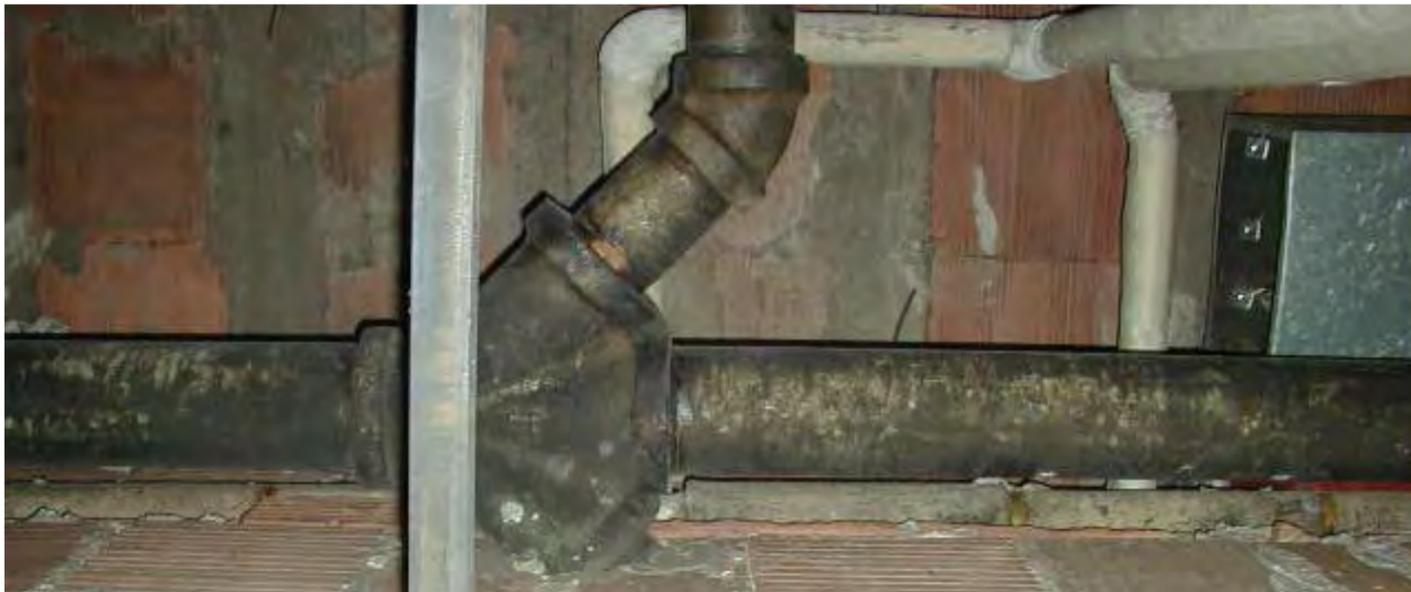
Cast-iron sanitary waste piping. CPL photo, February 13, 2001.
