**KING COUNTY COURTHOUSE REVITALIZATION  
BUILDING SYSTEMS REPORT**

# King County Courthouse Revitalization

## Building Systems Report

Ordinance 18239 Section 41 Proviso P5 Response  
Project No. 1124472

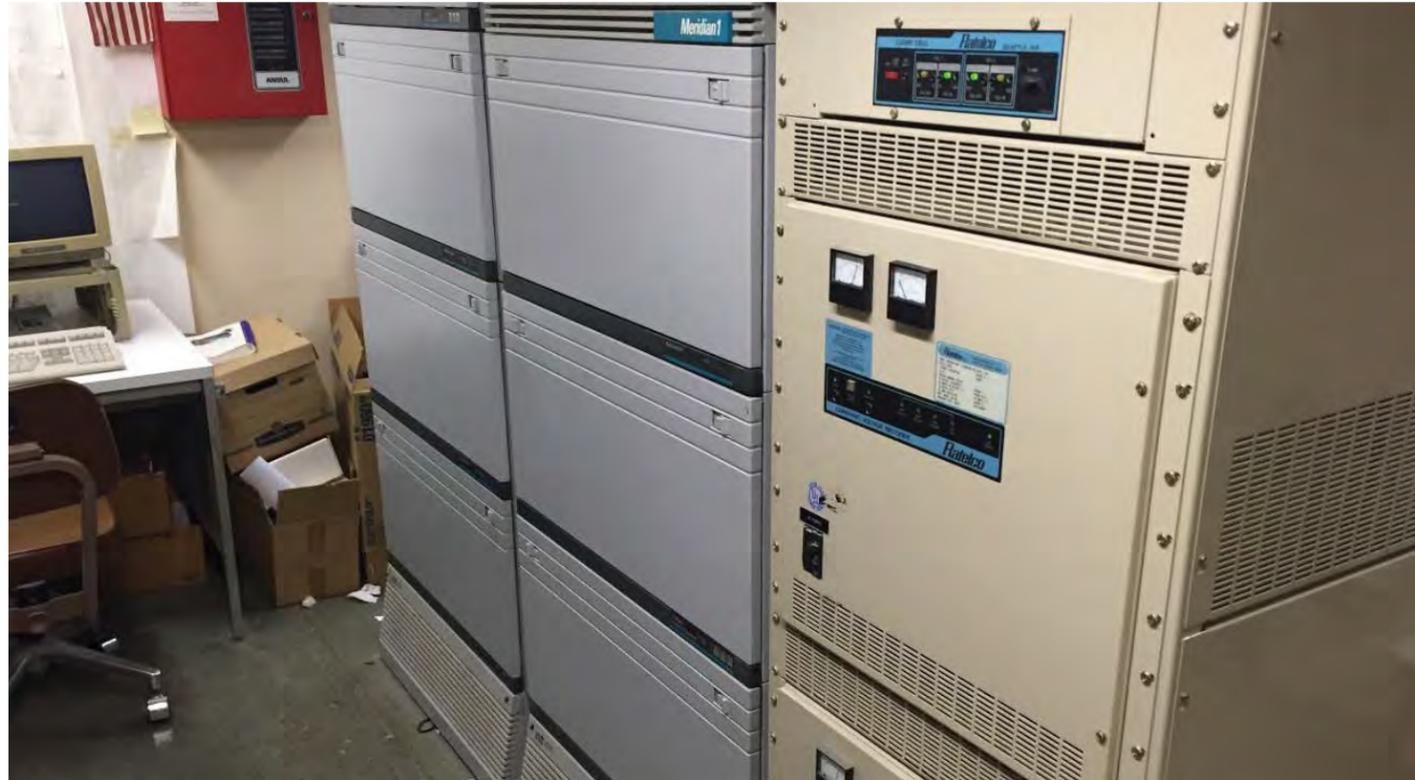
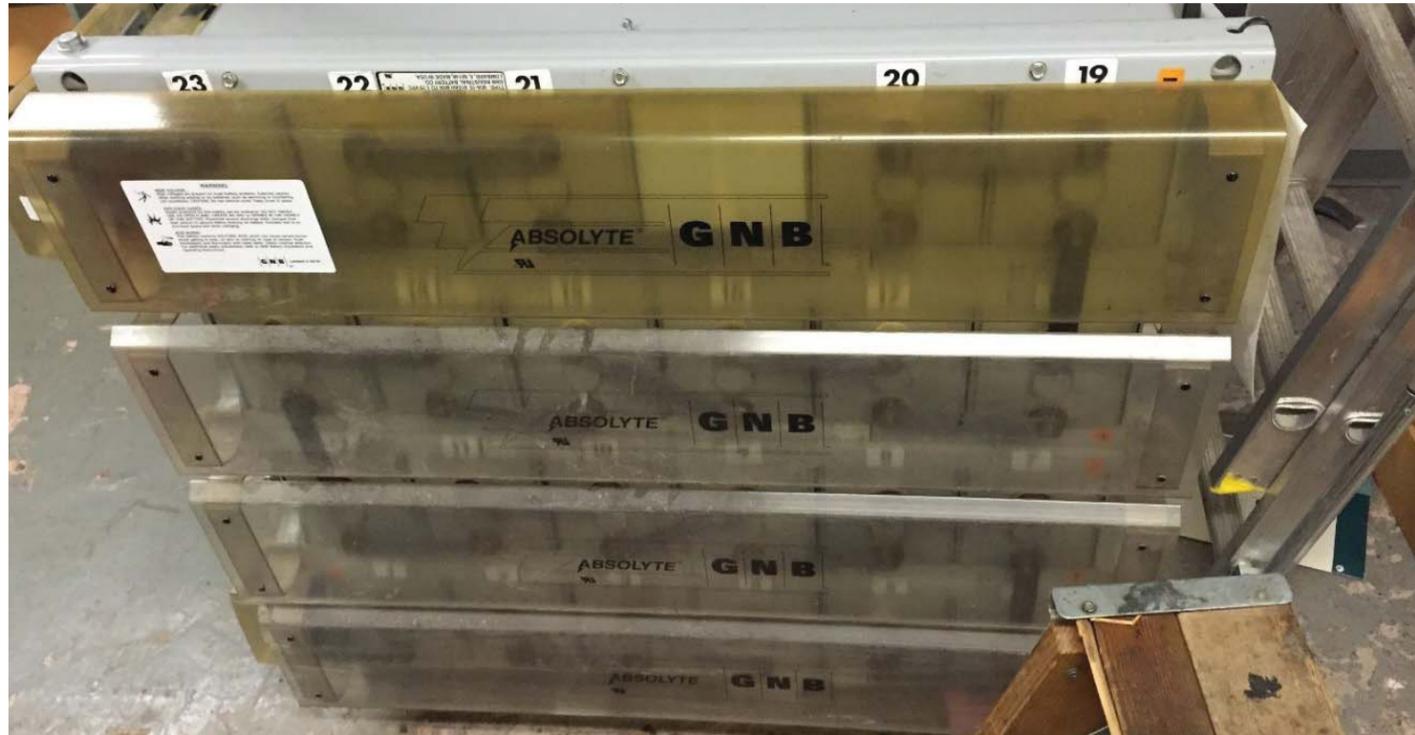
In spite of their obsolescence, abandoned systems and equipment appear to be in operating condition. One exception are battery banks for outdated Uninterruptable Power Supplies which require regular testing and maintenance for reliable operation. Reference FIGURES 6 and 7.

**FIGURE 7** Out of use Uninterruptable Power Supply (UPS) system and associated battery stack

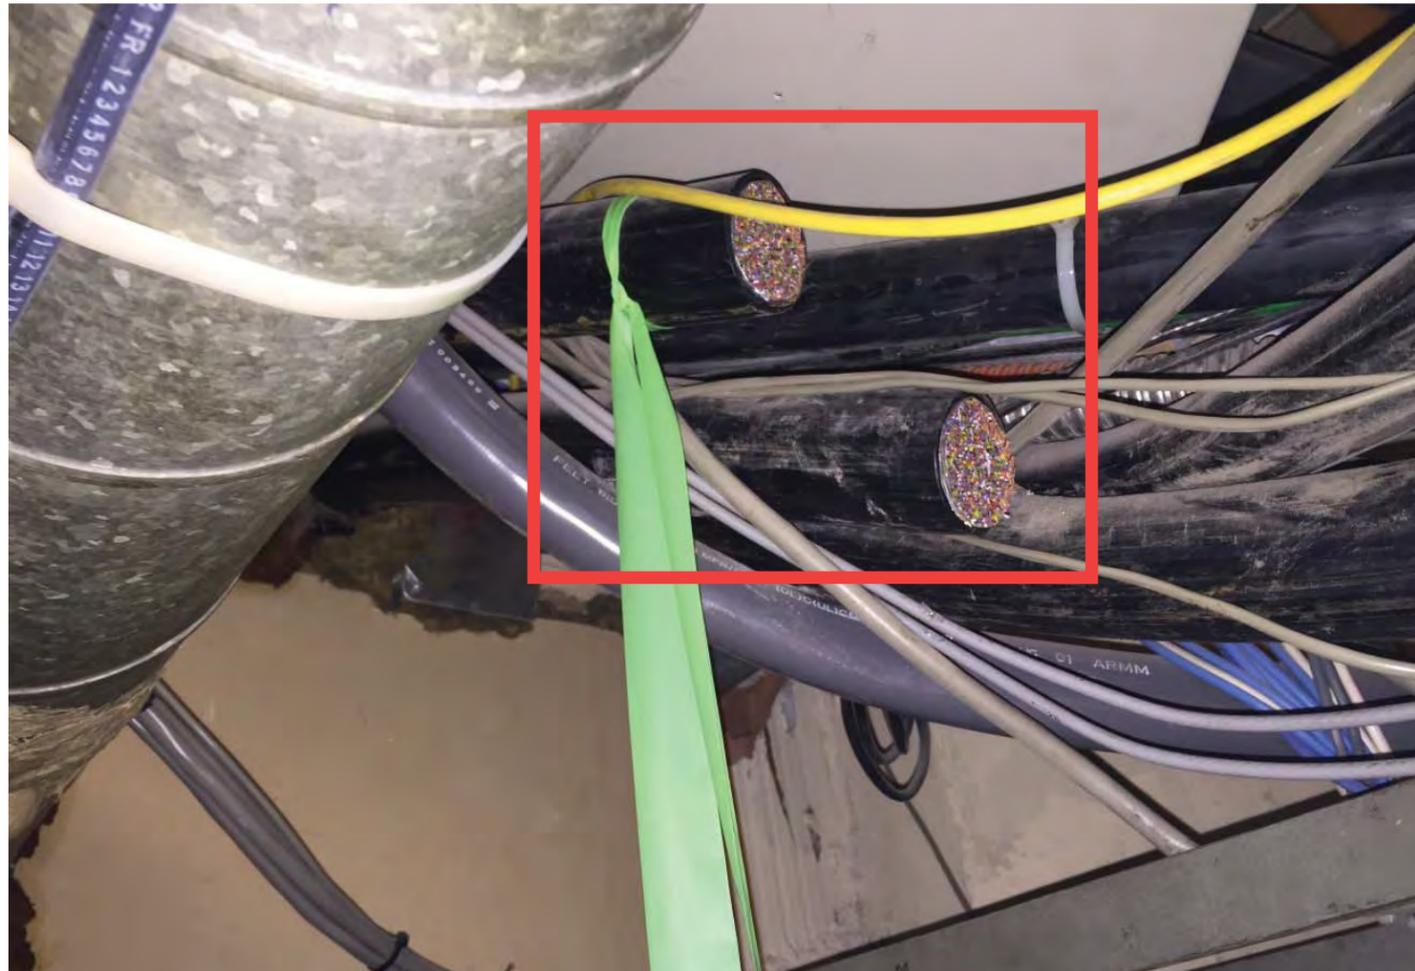
There are thousands of feet of abandoned cabling in place in varying conditions, from fully functional to degrading, to fully severed. Reference FIGURES 8 and 9.

**FIGURE 8** Communication cables have been severed and abandoned in place

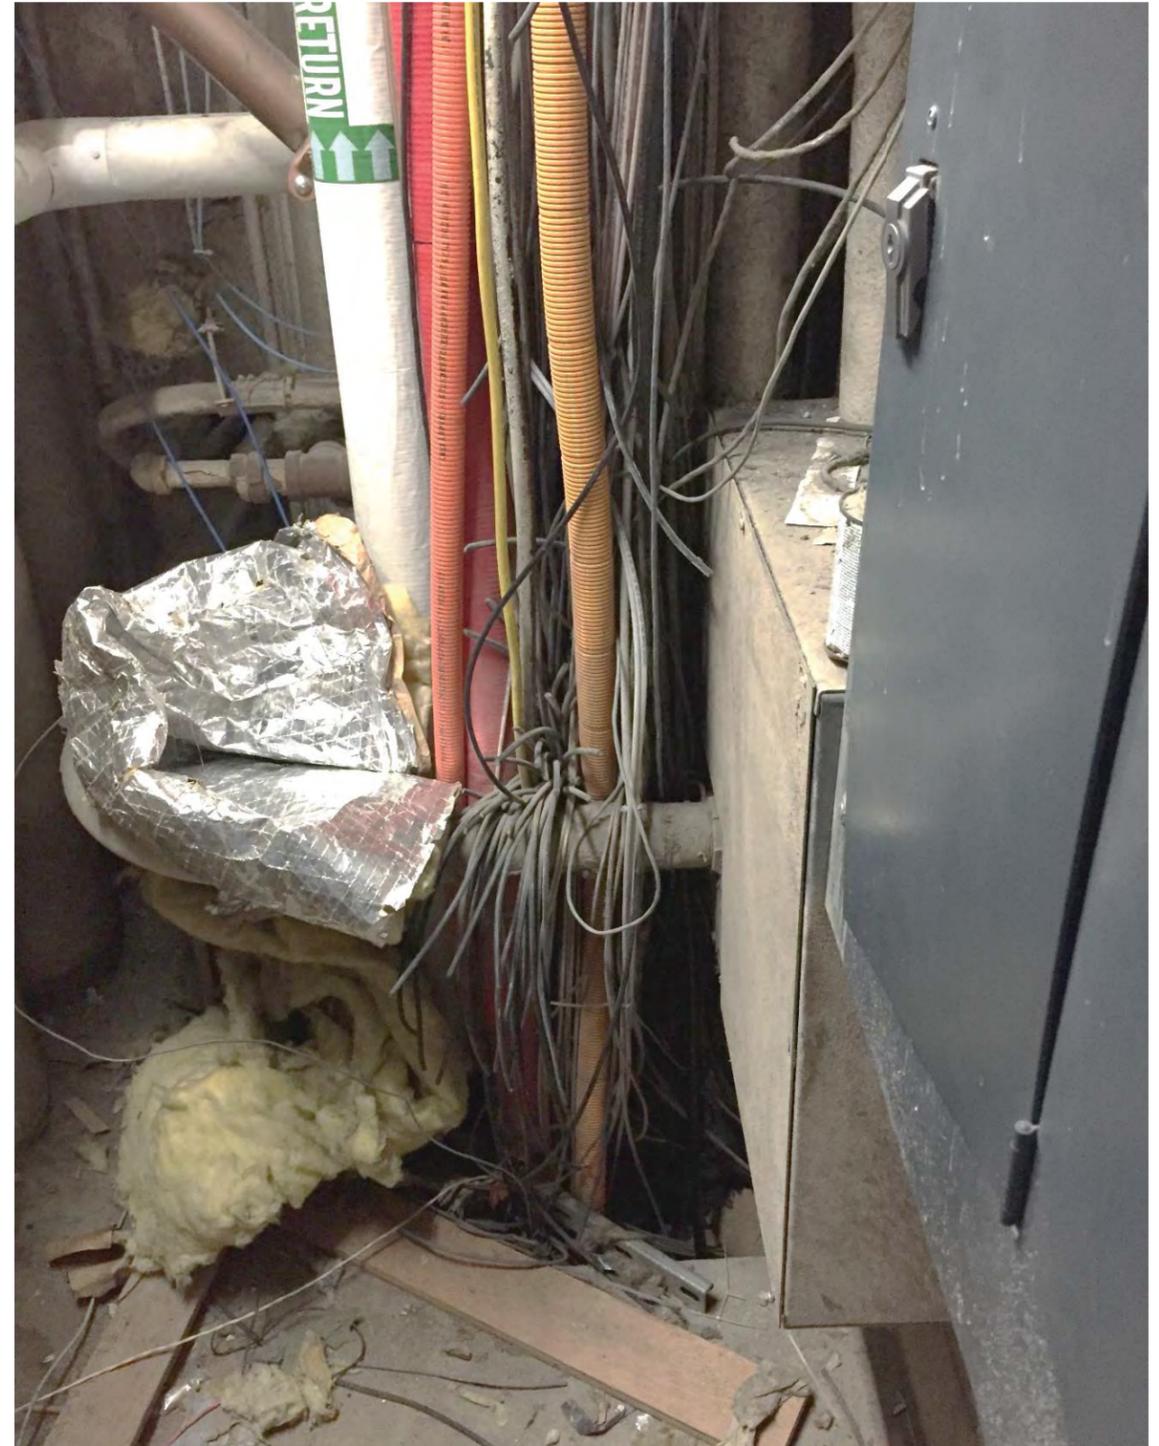
**FIGURE 9** Vertical cable run in mechanical chase. Abandoned and severed cables are run alongside operational functioning cables, along with construction debris. The National Electrical Code (NEC) requires removal of abandoned communications cabling

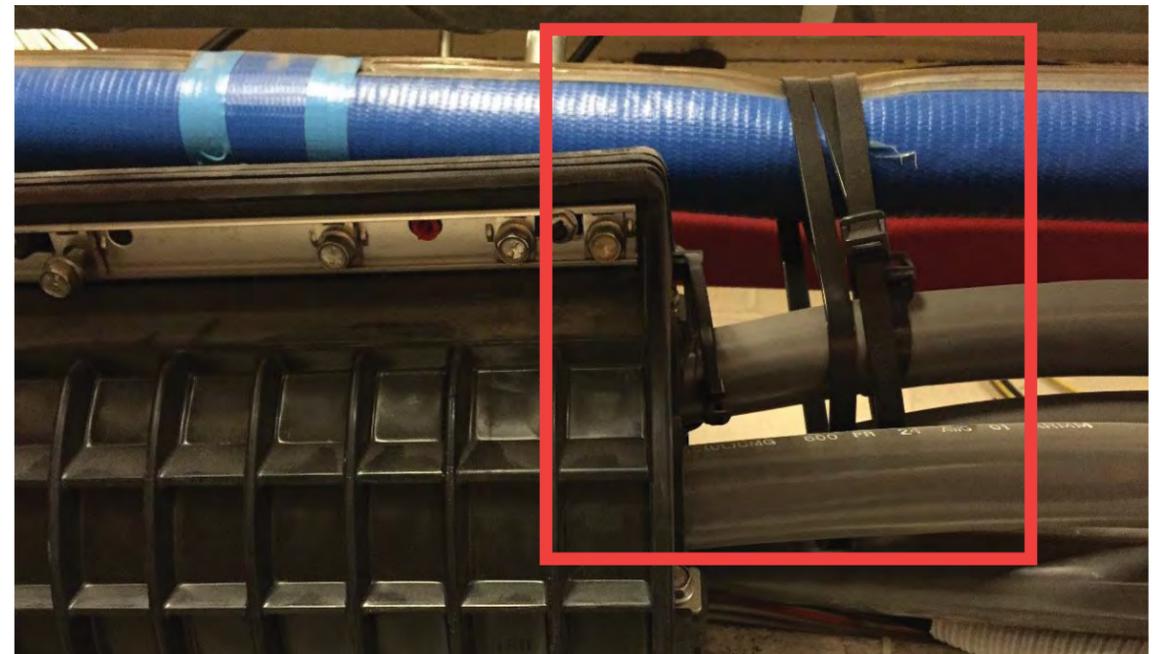
As systems have been upgraded, expanded and re-worked, low-voltage cabling has ended up in unsuitable locations, using inappropriate support methods, including equipment and piping from other trades. These conditions are pervasive throughout the facility, but are especially apparent on the basement level, where the highest concentration of cables is found. Reference FIGURES 10 and 11. Additionally, communication rooms throughout the facility use a proprietary patching and cable management system in lieu of standard Registered Jack 45 (RJ-45) patchbays. Reference FIGURE 12.

**FIGURE 11** A telephone cable splice is supported by cold water piping

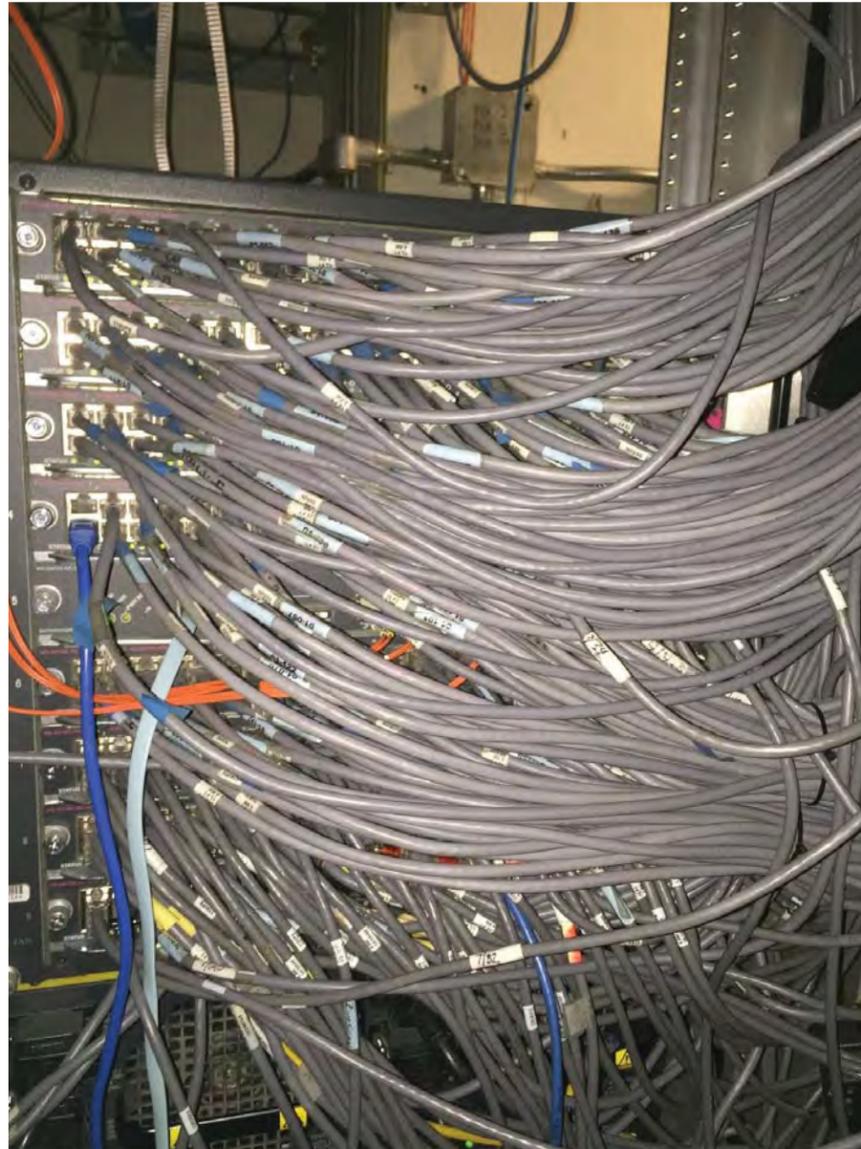
The equipment and cabling in question is currently functioning properly; detrimental effects from poor cable management are long-term and are often related to the operation of a facility. Though the systems are currently functioning, FIGURES 12 and 13 illustrate the difficulty both in poor cable management and the proprietary patching system. The patching system currently in use takes up a greater amount of wall-space per outlet than standard Registered Jack 45 (RJ45) connections. Non-standard cable management equipment has created an unorganized installation. Negative outcomes from poor cable management include damage to cables from excess bending, movement or sharp edges, excess tangles of cable blocking access to spaces and equipment and restricting airflow, an increase in maintenance time as cables have to be traced and identified repeatedly, and increased difficulty tracing and identifying cables. Improper support and placement of cables can reduce the effective life of the cables for all the reasons listed above. Reference FIGURES 13 & 14.

**FIGURE 14** Unmanaged cabling has been allowed to accumulate into a tangled mess, blocking access to equipment and increasing maintenance times.

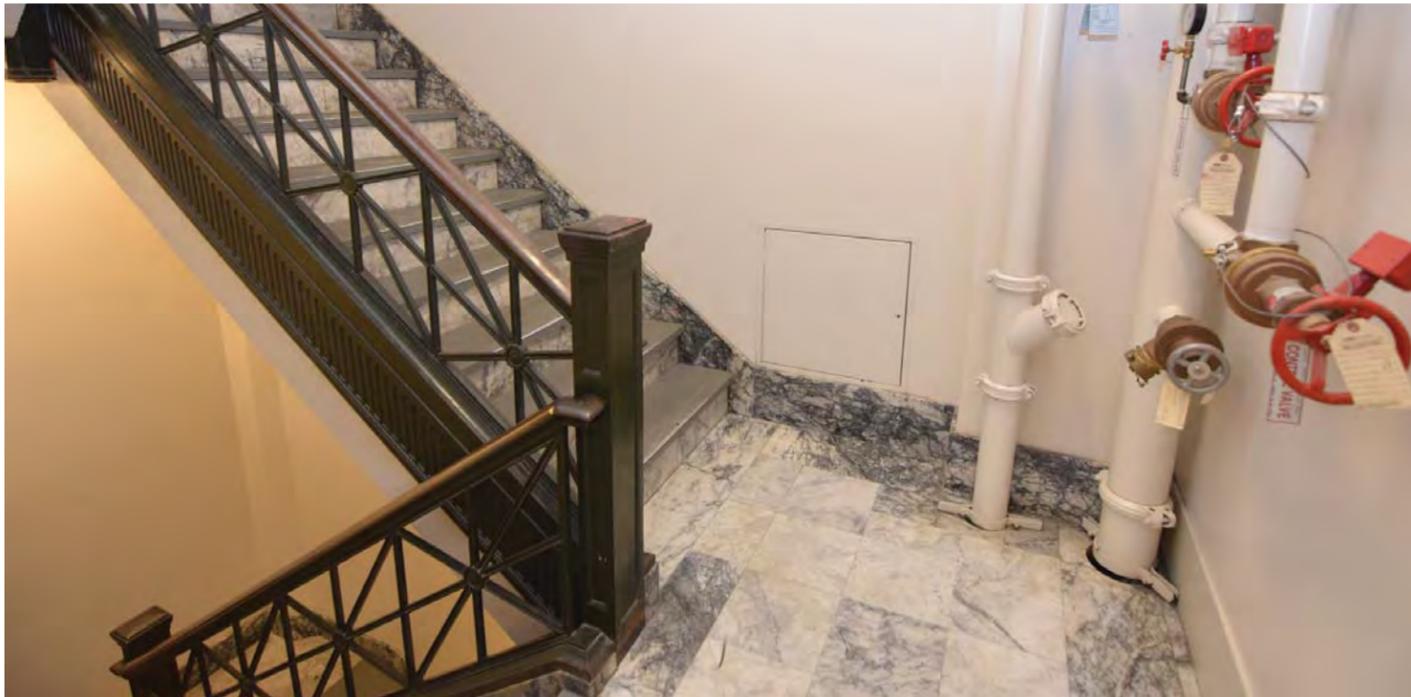
Photo of Stair 4 at level 5. The existing handrail is non-code compliant and may need to be upgraded if the building is substantially altered. CDG photo, May 7, 2016.

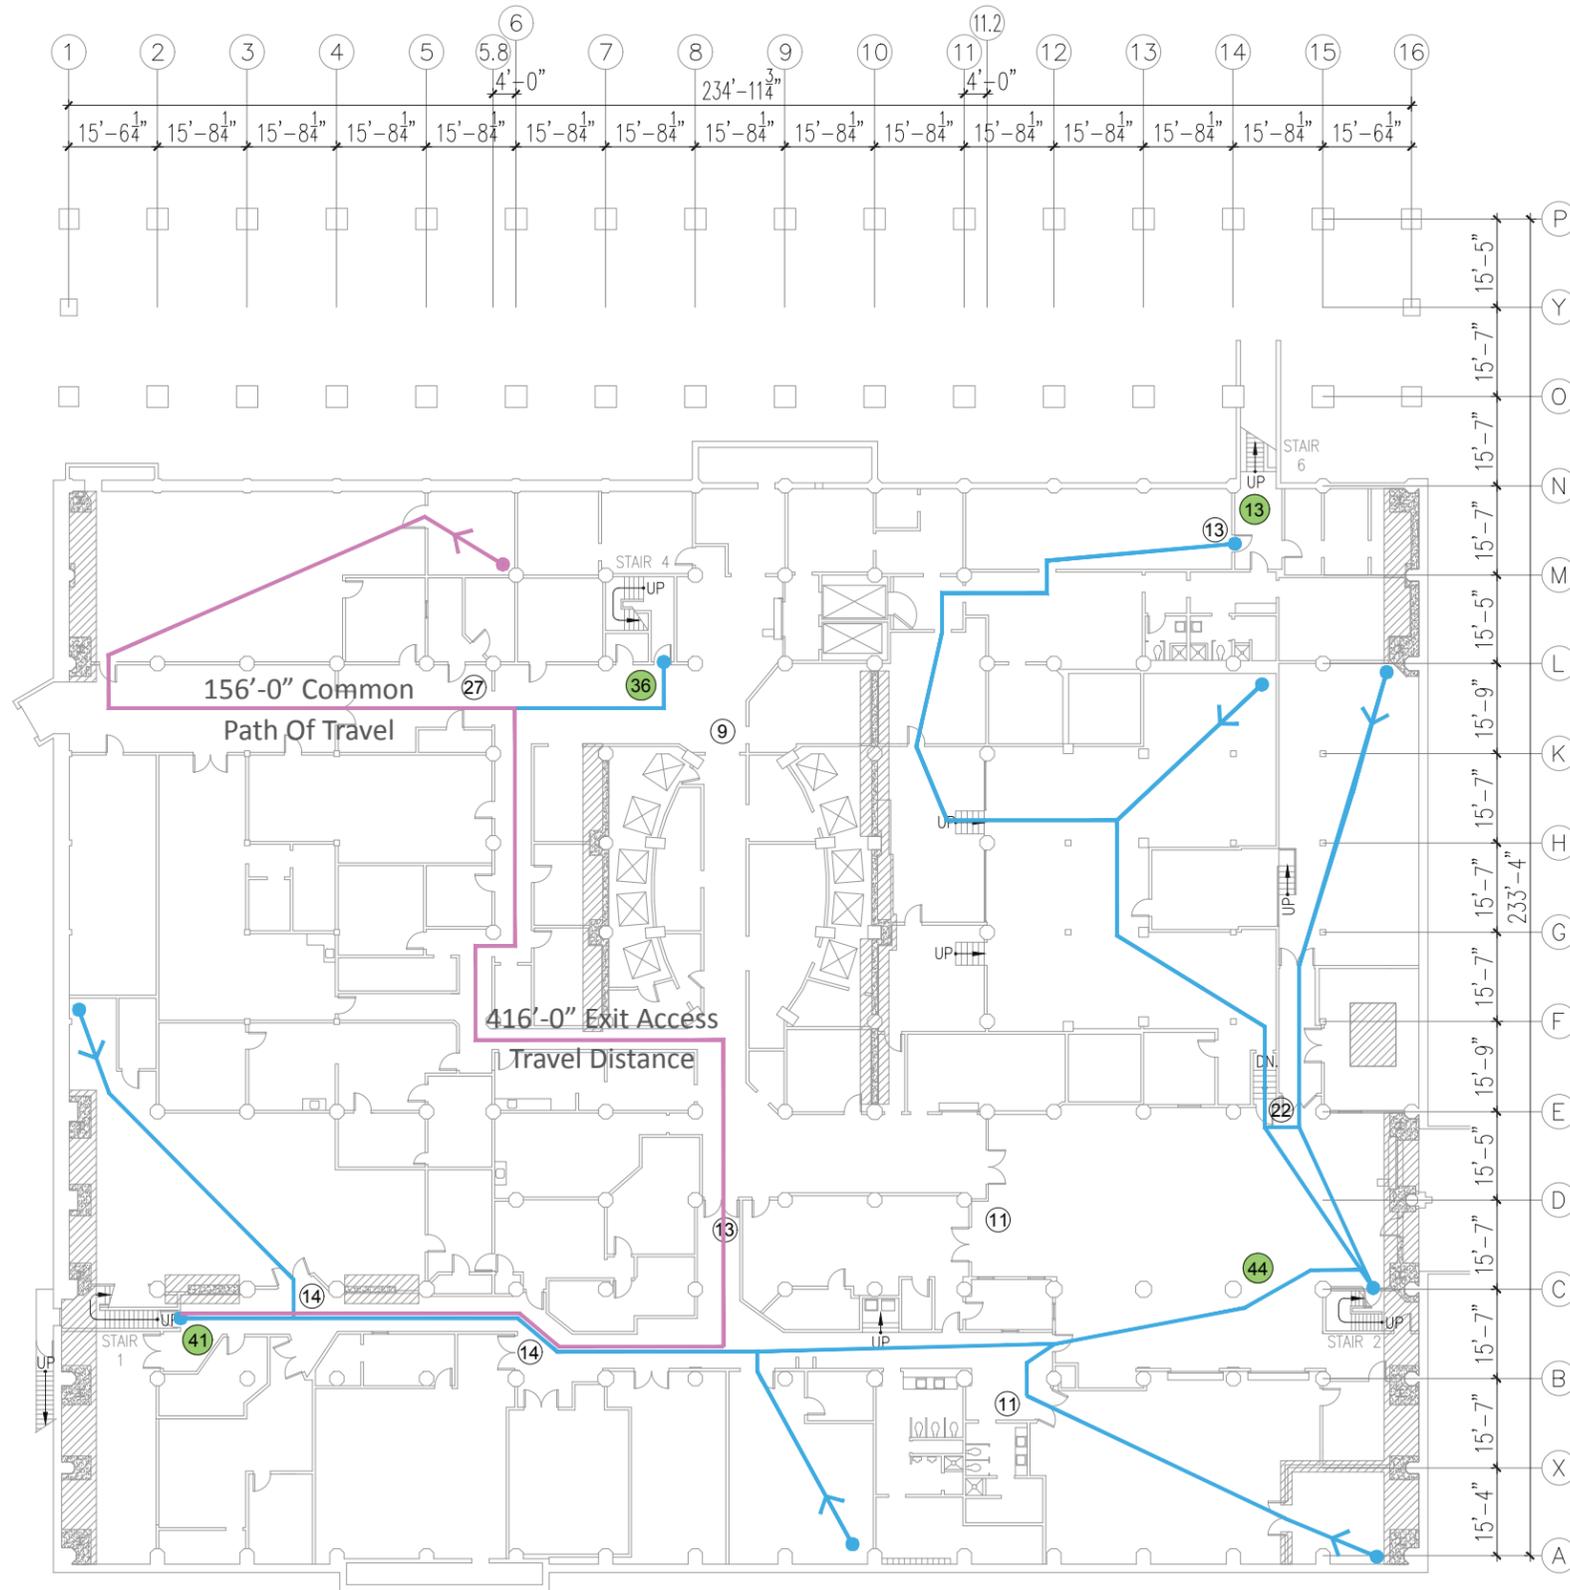
MECHANICAL PENTHOUSE

**Note:**  
 Maximum Common Path of Travel Distance Required For a Single Exit = 100'-0". Travel Distance Provided = 156'-0". Two Exits Are Required. Maximum Exit Access Travel Distance For Both Exits = 300'-0". Second Nearest Exit Travel Distance = 416'-0". Second Exit Does Not Comply. Further Review Required. (SBC: table 1014.3 & 1016.2)

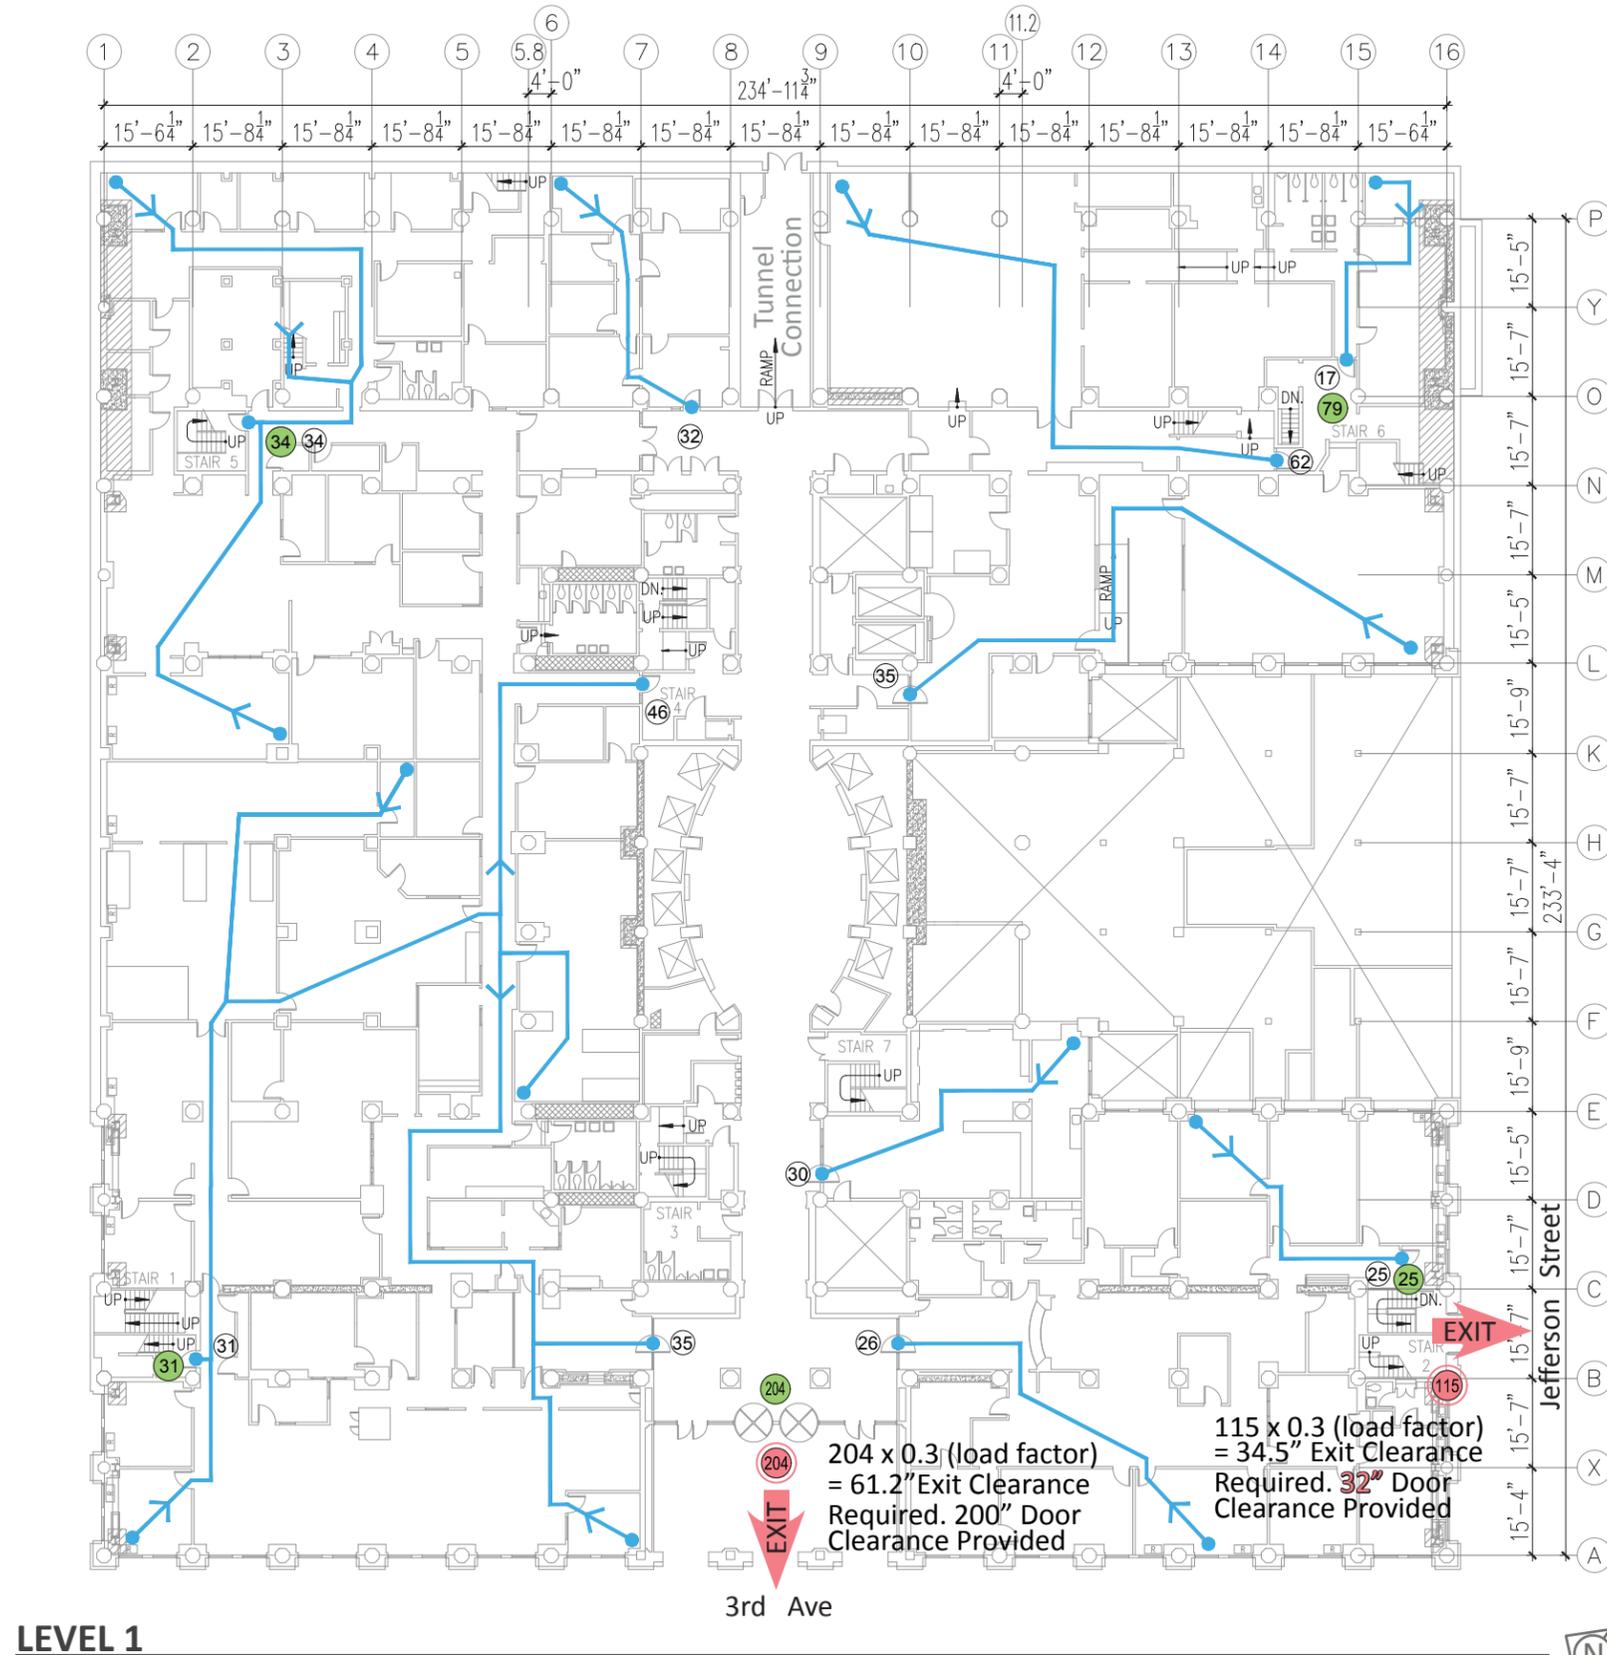
LEVEL 1

**Note:**  
 Jefferson Street Exit Clearance Required = 34.5". Exit Door Clearance Provided = 32". New 3'-6" Wide Door Recommended. Further Review Required. (SBC: 1005.3.1)

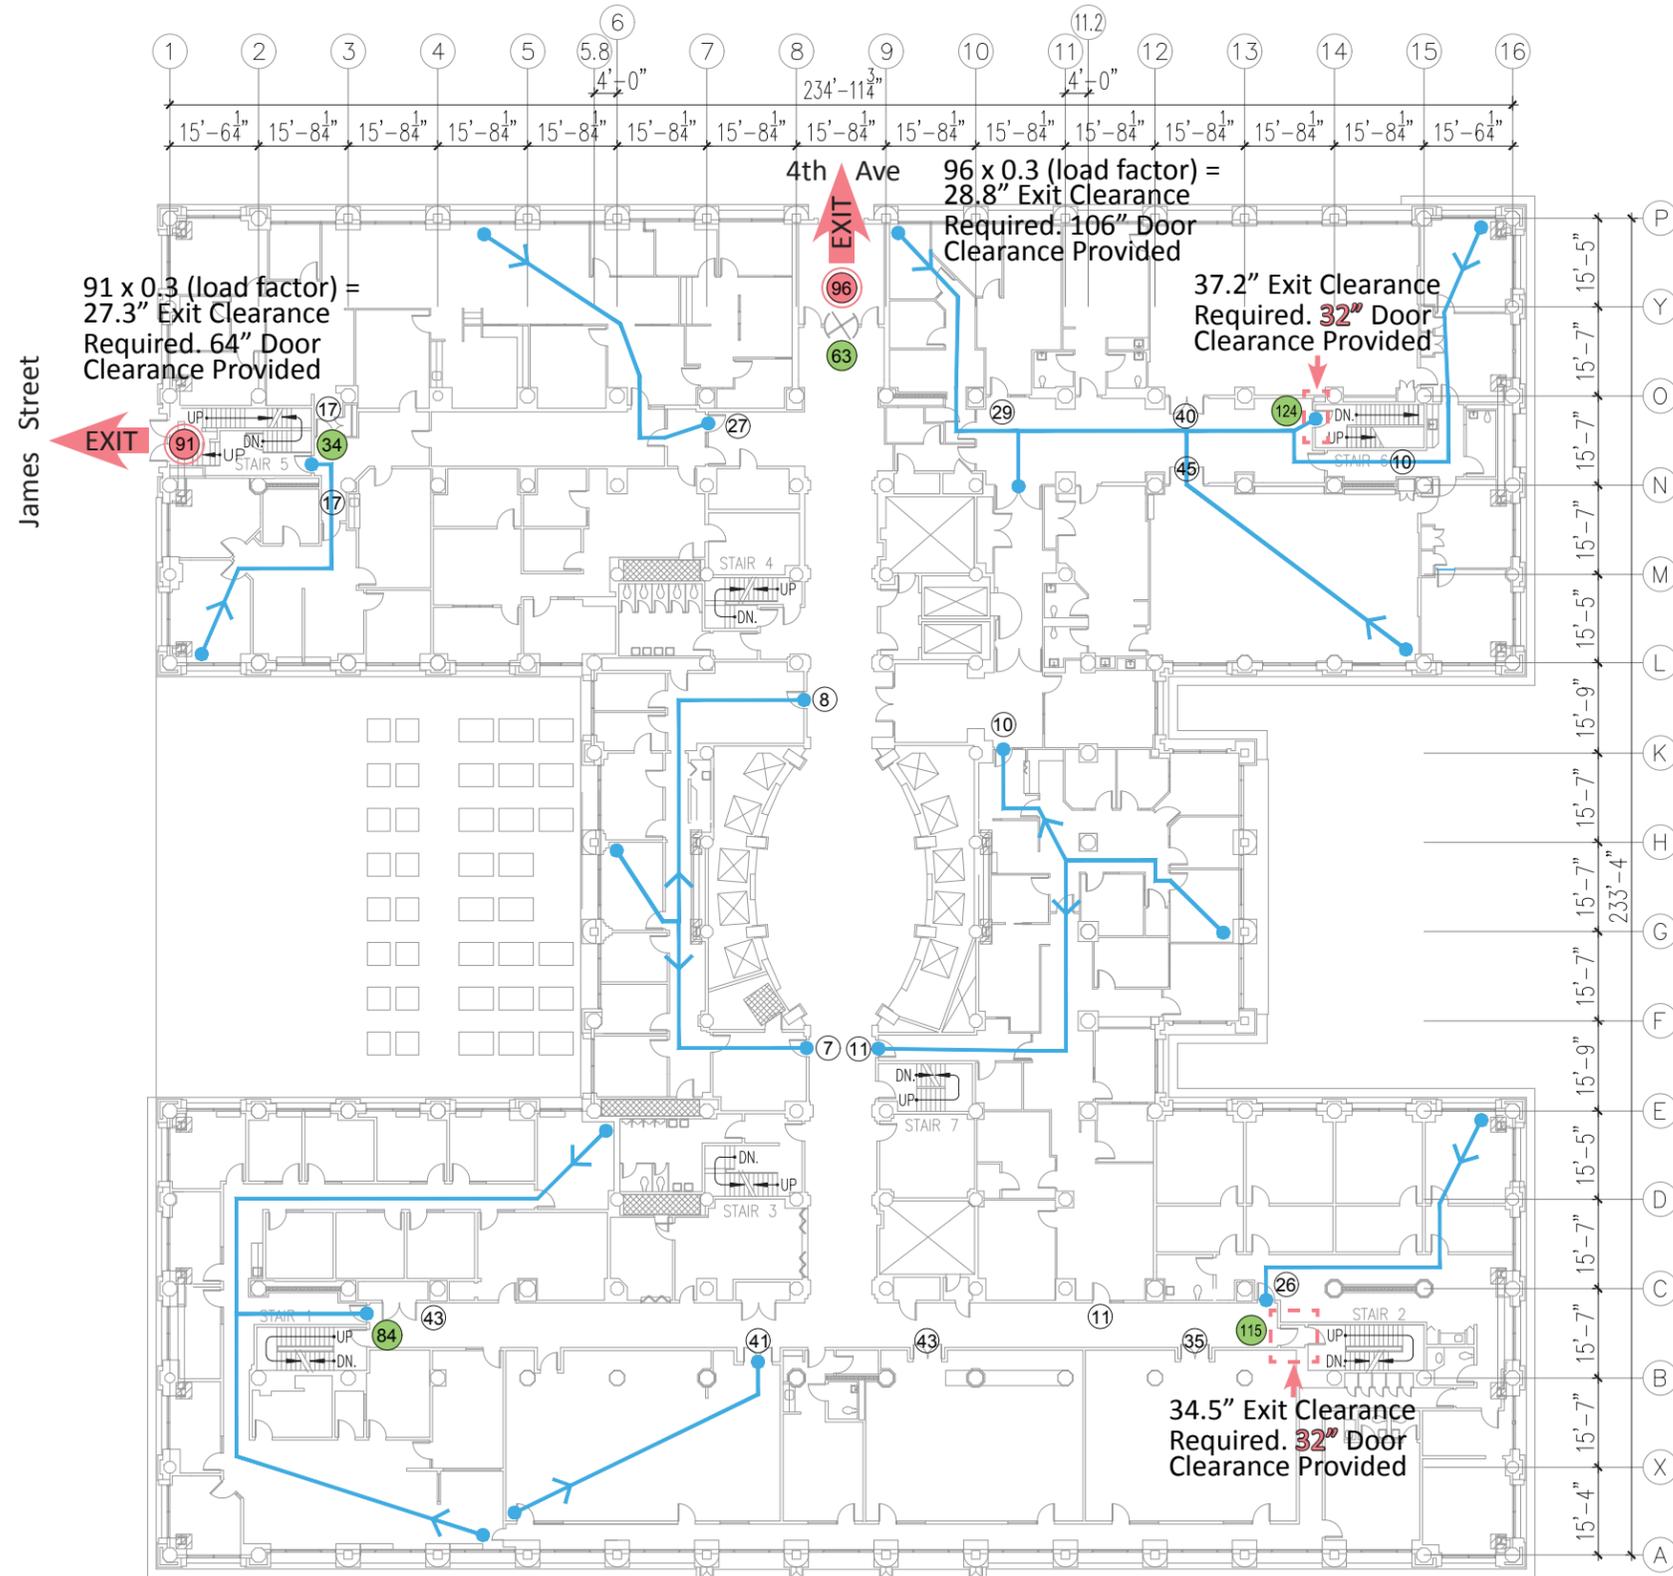
LEVEL 2

**Note:**  
 Exit Clearance Required For Stair 2 = 34.5". Exit Door Clearance Provided = 32". Exit Clearance Required For Stair 6 = 37.2". Exit Door Clearance Provided = 32". New 3'-6" Wide Doors Recommended. Further Review Required. (SBC: 1005.3.1)

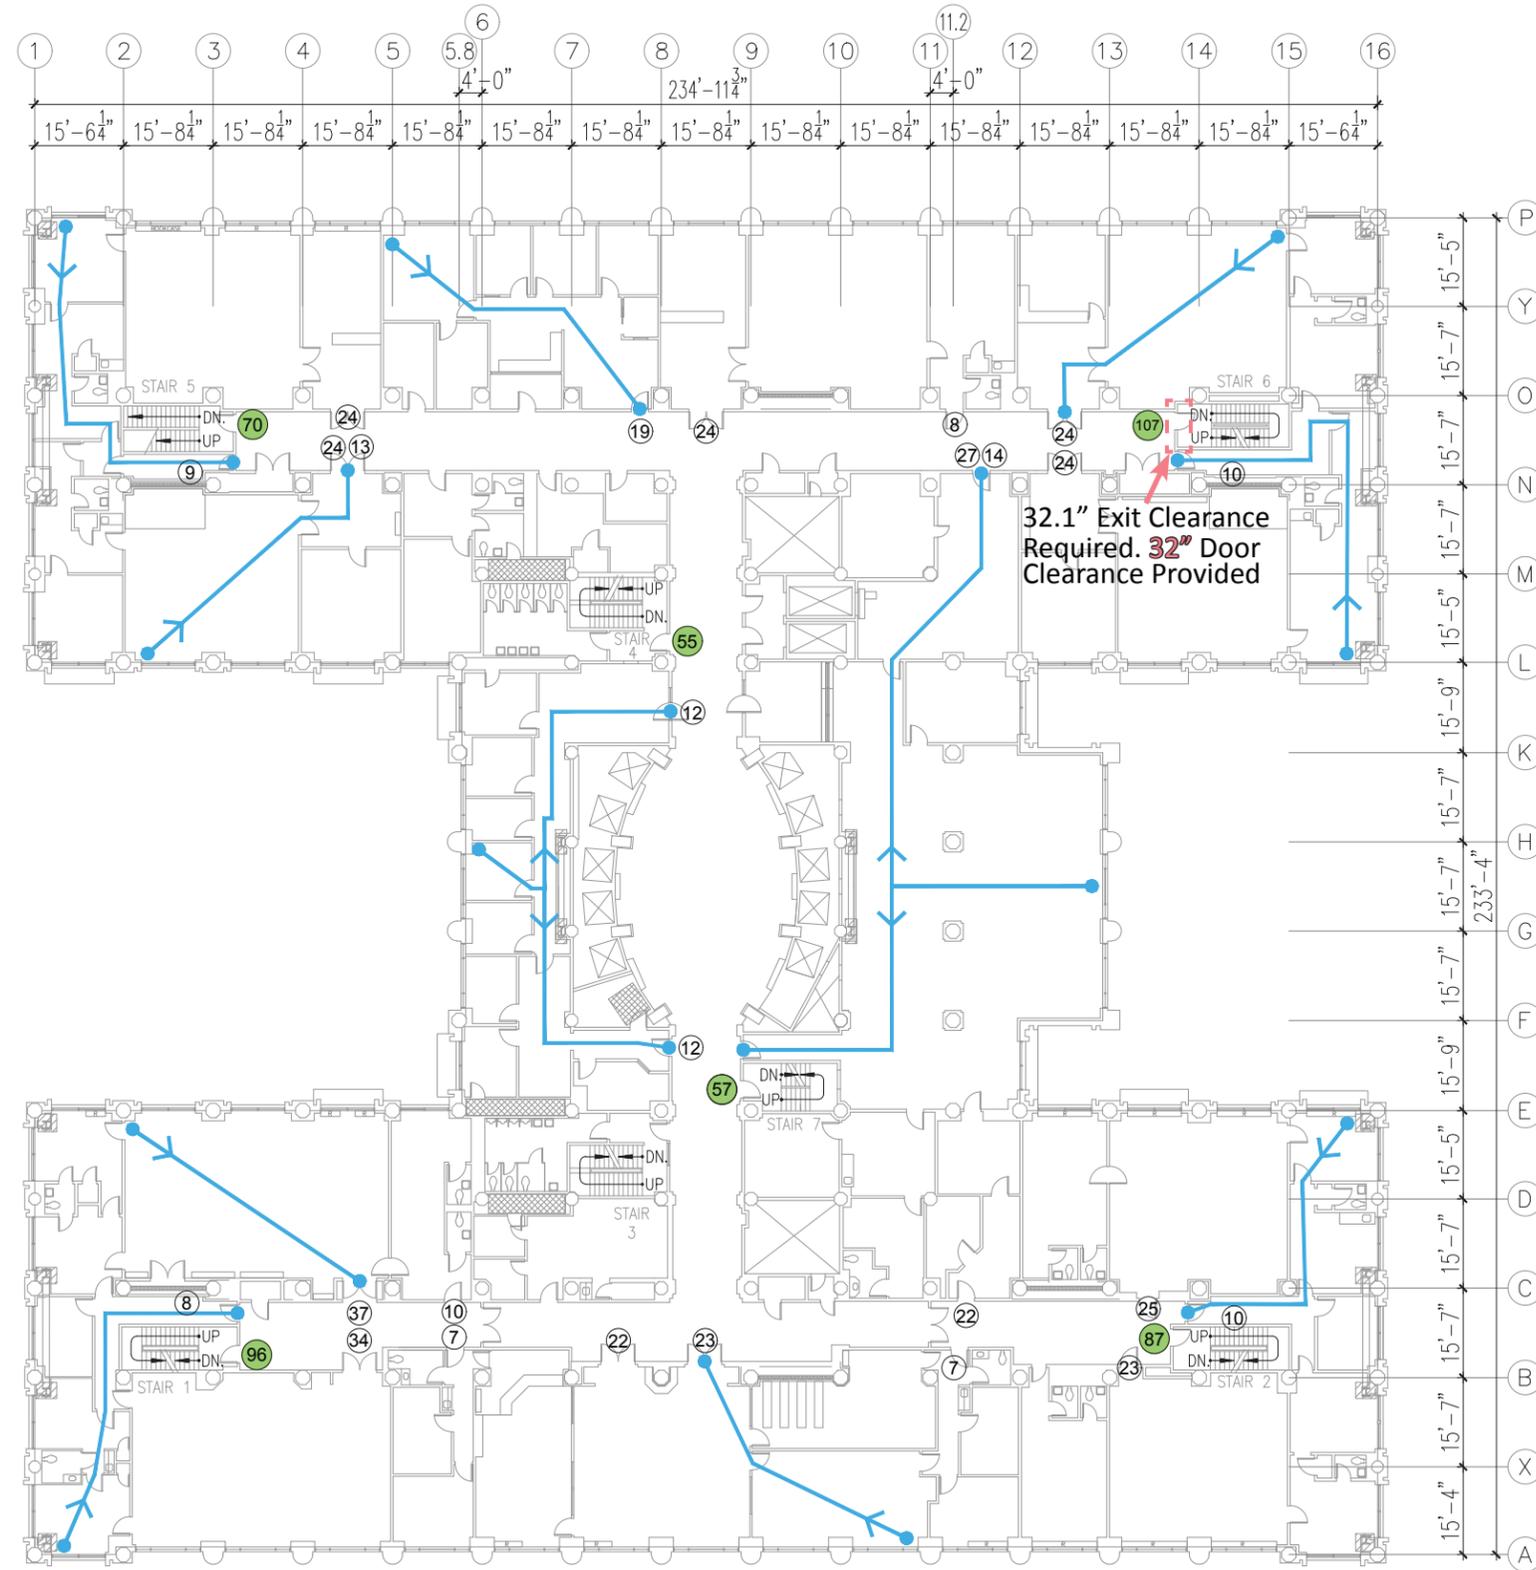
**LEVEL 3**

**Note:**  
 Exit Clearance Required For Stair 6 = 32.1". Exit Door Clearance Provided = 32". New 3'-6" Wide Door Recommended. Further Review Required. (SBC: 1005.3.1)

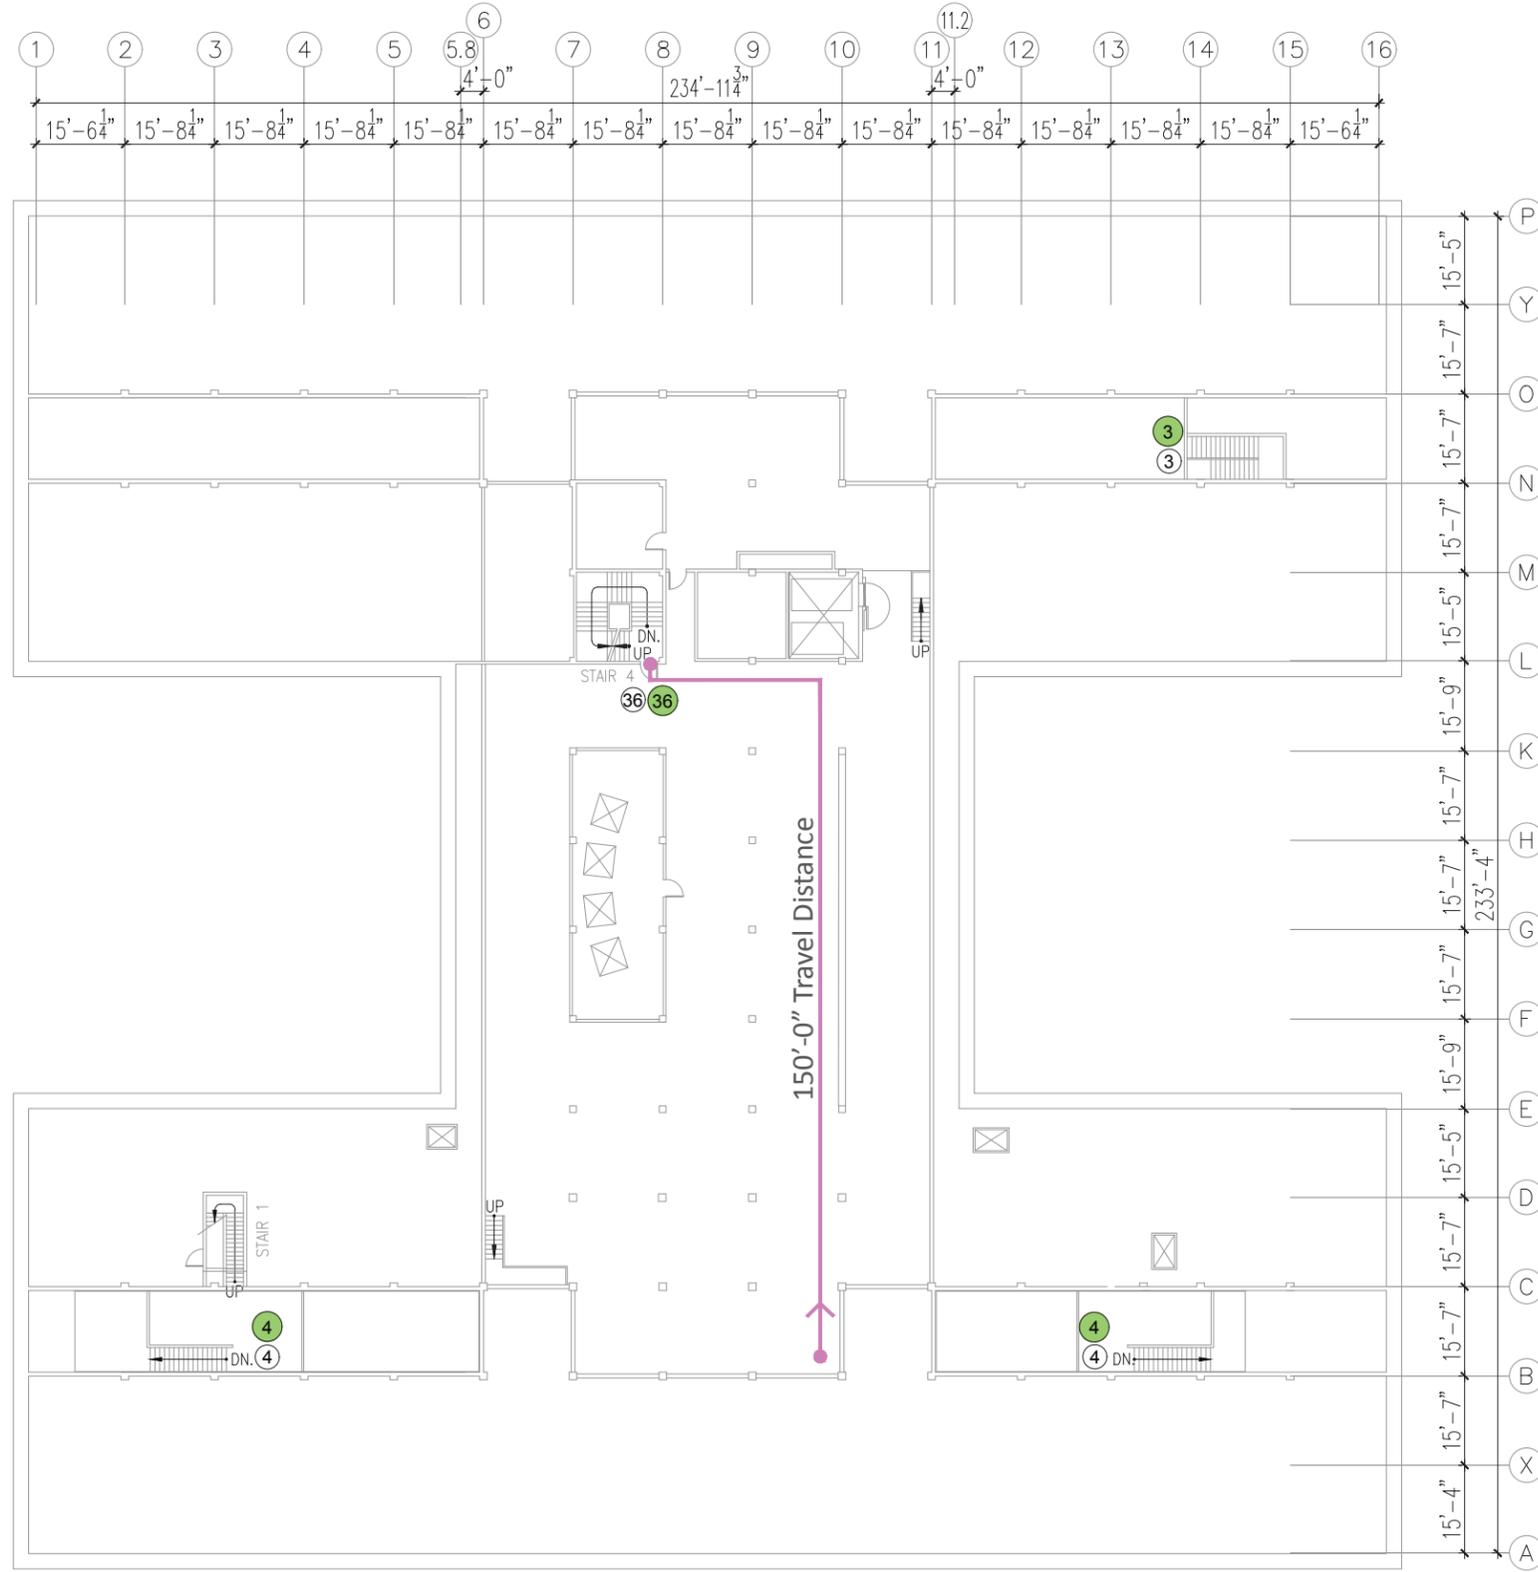
**MECHANICAL PENTHOUSE**

**Note:**  
 Maximum Common Path of Travel Distance Required For A single Exit = 100'-0". Exit Distance Provided = 150'-0". Two Exits Are Required. Further Review Required. (SBC: table 1014.3 & 1016.2)

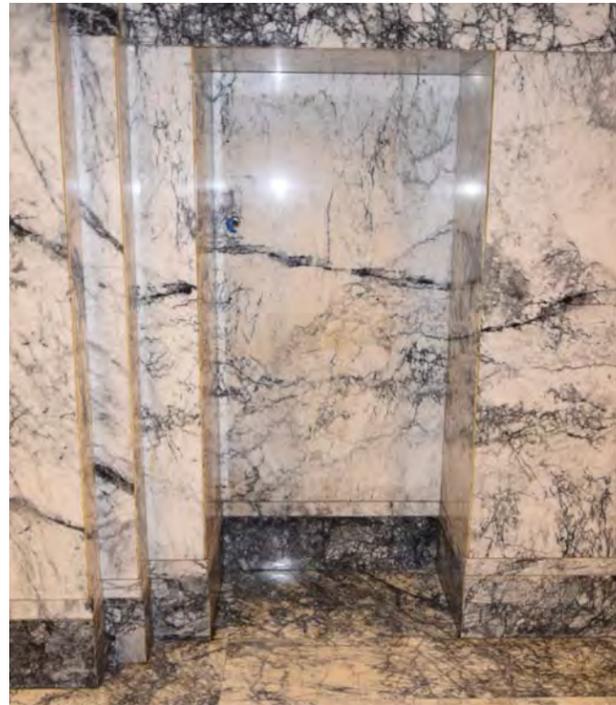
West corridor at level 9, looking north. Former location of drinking fountain. CDG photo, April 16, 2016.

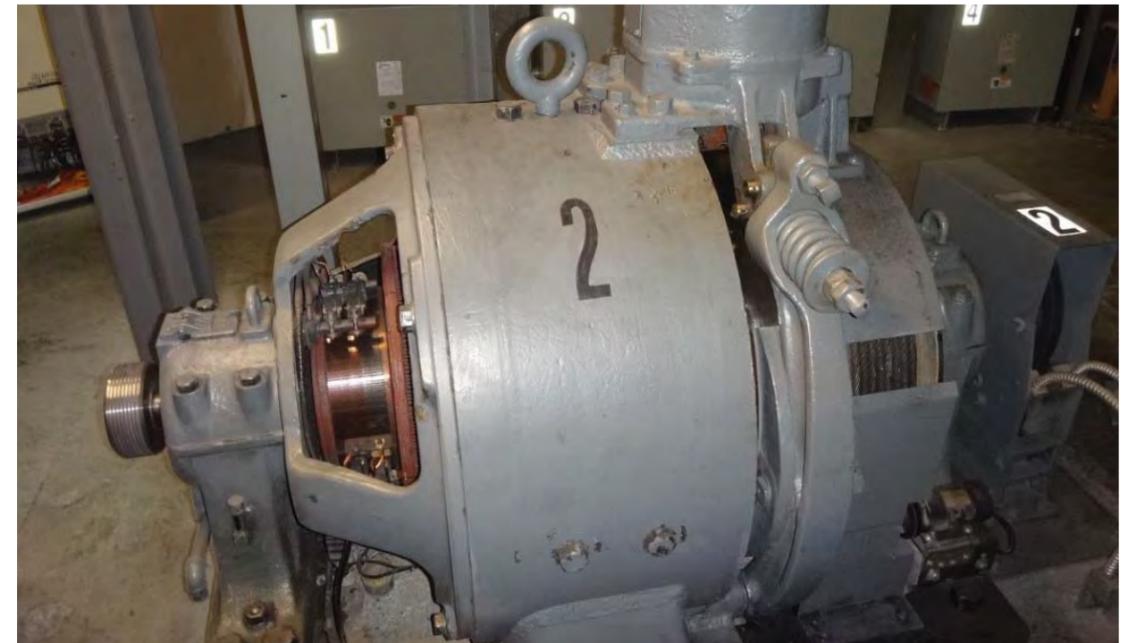
Figure 2 – Original Westinghouse Gearless machines for Cars 1-10 appear to have been installed during the 1960 modernization of the Court.
