**KING COUNTY COURTHOUSE REVITALIZATION  
BUILDING SYSTEMS REPORT**

# King County Courthouse Revitalization

## Building Systems Report

Ordinance 18239 Section 41 Proviso P5 Response  
Project No. 1124472

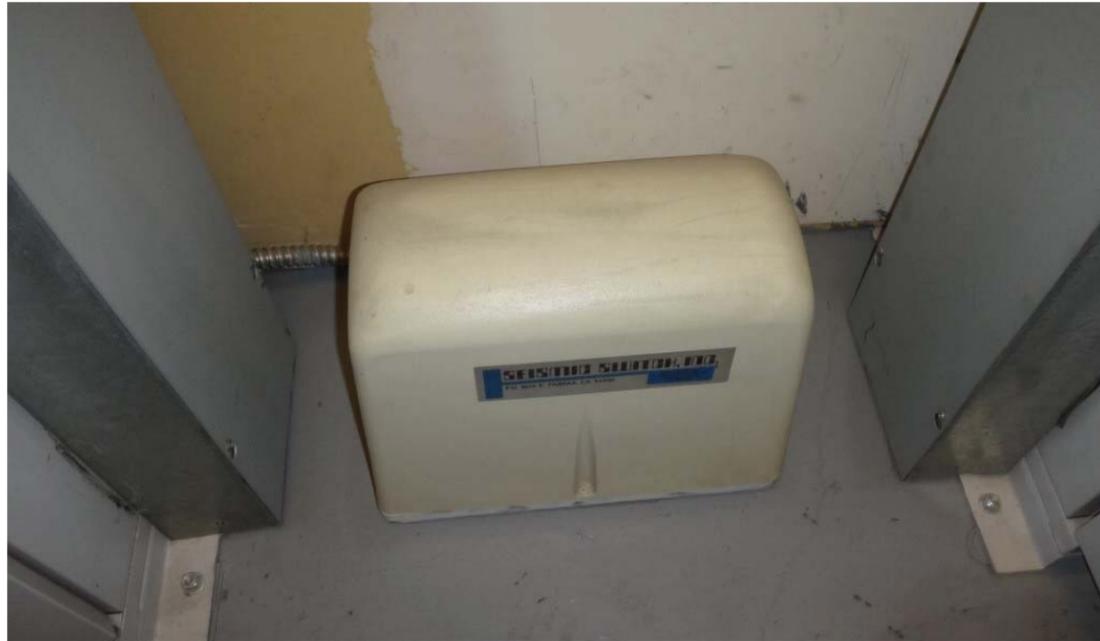
Figure 3 – Seismic switch installed during the modernization in 2004/05.

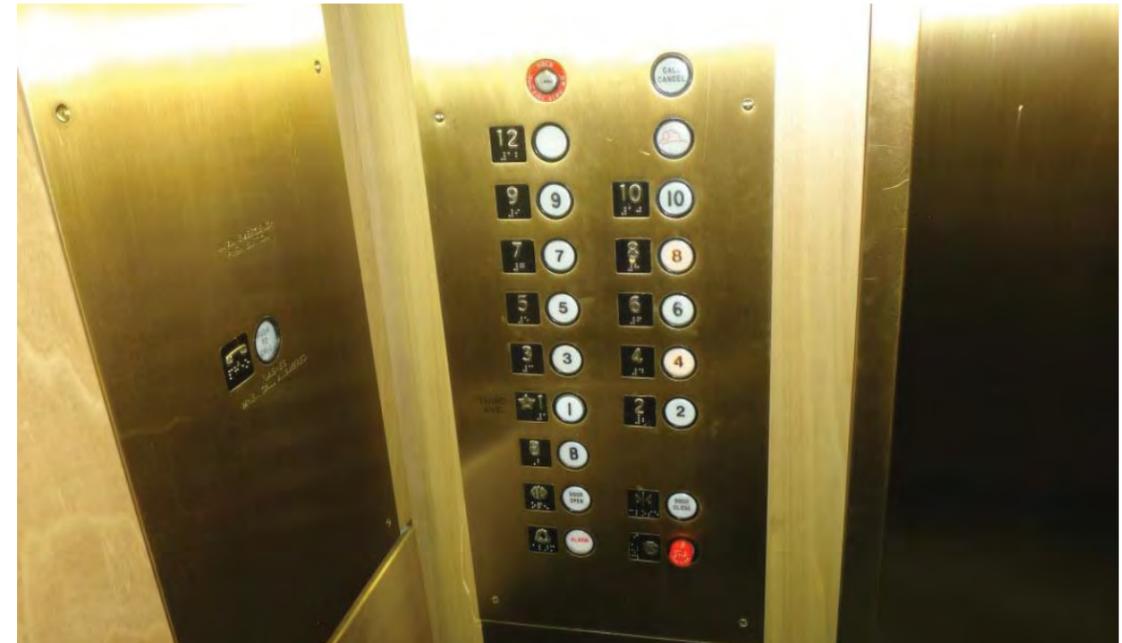
Figure 6 – Bronze fixtures installed in 2004/5 during modernization Meet code except for push/pull stop switch.

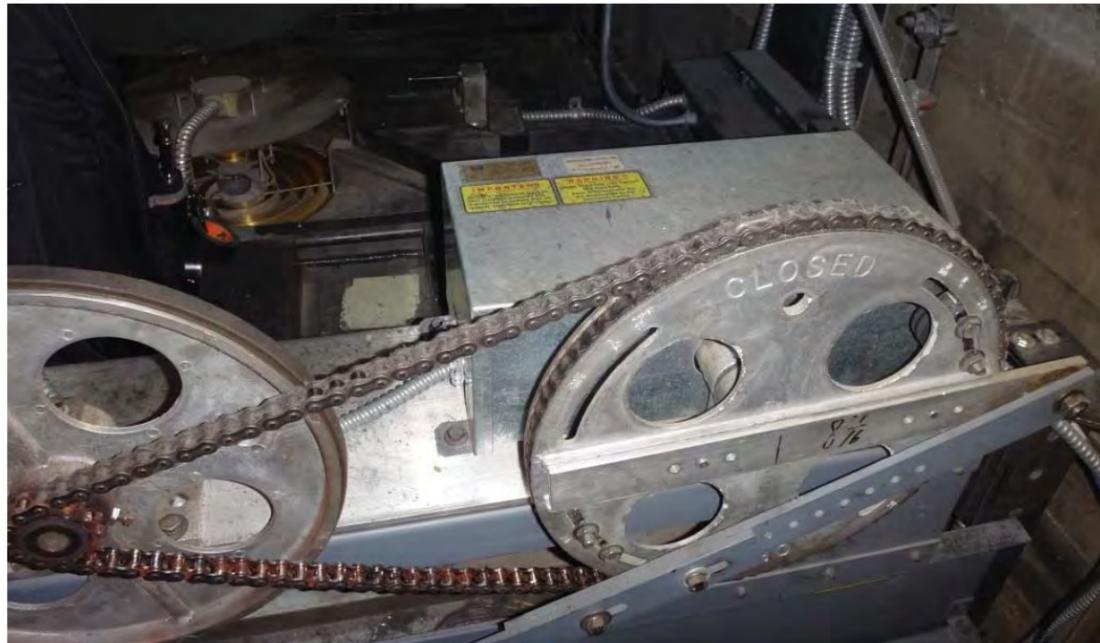
Figure 8 – GAL MOVFR closed loop door operators installed during modernization in 2004/5.

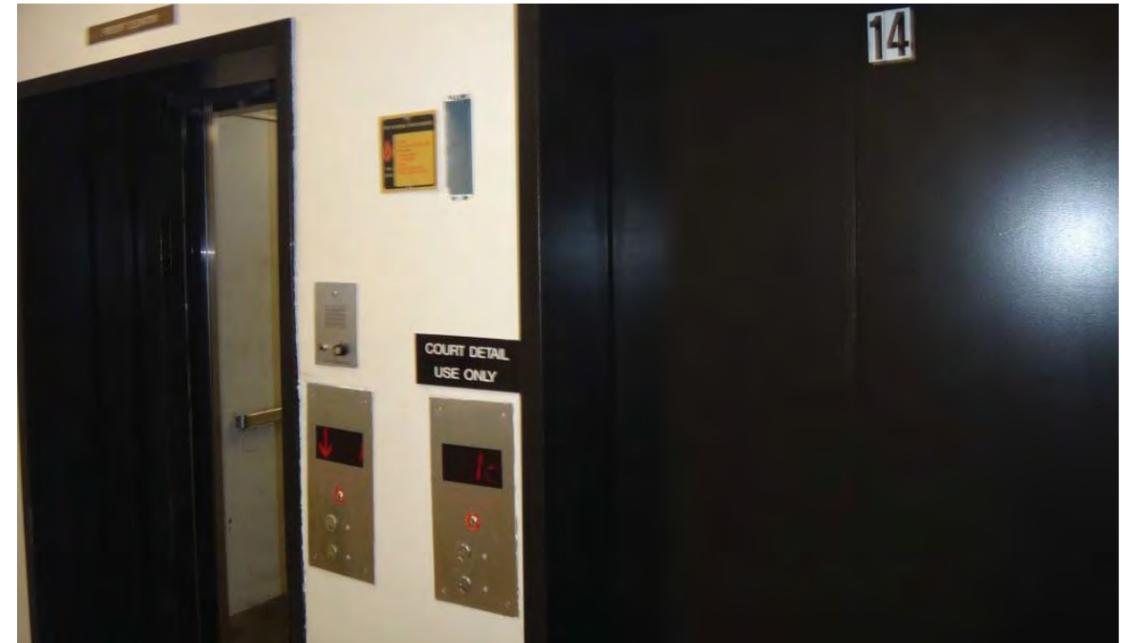
Figure 10 – Entrances to service Car 11 and Inmate Car 14. No jamb braille

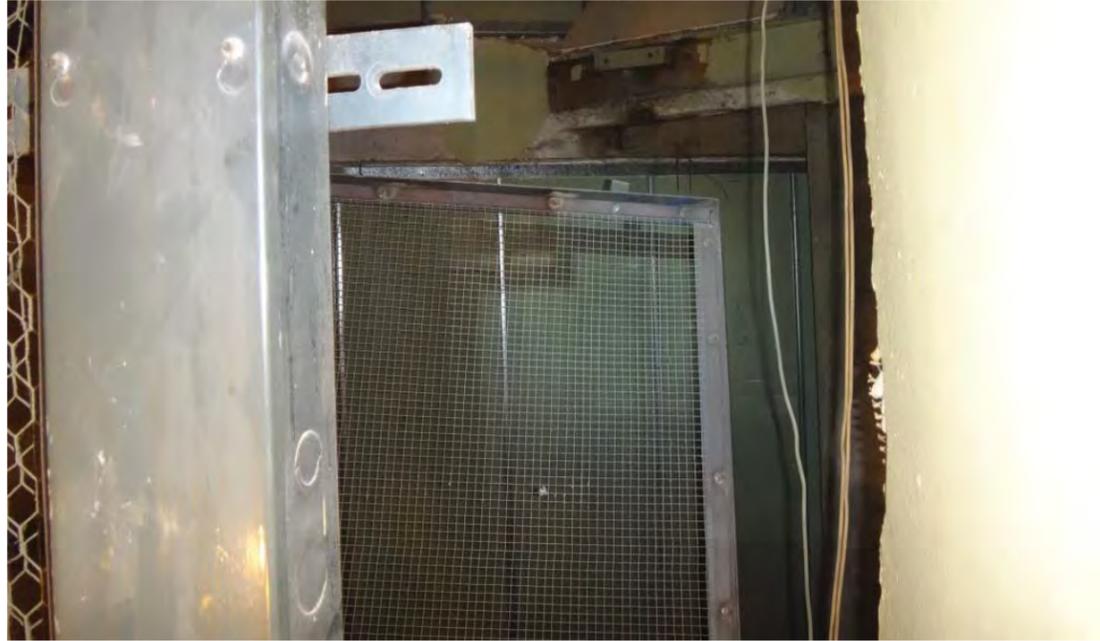
Figure 11 – Part of hoistway screening between Cars 9 and 10 is coming down and should be re-anchored.

Car #	GENERAL MAINTENANCE DEFICIENCIES	COMPLETED	DATE CHECKED
10.3	Door operator chain is rusty.		
10.4	Wire mesh between hoistways is loose and should be re-anchored.

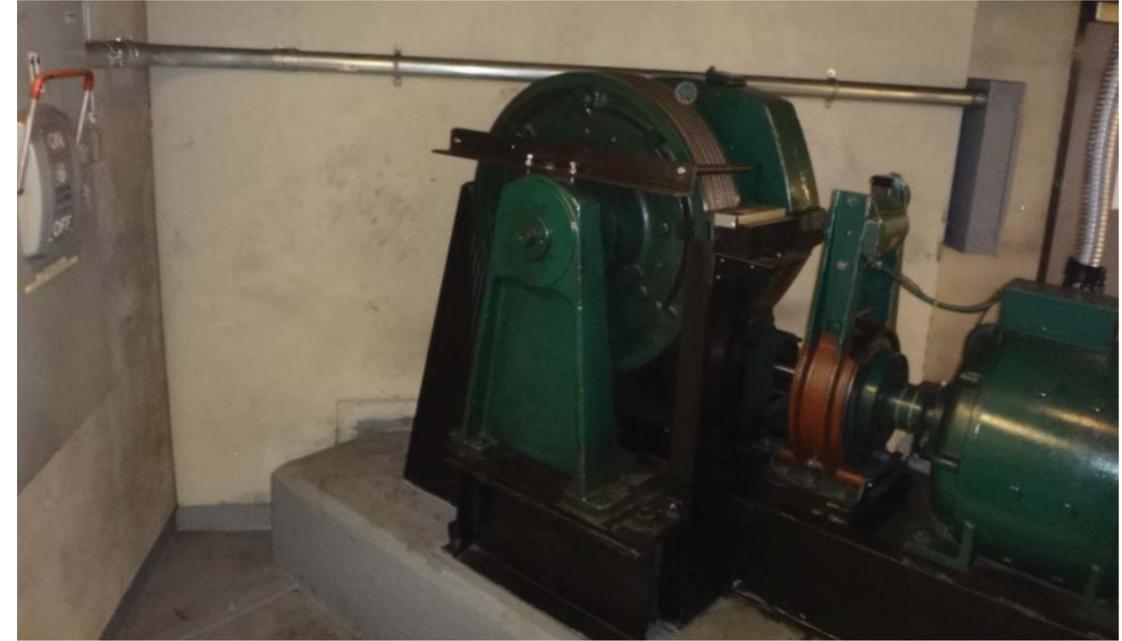
Figure 13 – Geared hoist machine for Car 11. Manufactured by Dover.

11.3	Leveling time takes too long.		
11.4	Machine is leaking a lot of oil.		
11.5	Motor brushes are making noise.		
11.6	Fire extinguisher is expired.		
11.7	Car top is dirty.

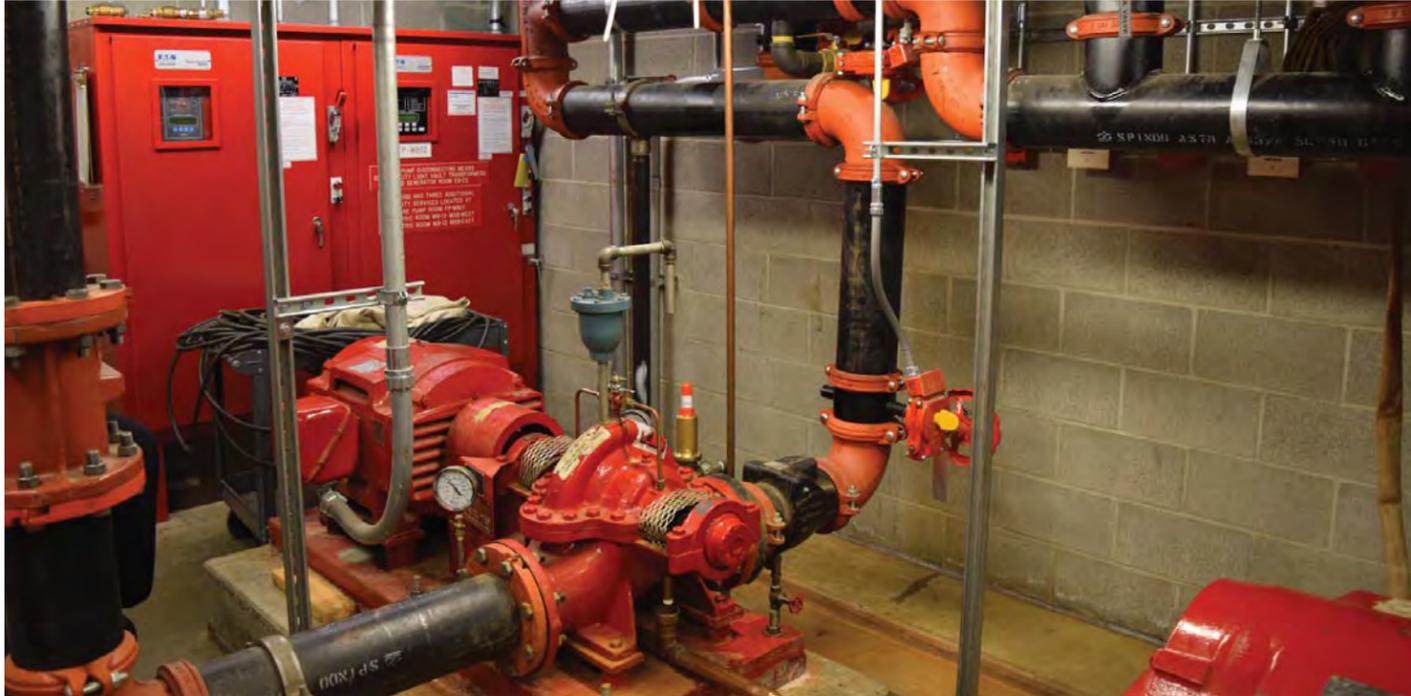
Photo of fire sprinkler pumps, fire sprinkler control panel, and fire protection water piping at basement Room WB9B. CDG photo, May 24, 2016.

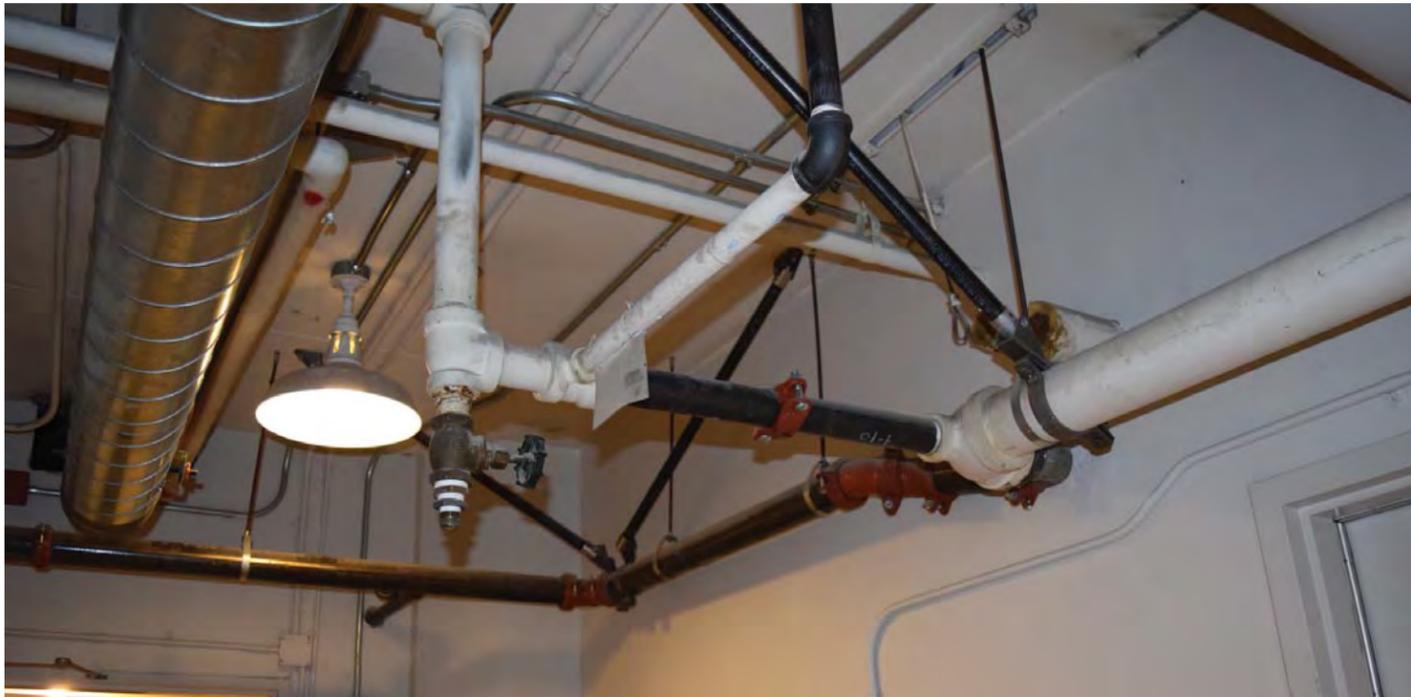
View of seismic bracing for fire protection water piping at ceiling of basement Room EB9. CDG photo, May 24, 2016.

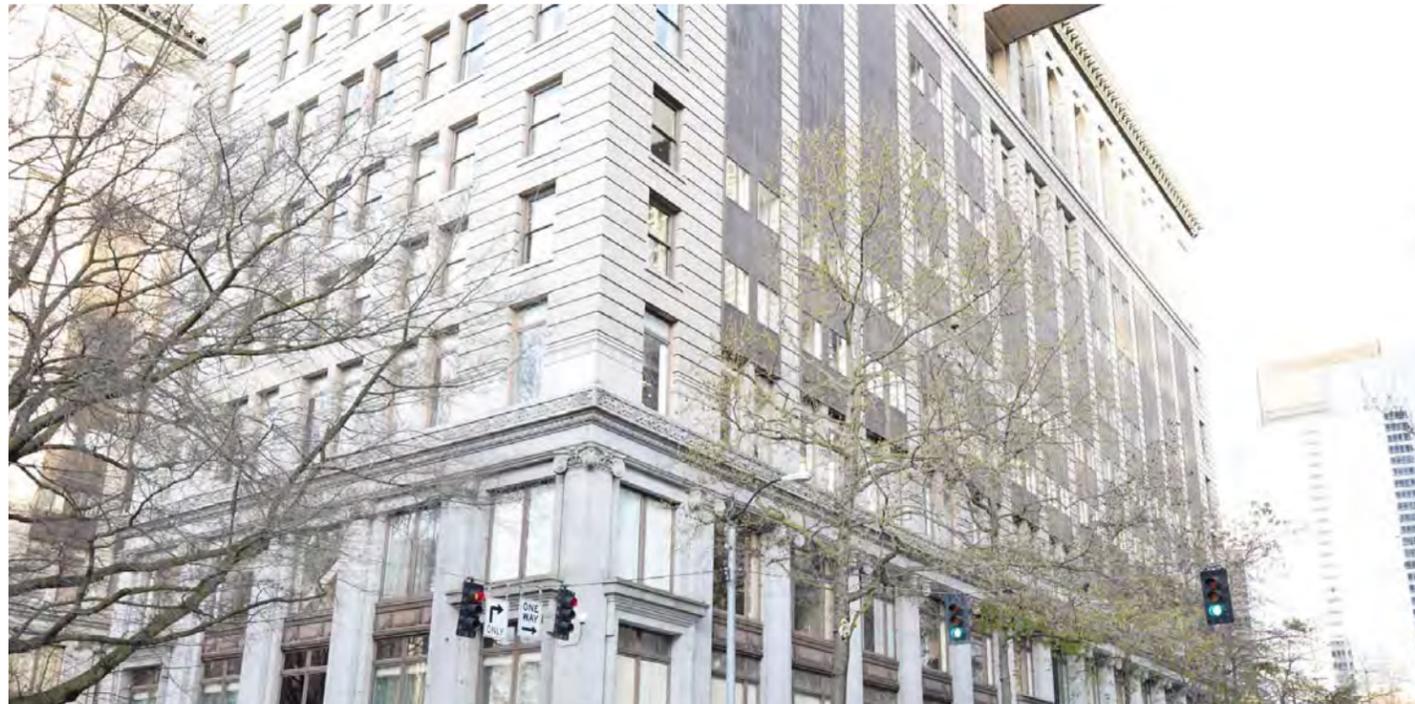
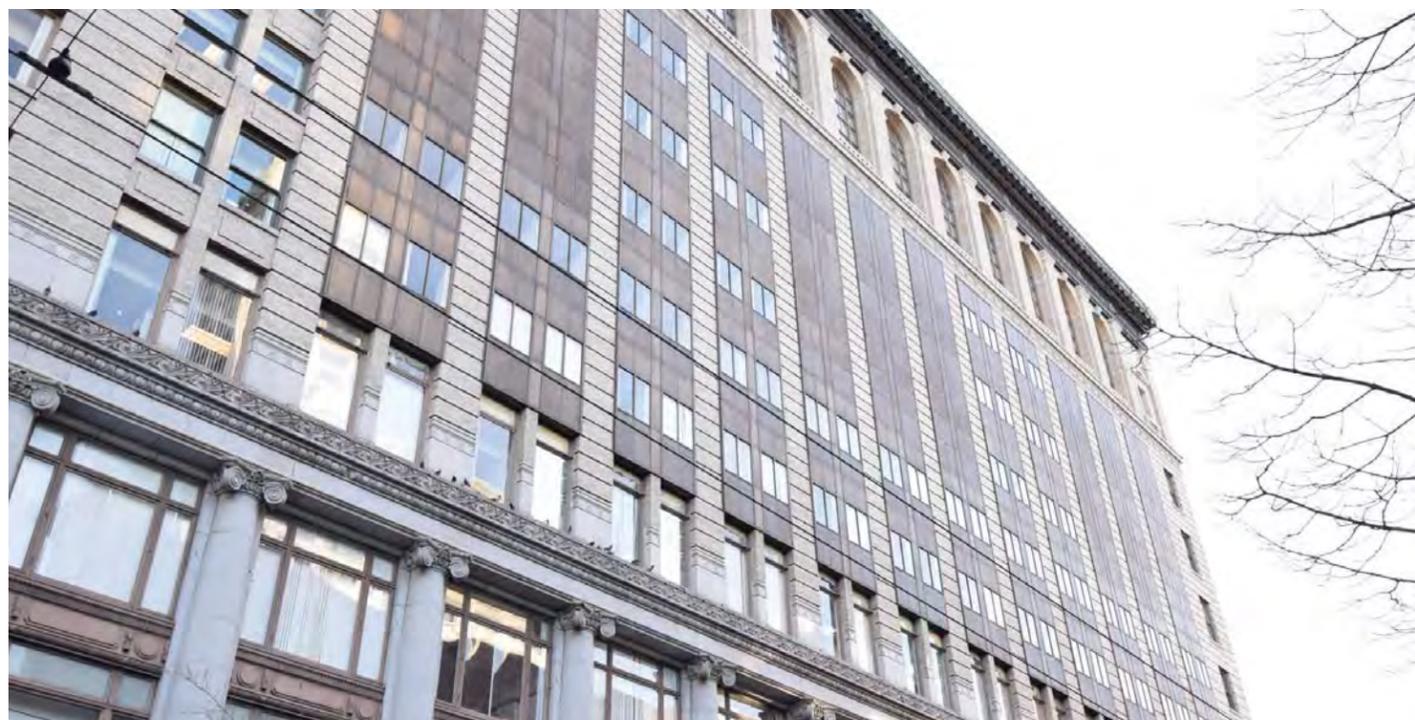
*King County Courthouse exterior, view of the aluminum window wall systems at the Fourth Avenue facade. CDG photo, March 18, 2016.*

*King County Courthouse exterior, view of the aluminum window wall systems at the Third Avenue facade. CDG photo, March 18, 2016.*

- North Elevation: Remove eight (8) 1960s-era aluminum window wall systems at the first floor and install historically-appropriate replacement window units.

- East Elevation: Remove thirteen (13) 1960s-era aluminum window wall systems at the fifth through ninth floors and install one-hundred, twenty-four (124) historically-appropriate replacement window units.

- West Elevation: Remove twelve (12) 1960s-era aluminum window wall systems at the first floor and install historically-appropriate replacement window units. Remove twelve (12) 1960s-era aluminum window wall systems at the fifth through ninth floors and install one-hundred, twenty (120) historically-appropriate replacement window units.

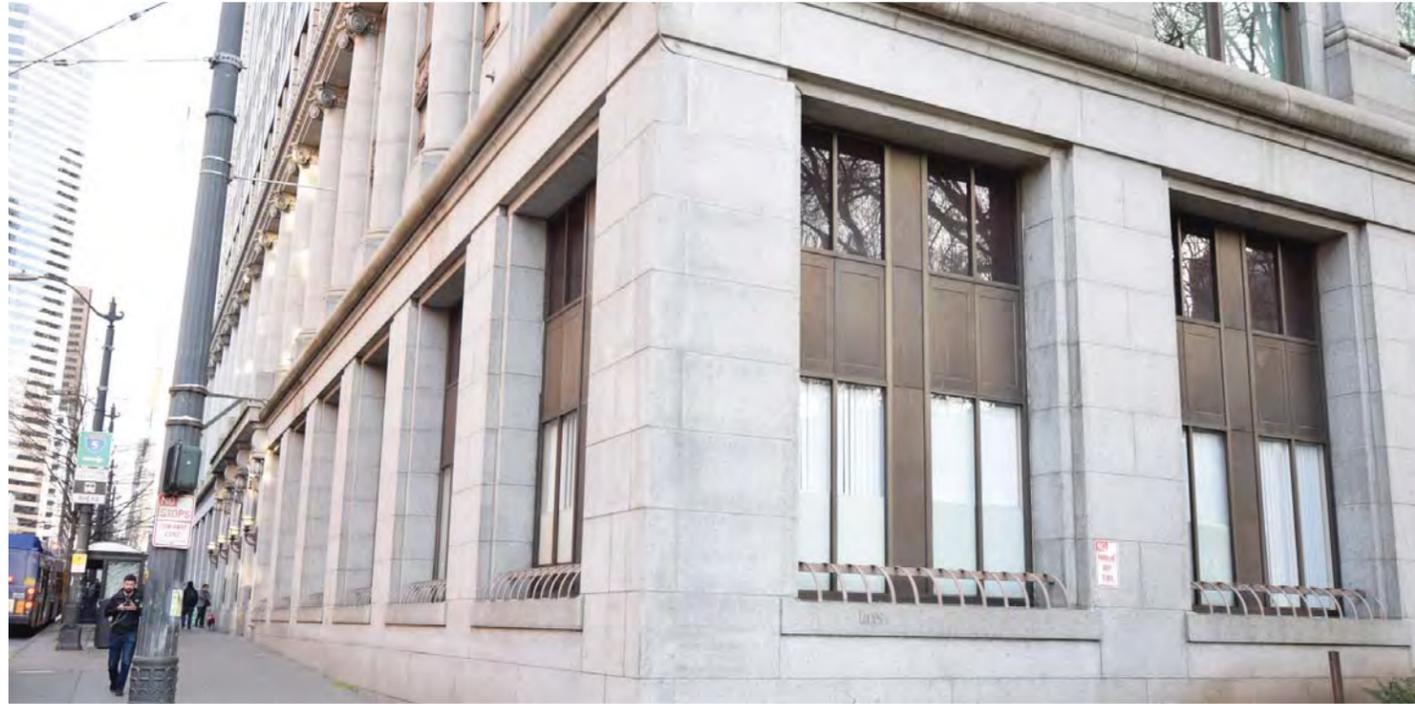
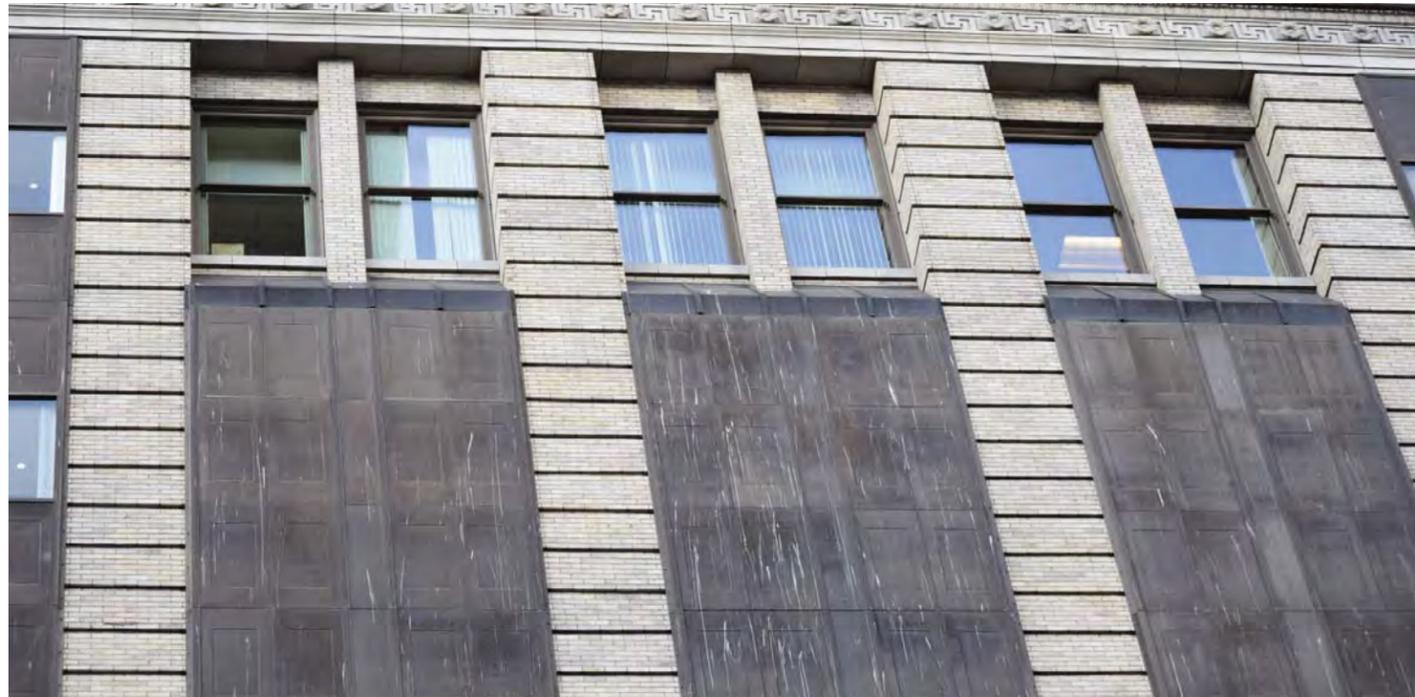
*King County Courthouse exterior, view of the aluminum window wall systems at the southwest corner of the first floor. CDG photo, March 18, 2016.*

*King County Courthouse exterior, detail view of the aluminum window wall systems at the Fourth Avenue facade. CDG photo, March 18, 2016.*

- **Granite masonry:** the removal of the 1960s aluminum window wall systems at the first floor could reveal hidden damage to the granite masonry base of the building. The extent of any damage to the granite masonry is currently unknown and would not be revealed until the window wall panels are removed. Any damaged granite would need to be repaired. Minor damage such as holes, chips, or cracks in the granite panels can be repaired using restoration mortar injections or patches to help prevent moisture intrusion into the wall assembly. Major damage such as cracked or missing granite will require more extensive and costly repair measures such as replacement granite Dutchmen. Damage to mortar joints in the granite will require repointing the mortar. Finally, exterior and interior installation details of new historically-appropriate replacement window units would be required to minimize additional damage to the granite masonry.

- **Brick masonry:** the removal of the 1960s aluminum window wall systems at the fifth through ninth floors could reveal hidden damage to the brick masonry facades. The extent of any damage to the brick masonry is currently unknown and would not be revealed until the window wall panels are removed. Any damaged brick masonry would need to be repaired. Minor damage such as holes, chips, or cracks in brick masonry units can be repaired using restoration mortar injections or patches to help prevent moisture intrusion into the wall assembly. Major damage such as cracked or missing brick masonry units will require more extensive and costly repair measures such as replica replacement brick units. Damage to mortar joints in the brick masonry will require repointing the mortar. Finally, exterior and interior installation details of new historically-appropriate replacement window units would be required to minimize additional damage to the brick masonry.

- **Terra-cotta masonry:** the removal of the 1960s aluminum window wall systems at the fifth through ninth floors could reveal hidden damage to terra-cotta window sills. The extent of any damage to the terra-cotta masonry is currently unknown and would not be revealed until the window wall panels are removed. Any damaged terra-cotta masonry would need to be repaired. Minor damage such as holes, chips, or cracks in terra-cotta units can be repaired using restoration mortar injections or patches to help prevent moisture intrusion into the wall assembly. Major damage such as cracked or missing terra-cotta units will require more extensive and costly repair measures such as replica replacement terra-cotta units. Damage to mortar joints in the terra-cotta masonry will require repointing the mortar. Finally, exterior and interior installation details of new historically-appropriate replacement window units would be required to minimize additional damage to the terra-cotta masonry.

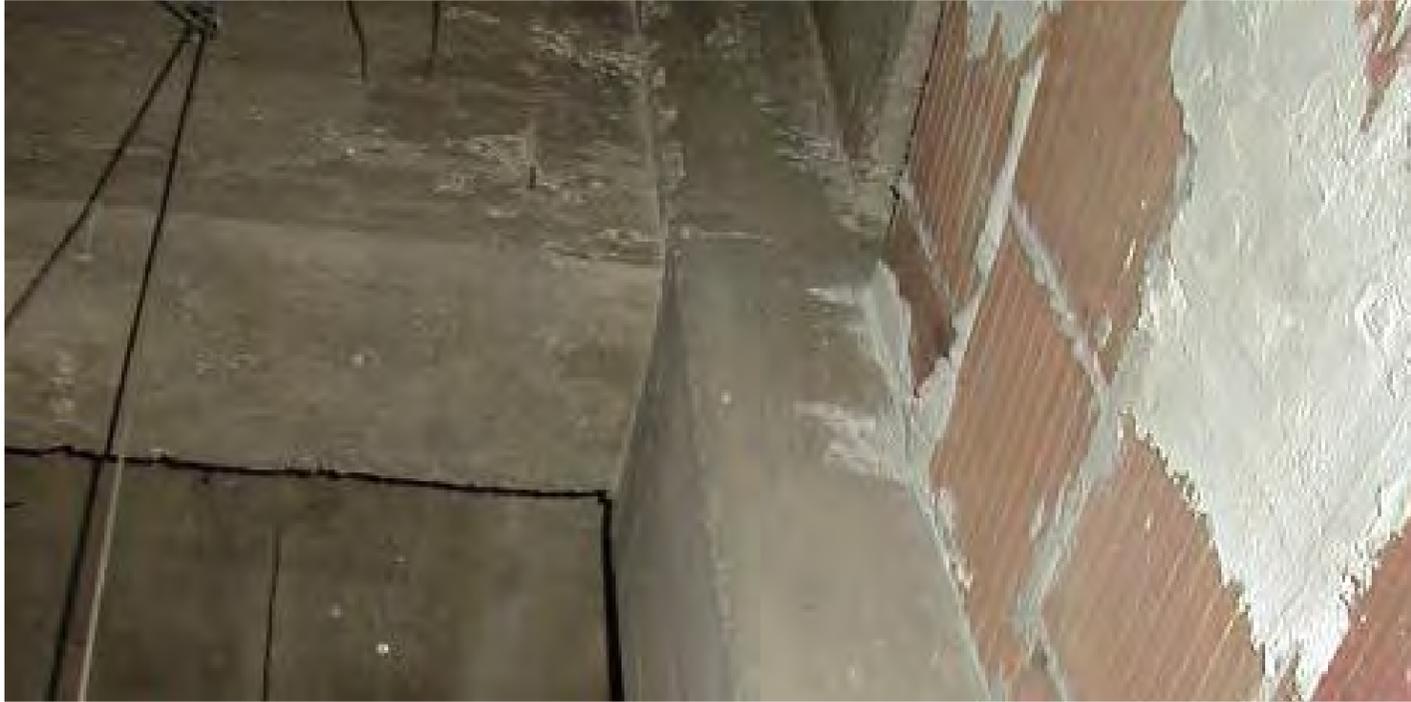
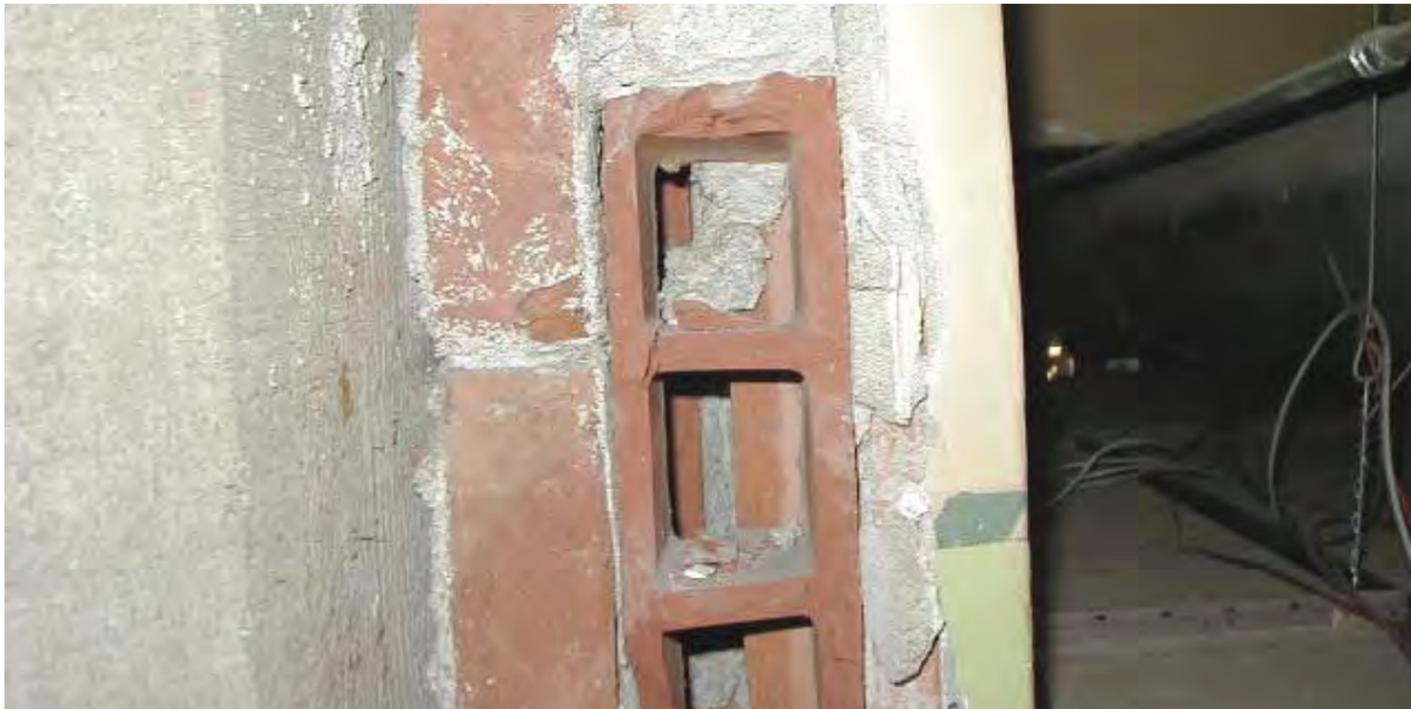
*King County Courthouse, view of hollow clay tile infill between reinforced concrete columns at exterior walls. CPL photo, February, 1, 2001.*

*King County Courthouse, detail view of voids inside hollow clay tile infill at exterior walls. CPL photo, February 1, 2001.*

The exterior walls of the King County Courthouse consist of hollow-clay tile masonry infill in the area between the reinforced concrete structural columns, beams, floors, and ceilings. The outside face of the exterior walls consists of granite veneer and brick masonry veneer with terra-cotta window sills, trim, and belt courses. The historic interior partitions inside the King County Courthouse are also hollow-clay tile masonry, and in some cases are older gypsum tile block. While some of the interior partitions have been removed over the years and in some cases replaced with concrete masonry units (CMU), many of the hollow-clay tile partitions remain in place inside the building.

Hollow-clay tile masonry walls and brick masonry veneers are examples of unreinforced masonry walls (URM). The connections between the masonry infill and the reinforced concrete structure are typically very weak gravity connections and lack the strength to resist tension loads imposed on the wall during a seismic event. Strong earthquakes can cause the partial or complete collapse of unreinforced masonry walls, endangering both the building occupants and pedestrians nearby who could be exposed to falling masonry debris.

- Install stainless steel helical fasteners through the mortar joints in the exterior masonry veneers to secure the masonry veneer to the strongbacked walls.

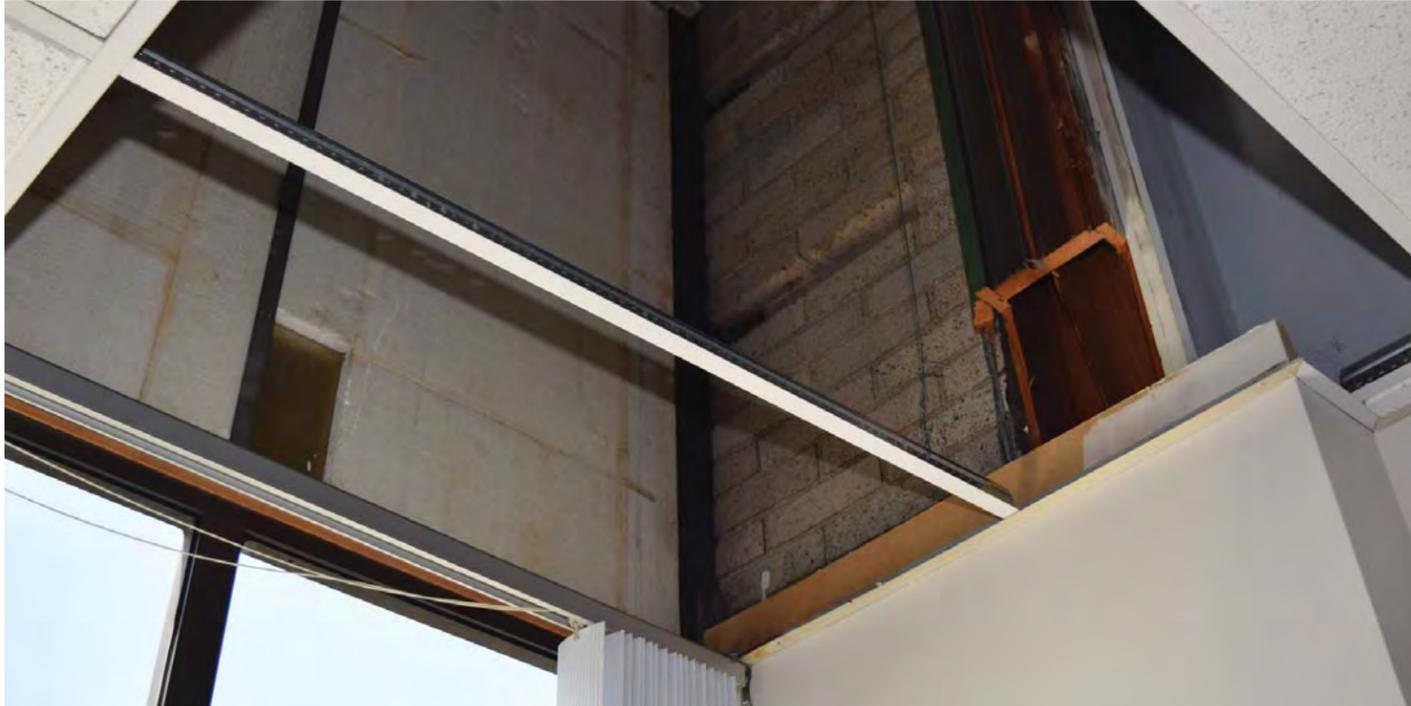
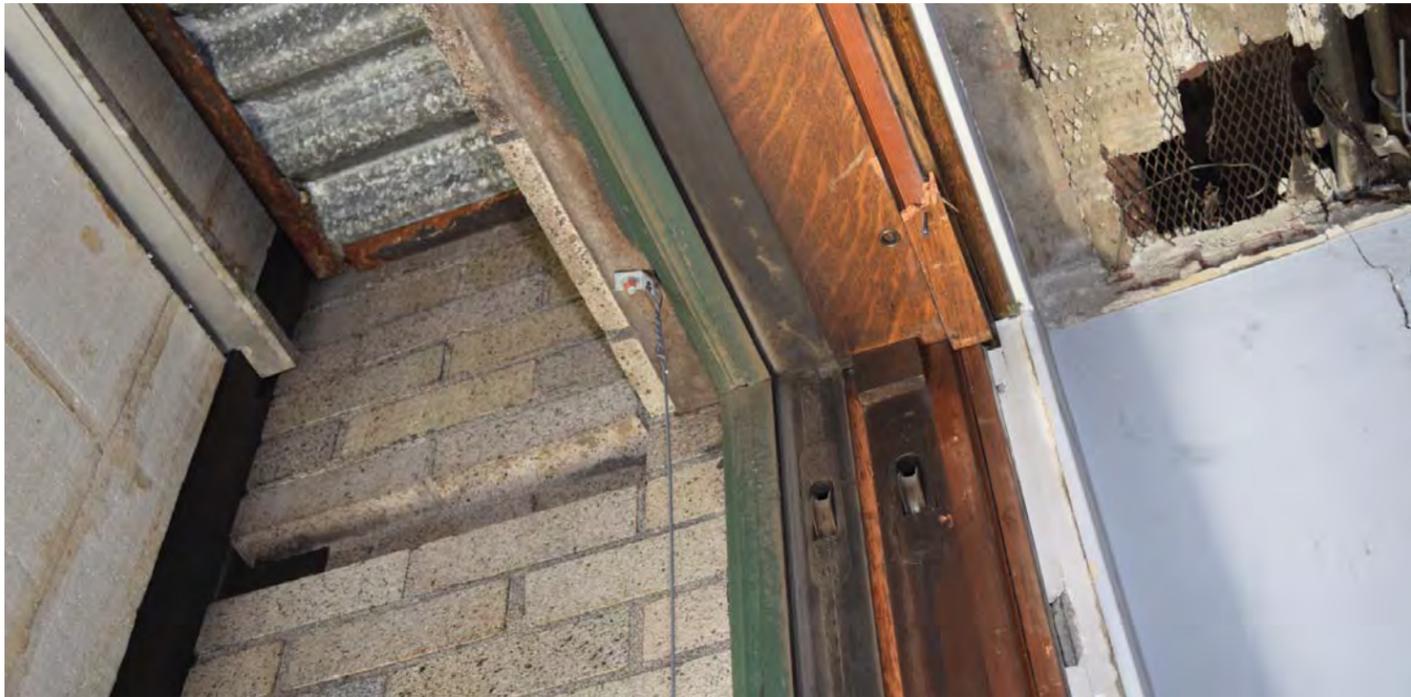
King County Courthouse interior, view of the aluminum window wall and remains of historic wood double hung window at the Third Avenue facade. CDG photo, May 20, 2016.

The proposed removal of the non-historic window wall panels and restoration of missing windows on the exterior of the building will have a significant impact on the existing interior finishes on several levels of the King County Courthouse. Once the window wall panels are removed and the window openings and interior wall surfaces restored to their historic condition, spaces within the building that have been sealed off from natural light for the past 50 years will once again have natural lighting.

The reintroduction of natural light is an issue that will need to be addressed, in particular at the courtrooms and jury deliberation rooms. Even though the replacement window units will have thermally-broken frames and feature energy-efficient double-pane glazing, window coverings such as venetian blinds or roller shades will need to be installed at these restored window openings. Light control is required to help reduce solar heat gain and glare into interior spaces and to allow for room darkening for audiovisual presentations during court proceedings. Significant advances have been made in roller shade technology in recent years, and modern roller shades are offered in a wide range of attractive materials. Materials range from partially translucent to totally opaque.

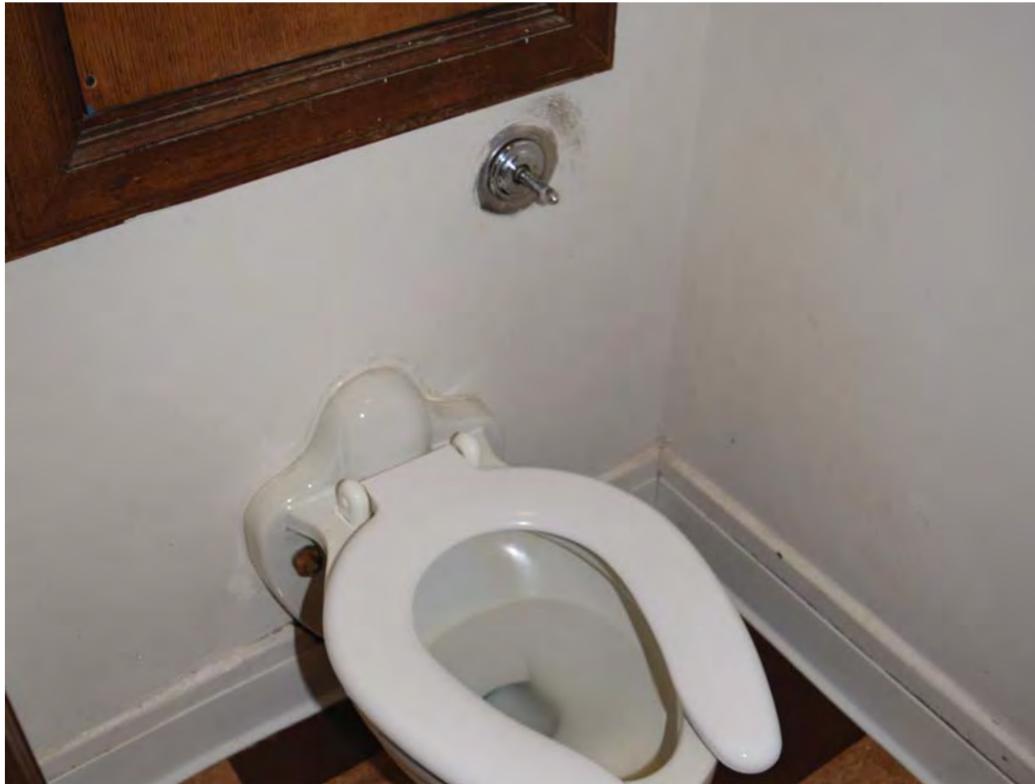
King County Courthouse interior view of plaster wall finish at jury deliberation room restroom W727B. CDG photo, May 20, 2016.

In order to replace plumbing fixtures such as water closets, it will be necessary to open up the restroom walls in order to replace piping, change out the carriers for the water closets, upgrade flush valves. This work has the potential to affect existing historic materials at the restrooms. There are a variety of existing materials at the water closet locations, ranging from historic marble wainscoting and plaster walls in some of the judge's chamber and jury deliberation room restrooms to 1960s-era tile in the public restrooms. Additionally, some of this work may also affect historic flooring materials such as tile or terrazzo.

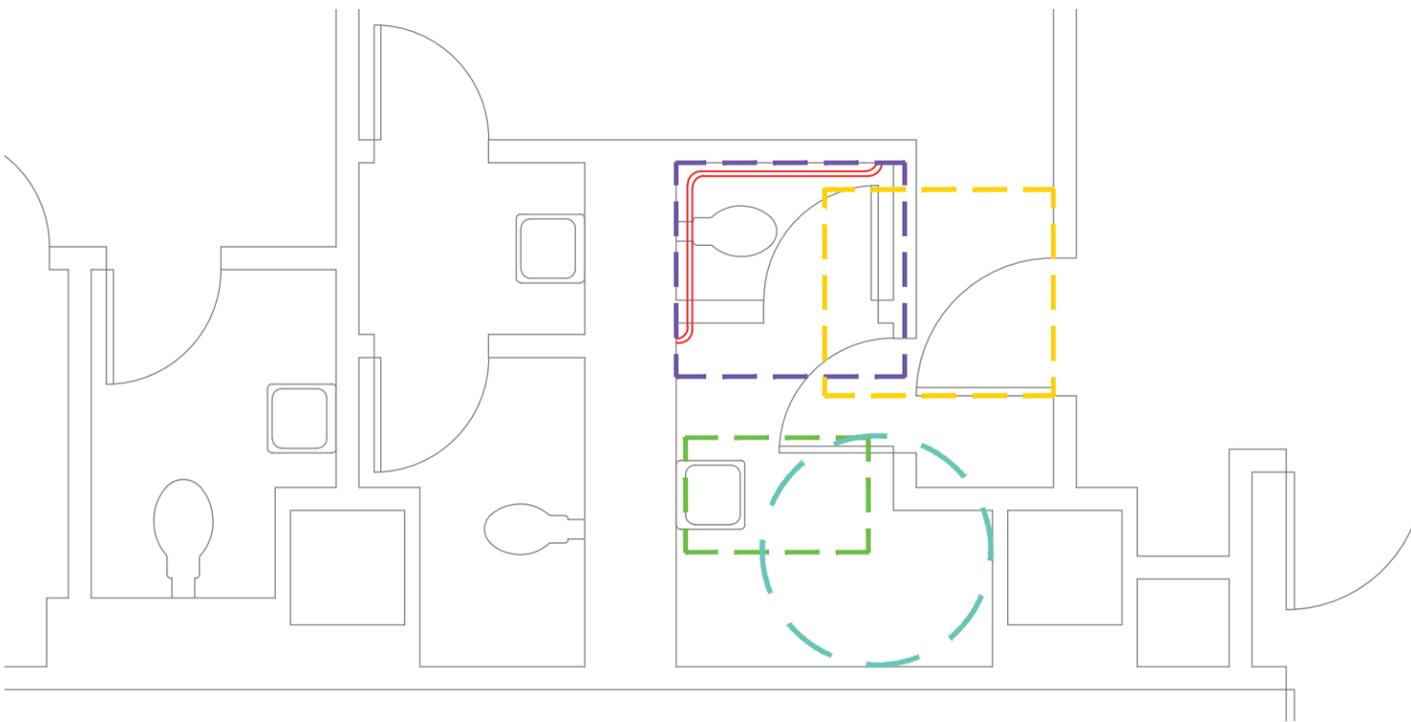
Diagram showing the required ADA clearances for toilets and lavatories superimposed over a drawing of the existing toilet room configuration at the jury deliberation rooms.

- Jury Room W721 at Superior Court Courtroom W719 (toilet rooms are W721A and W721B)
- Jury Room W727 at Superior Court Courtroom W728 (toilet rooms are W727A and W727B)  
(Note: Clark Design Group observed this jury room and two toilet rooms on May 20, 2016 and confirmed that these toilet rooms are not ADA-compliant)

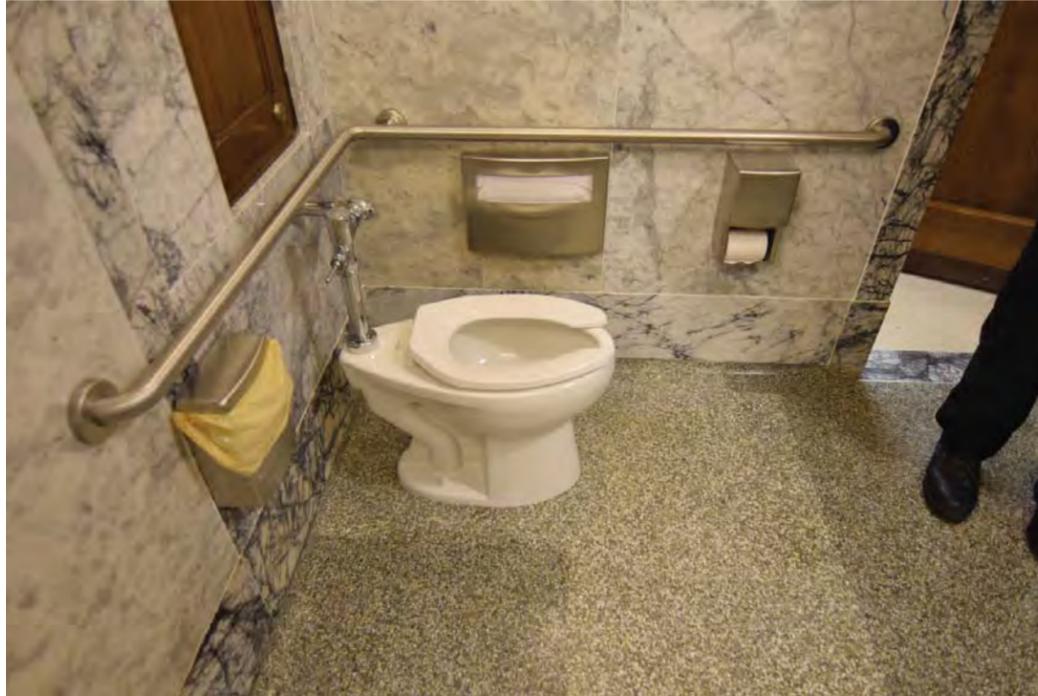
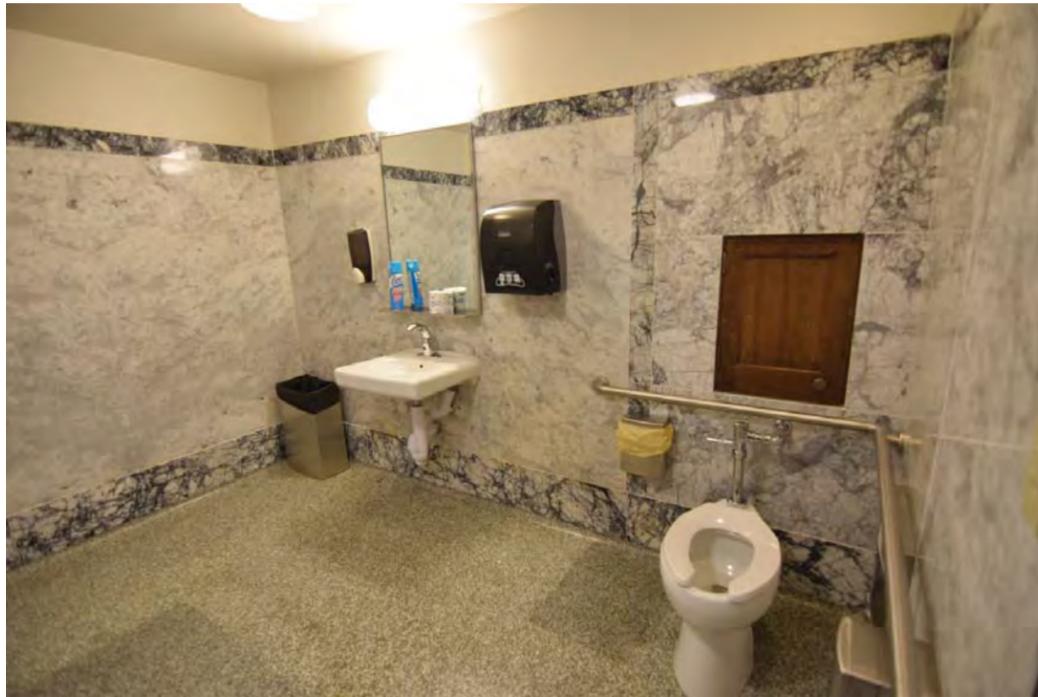
King County Courthouse jury deliberation room restroom E761B showing the ADA upgrade performed by King County Facilities Management Division. CDG photo, June 2, 2016.
