King County Department of Natural Resources and Parks Water and Land Resources Division 2019-2020 Flood Season Report

May 1, 2020

Department of Natural Resources and Parks
Water and Land Resources Division
River and Floodplain Management Section
201 South Jackson Street, Suite 600
Seattle, WA 98104
<http://www.kingcounty.gov/wlr>

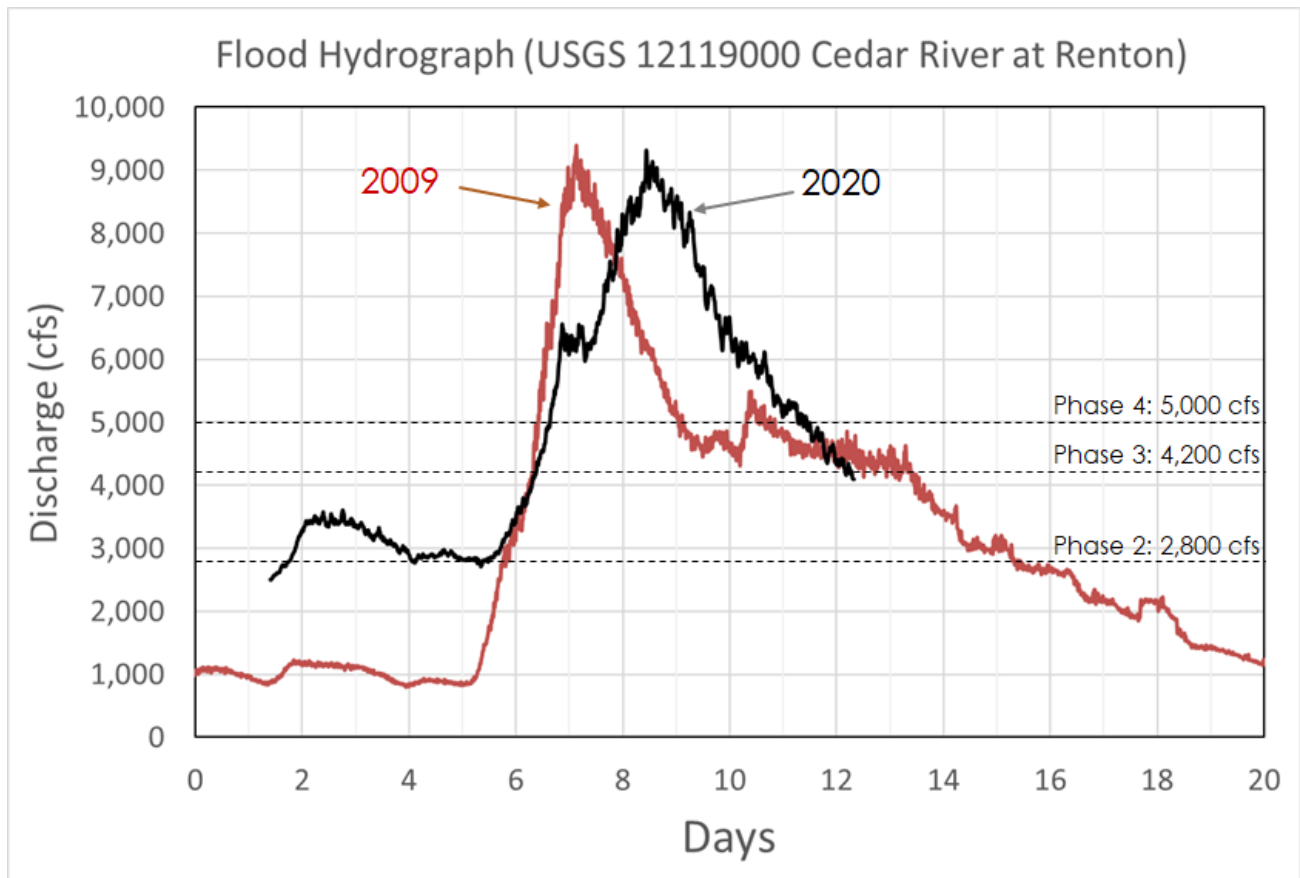
Figure 2. Flood Hydrograph for Cedar River at Renton (2009 vs. 2020).

Flows in the Cedar River during the February 5-11, 2020, flood were similar in magnitude to the 2009 flood (9,620 cfs at Renton on February 8, which is approximately a 2 percent annual chance flood or 50-year recurrence interval), but remained above Phase 4 for twice the duration (4 versus 2 days over 5,000 cfs) compared to the 2009 flood (Figure 2). Longer durations of Phase 4 high velocity erosive flows caused extensive flooding and flood-related damage throughout the Cedar River valley below Landsburg. The February 2020 flood caused the Cedar River to avulse (a rapid change in the course of a river alignment) at two locations. The loss of a portion of the Riverbend Lower Revetment at RM 6.85 allowed the river to avulse through Cavanaugh Pond and damage the upstream end of the Cedar River Trail (CRT) Site 2 Revetment. The second avulsion on the Cedar River occurred near RM 16.48 in the Dorre Don neighborhood, where the main flow of the river occupied a left floodplain side channel that could potentially increase bank erosion. Heavy rainfall triggered several landslides throughout the valley that led to temporary road closures, including State Route 169 (SR 169) and closure of the Cedar River Trail within the City of Renton.
